# COMPO BEACH BUILDINGS WESTPORT, CT

A REPORT PREPARED BY:  
First Selectman's Maintenance Study Committee  
Town of Westport, Westport CT 06880

FIRST SELECTMAN'S MAINTENANCE STUDY COMMITTEE  
REPORT FOR COMPO BEACH BUILDINGS  
REPORT PREPARED ON April 10, 2023

INSPECTION OF THE COMPO BEACH BUILDINGS ON MARCH 21, 2024

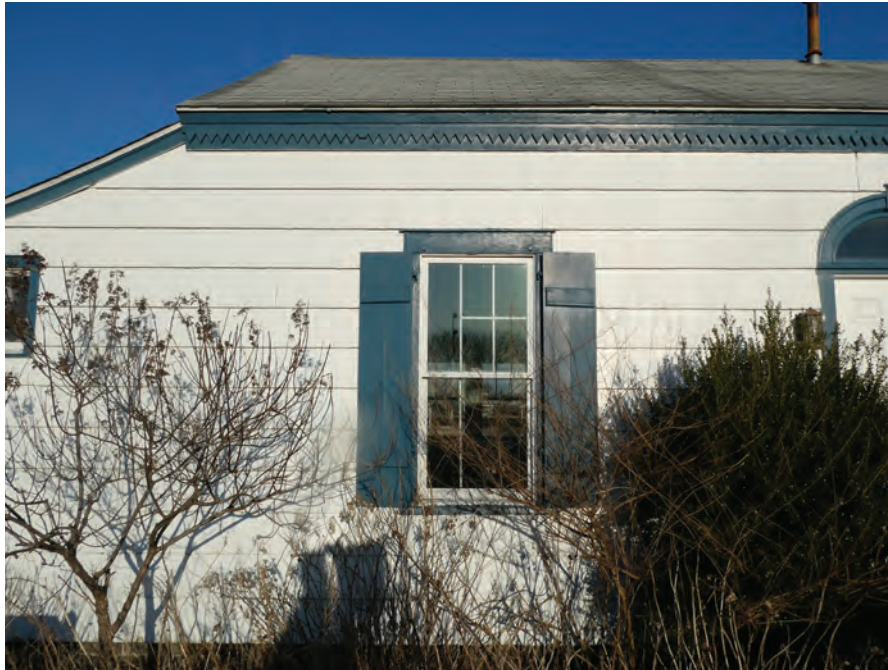
ROTTED SILL AND OLD WINDOW (REPLACE)

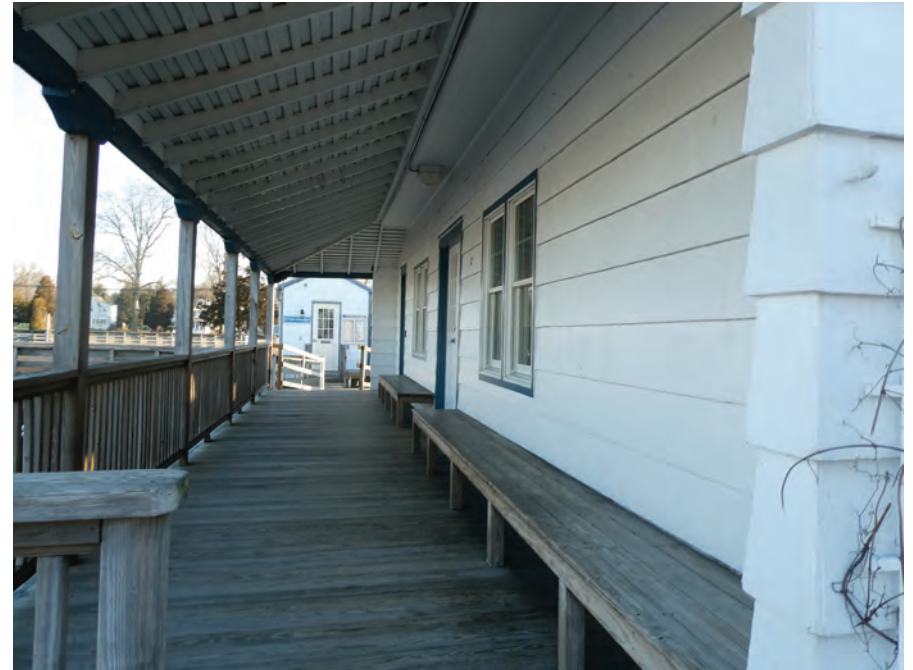
PAINT SIDING SOON

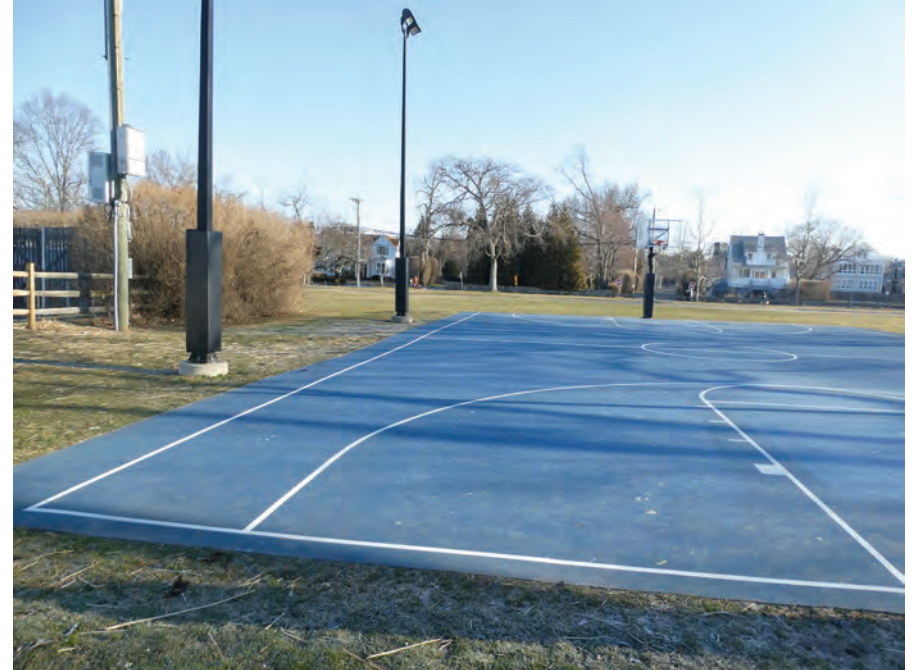
SELECT AREA DETERIORATION

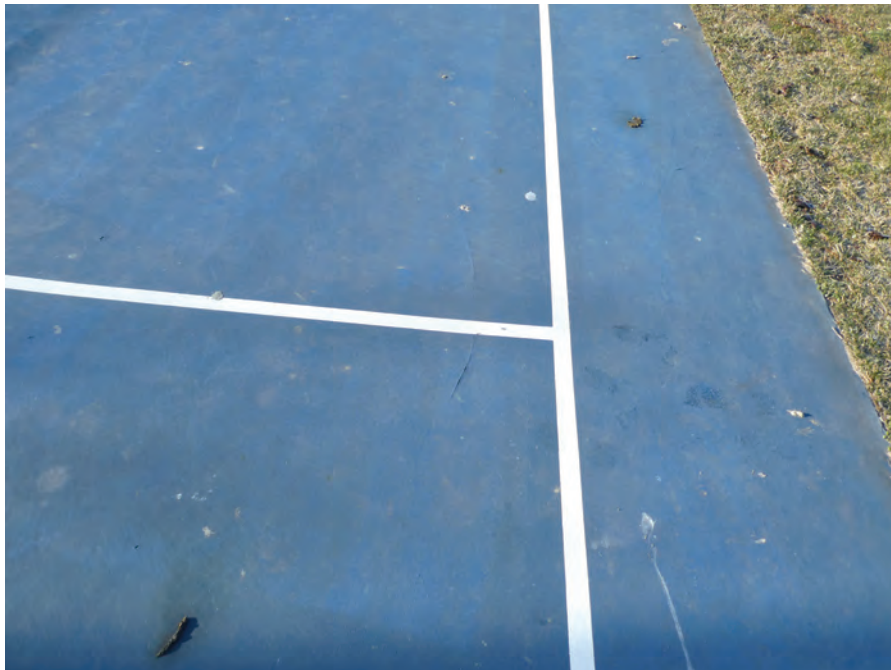
The basketball courts, though in whole appear in good shape, do have some slight cracking of the asphalt and topping surface from side to side of the north court and spider cracking in the south court, also across the width of the court. The open crack joints have previously been repaired. These cracks are again open and, in some areas, could cause a tripping hazard. Repairs should be made to the newer topcoat in these areas. Lighting appears adequate.

TRIPPING HAZARD

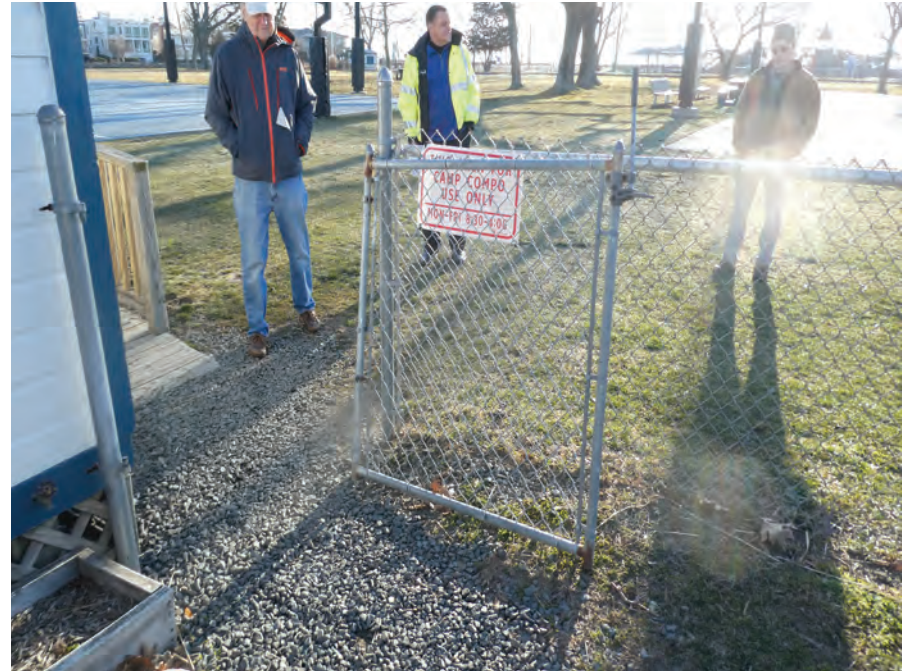
GRAVEL AREA SHOULD BE PAVED.

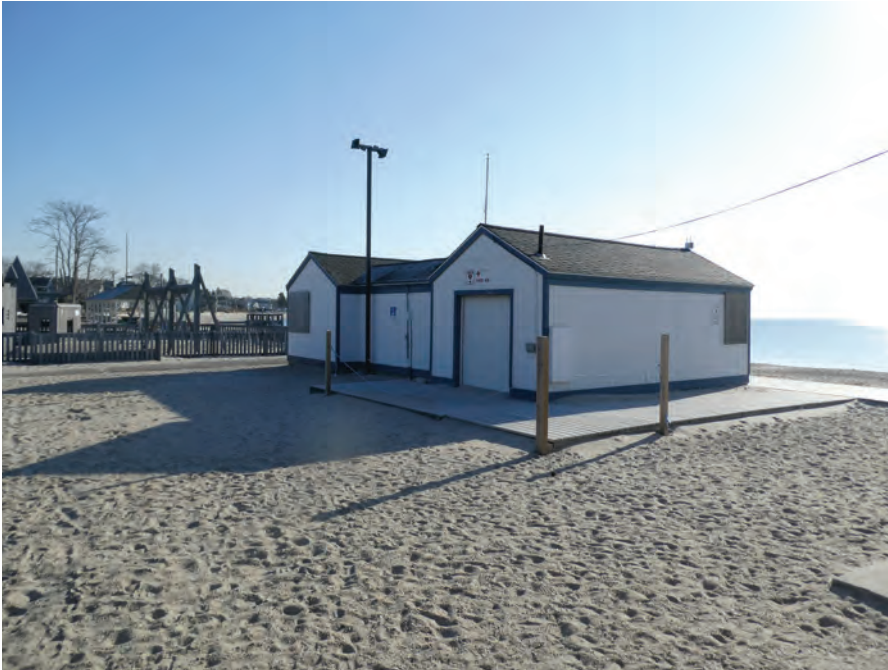
These two wood frames, shingle roofed structures are located near the Basketball courts. The barn-type prefab structure is newer than the older pitched roof building of 30 x 14 +/- feet. The older structure requires some maintenance to the exterior as can be found in the budget costing. There is some grading and pavement that is needed at the bottom of the wood ramp area, the chain link gate requires repair.

GATE UNHINGED REQUIRED REPLACEMENT.

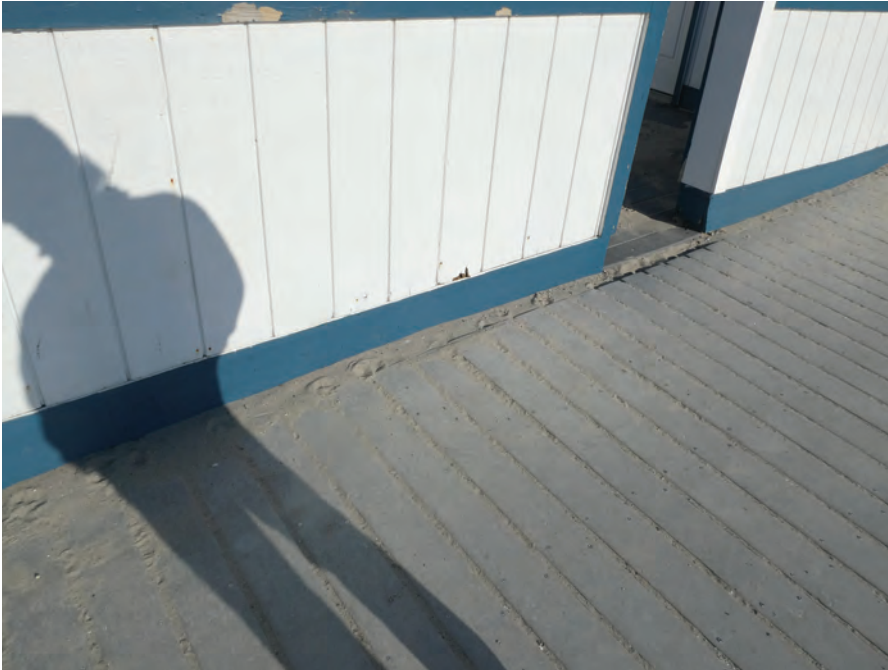
AREA REQUIRED SOME SIDING REPLACEMENT

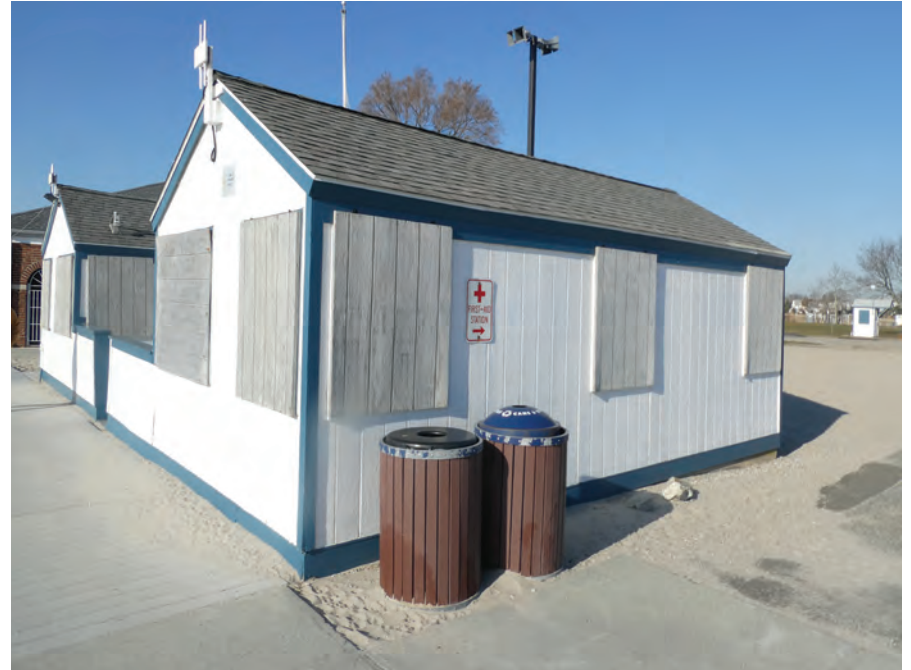
REPAIRS REQUIRED

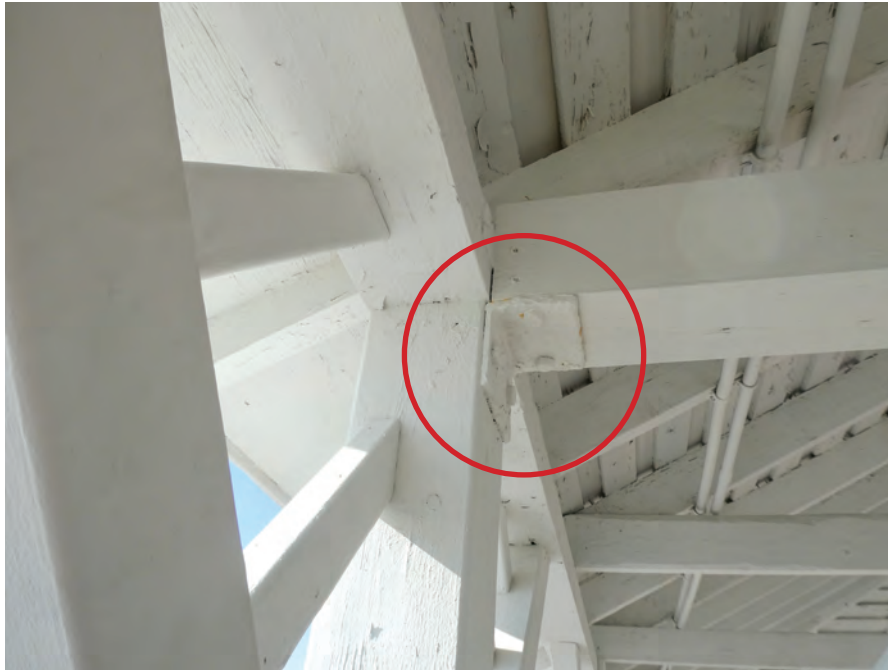
PAINT UNDERSIDE OF ROOF

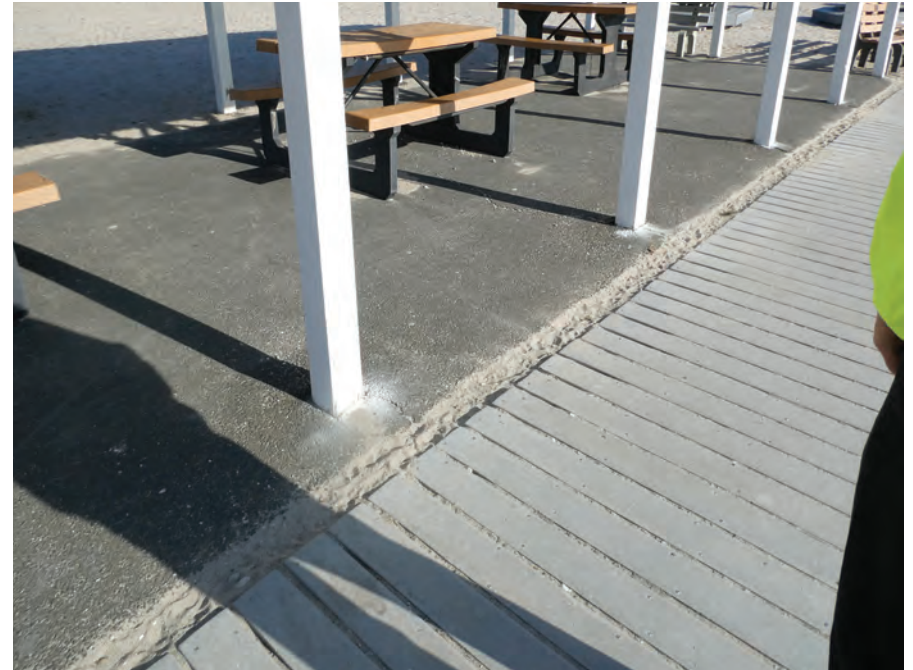
The original white Pavilion (towards the north) in 2010 recently had its columns rebuilt and reinforced, and the structure stands as an icon of the history of Westport, with its gusset column to beam framing and interior truss and framing patterning. The sill to rafter brackets are rusting and should be replaced. The underside of the Pavilion requires proper repainting as some peeling, flaking, and other similar wear and tear is quite evident. The asphalt slab floor, atop where picnic benches sit, is in good shape. The main spire (mast) was replaced after the last hurricane broke the element.

REPLACE RUSTED ANGLES AND TIES

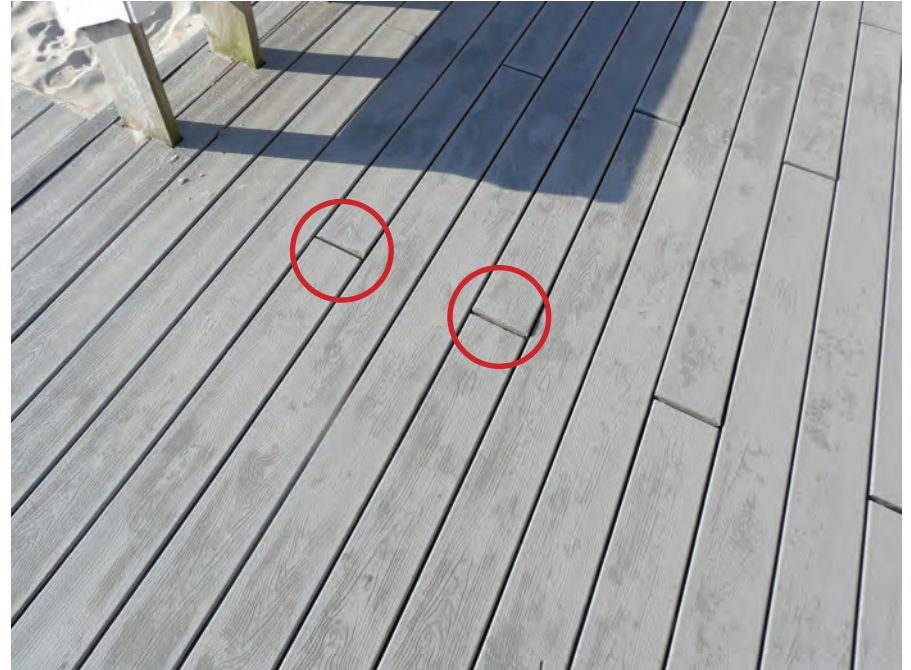
It was noted and observed that the main northern boardwalk surface is getting very old, (different from in front of the concession area). It has lost much of its surface grip and can be slippery when wet. Further the board have derogated with sun and wind and the SS screws are sticking up, this is a potential hazard too bare foot walkers, and others. Some screws also appear sharp. Screws are set into sleepers of the same vintage as the boards. The boardwalk has been reset and repaired many times over the years, after various bad storms. It is time to consider a full replacement of this boardwalk area, with a material and color to be selected, that also perhaps does not get so hot in the summer sun. The area in front of the concession (see pictures) also has some board ends with cupping and can be tripping hazards, as observed, and noted in photos.

OLD BOARDWALK - REPLACE

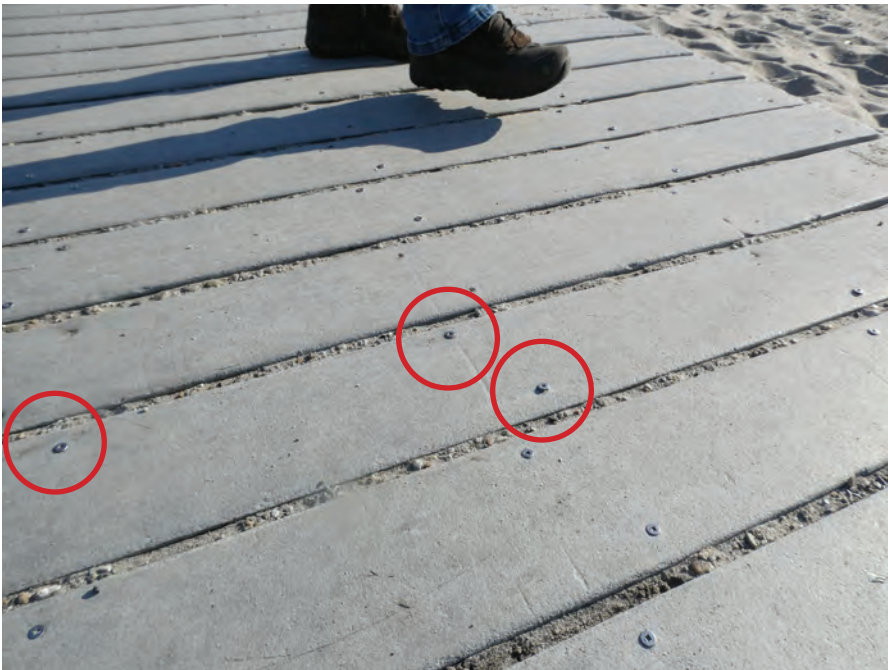
TRIPPING HAZARDS

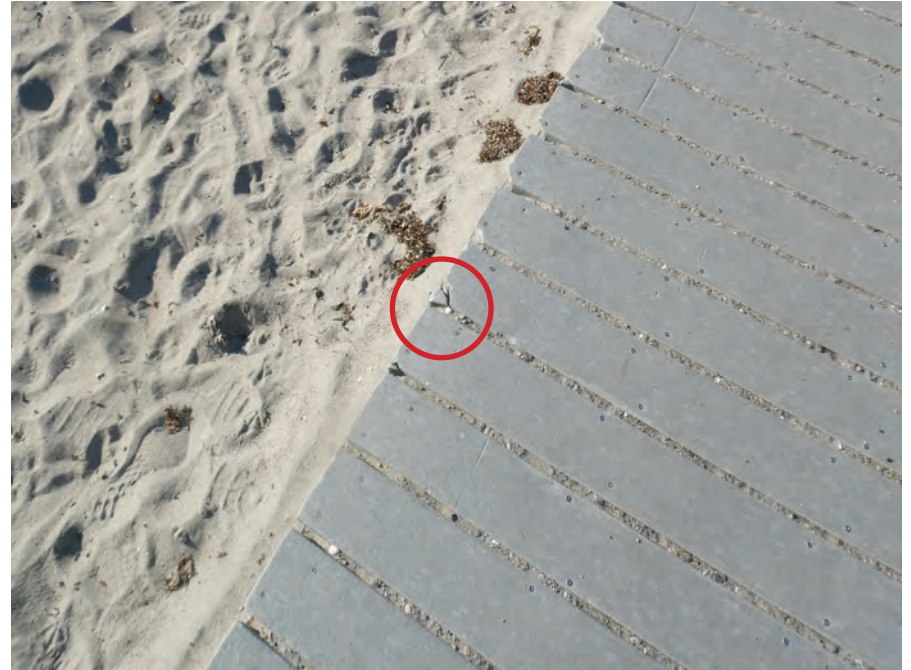
SHARP EDGES SCREWS

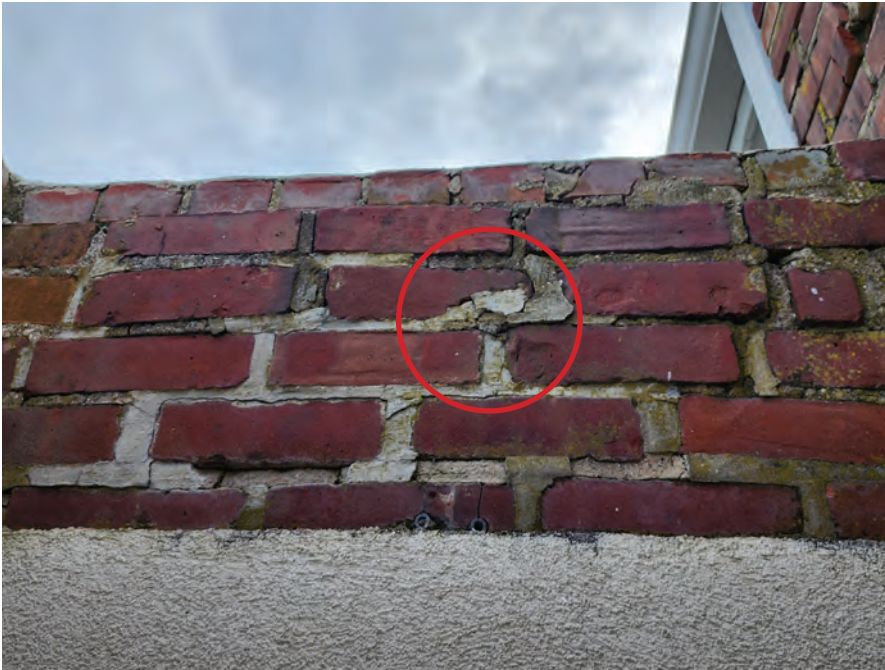
TREE ROOT AFFECTING WALL REPOINTING REQUIRED IN SELECT AREAS.

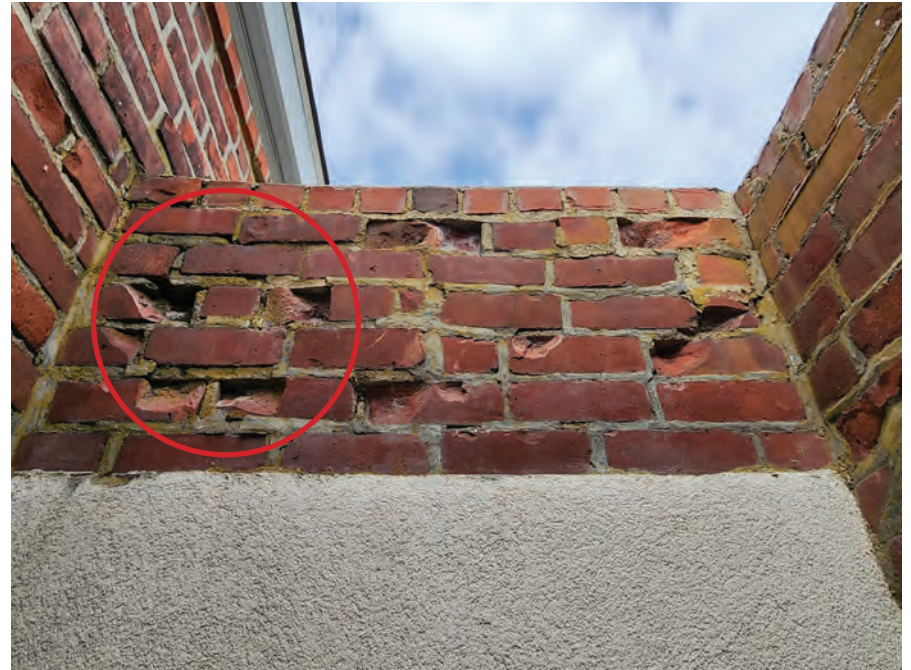
SPALLING POINTING

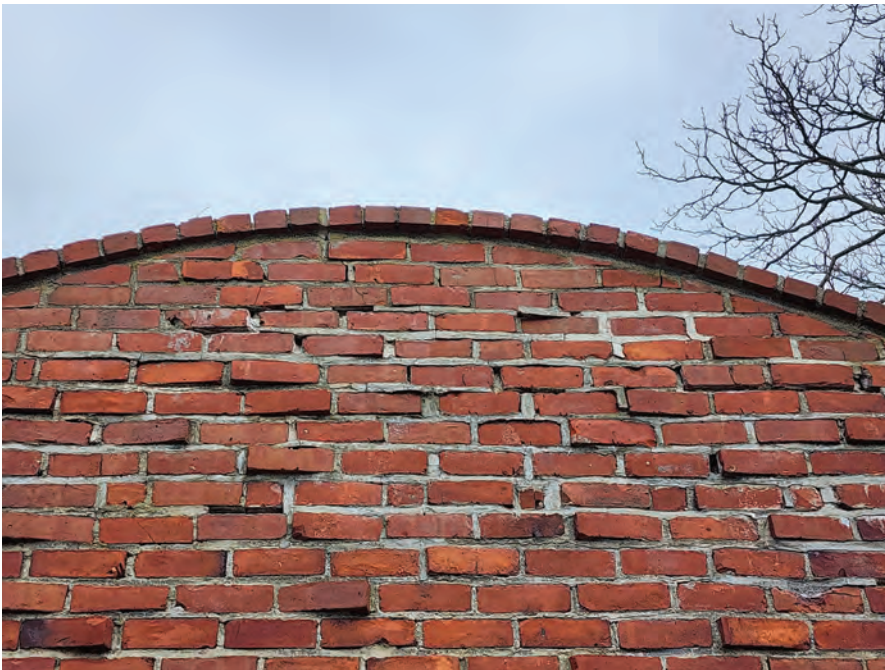
LOOSE BRICK SHARDS

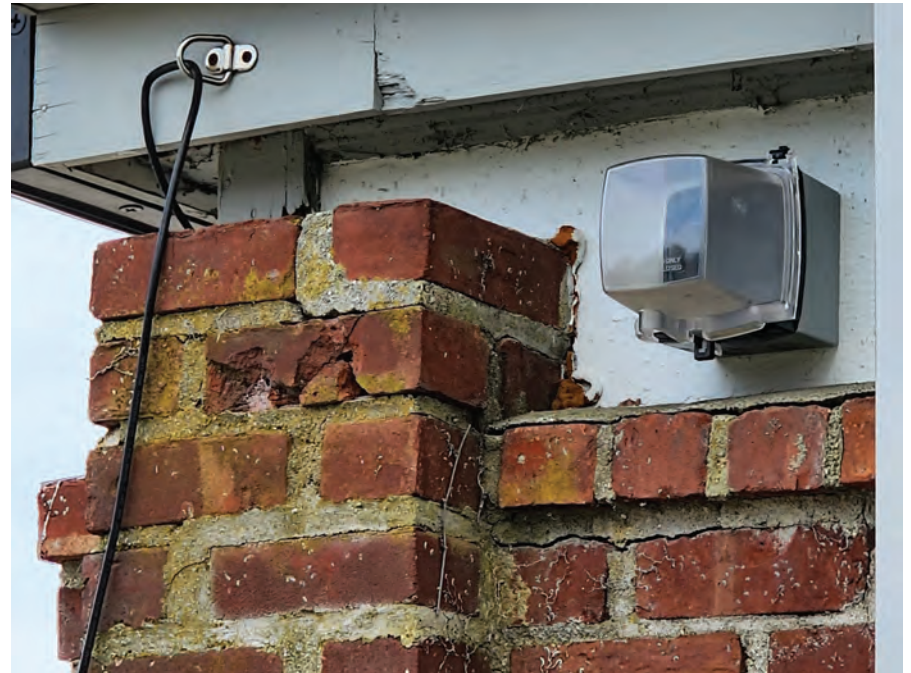
FAILING REPOINTING

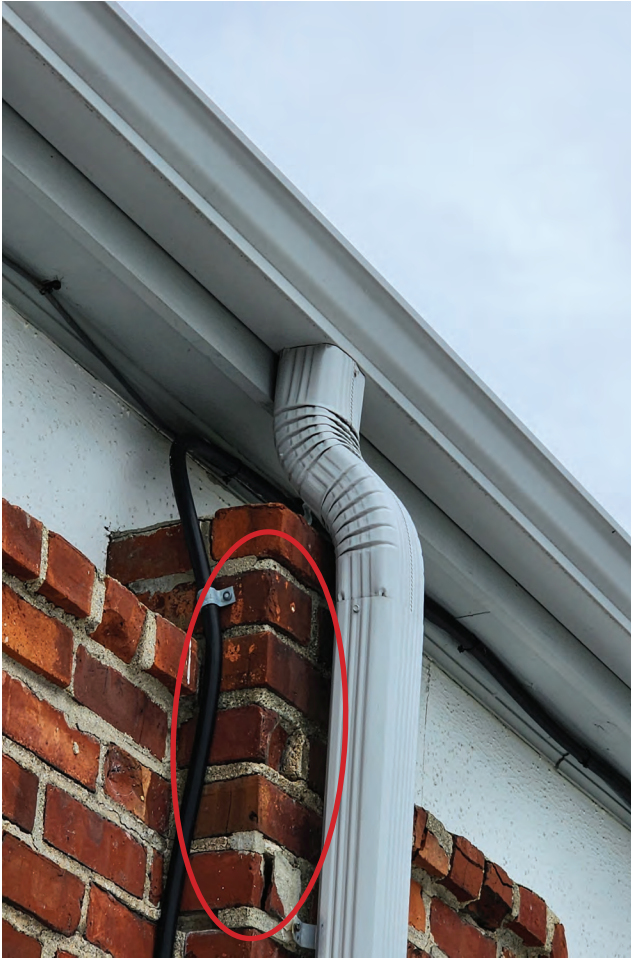
LOOSE BRICK TOP CAP

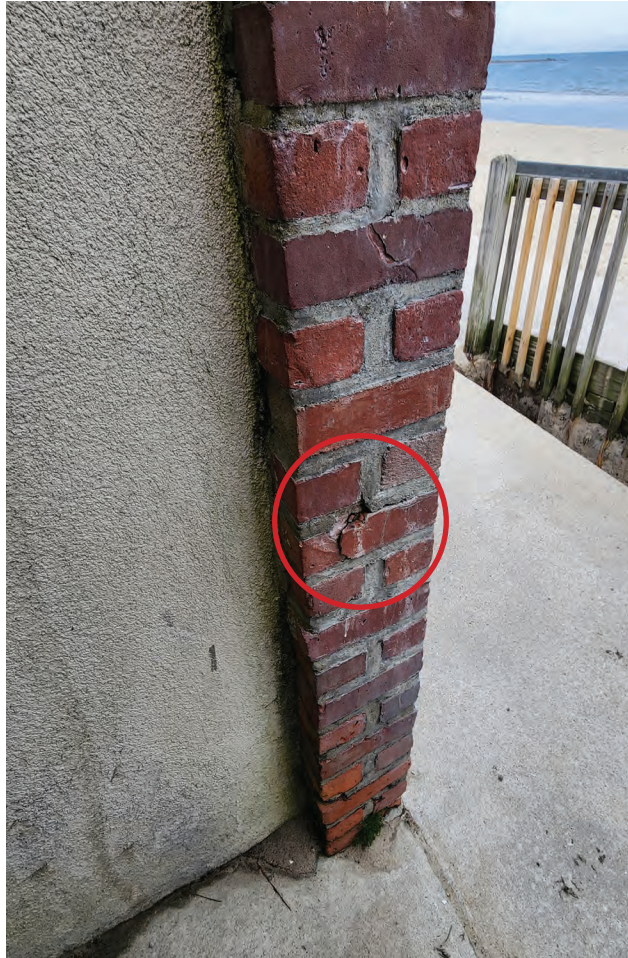
REPOINTING AT COLUMN CAP

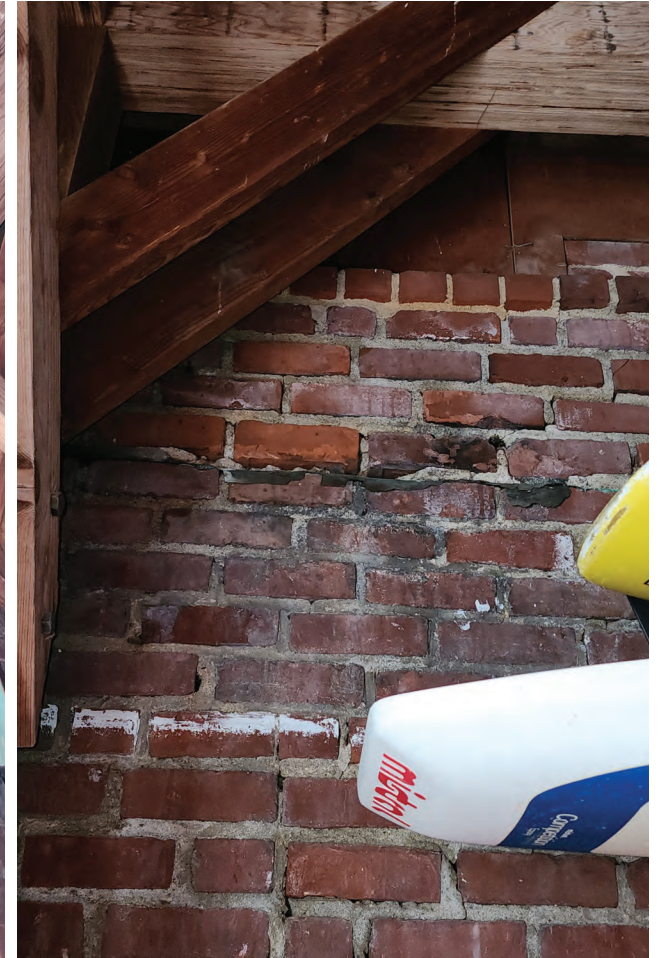
HORIZONTAL CRACK IN WALL.

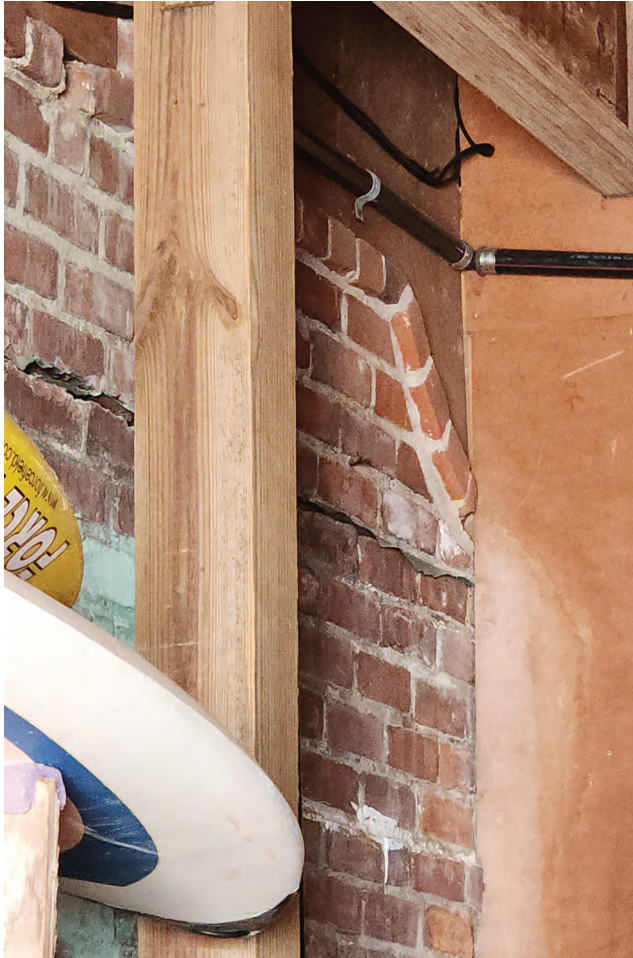
REPOINTING REQUIRED.

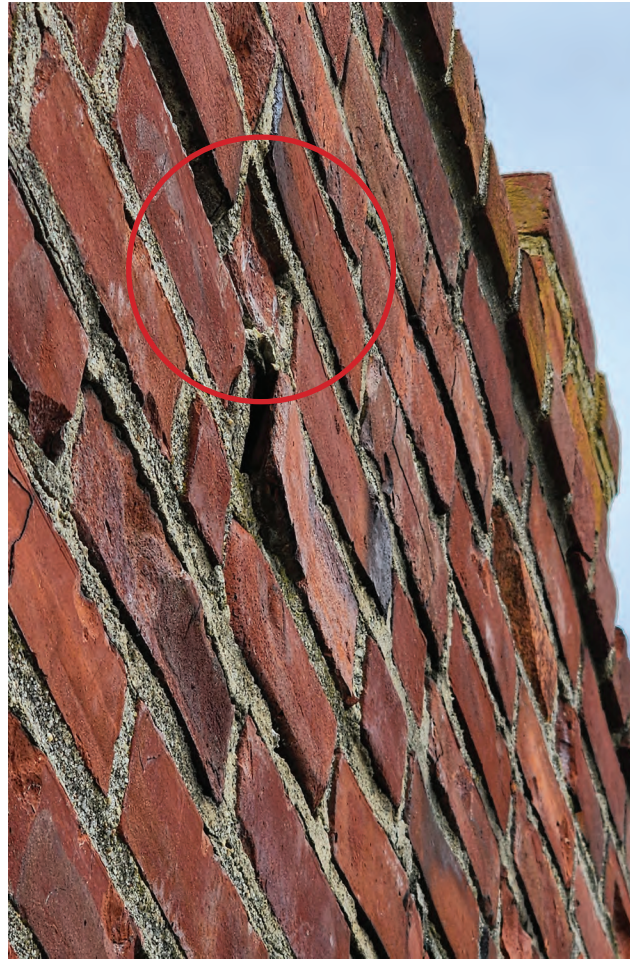
COLUMN BUTTRESS SEPERATION

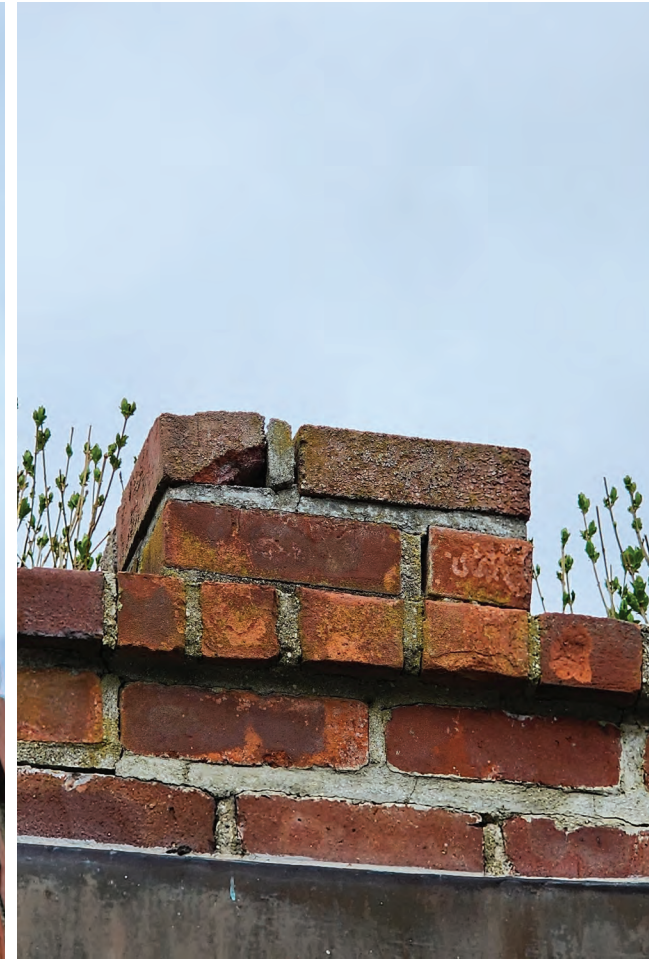
SOME SPALLING BRICK.

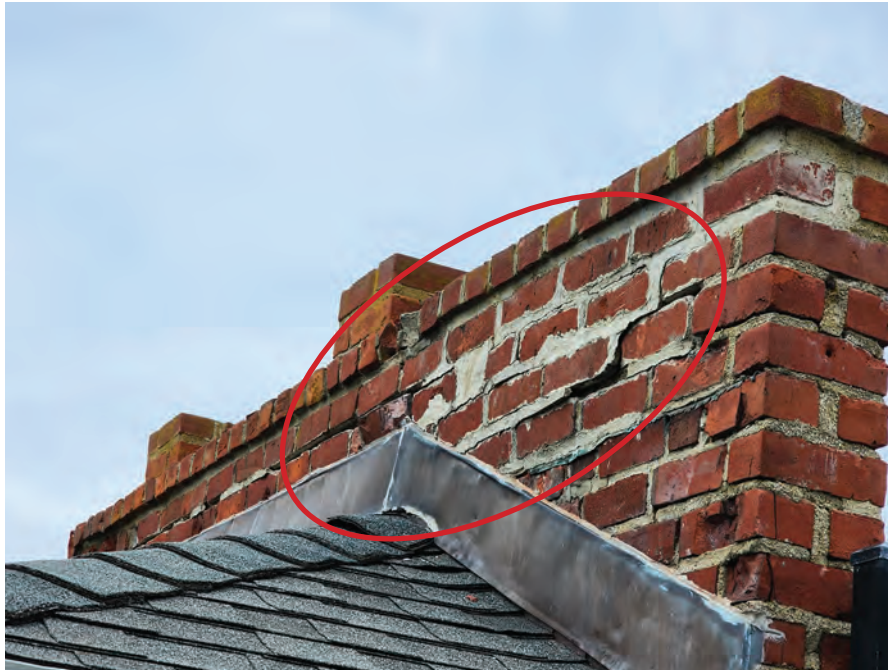
BRICK TOP CAP REQUIRED RESETING (REPAIR)

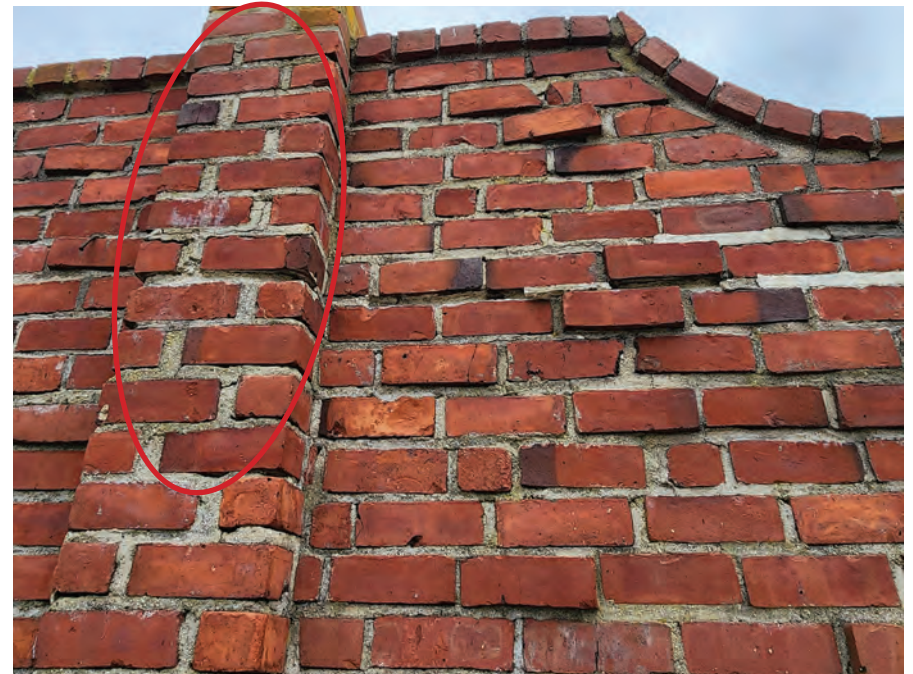
PARAPET REBUILD REQUIRED.

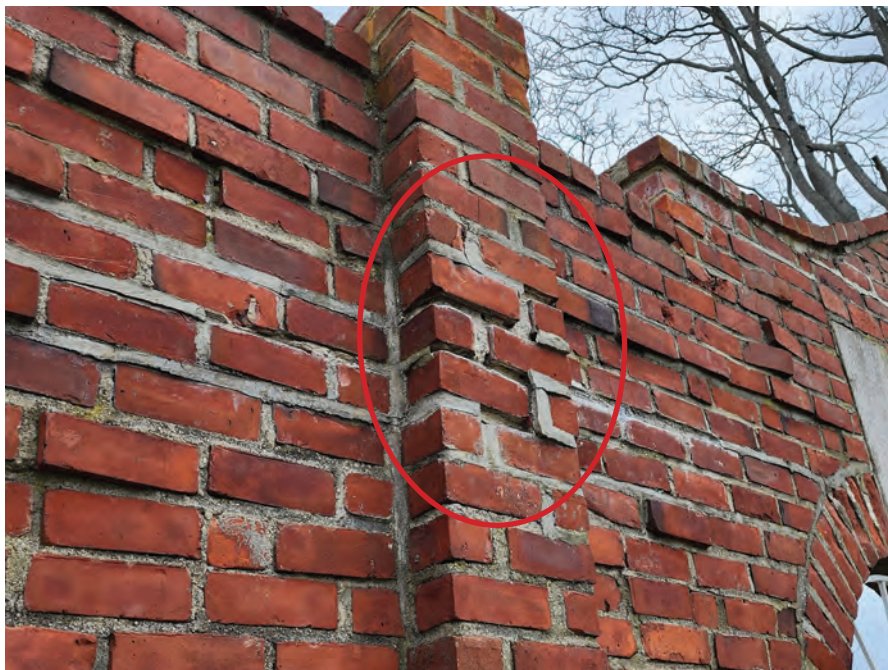
BUTTRESS COLUMN REQUIRED REPOINTING.

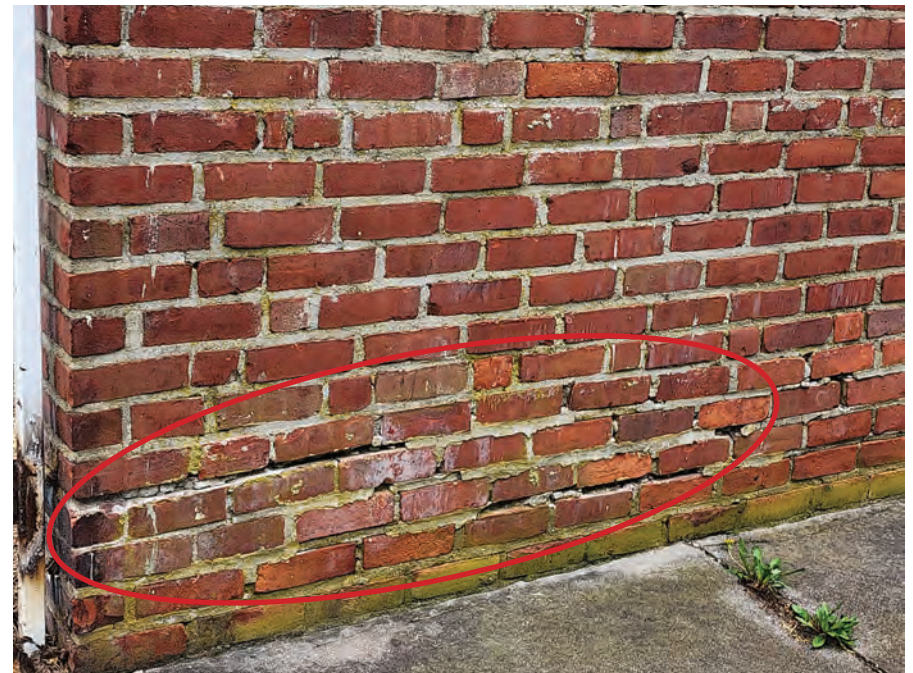
LOOSE BRICKS

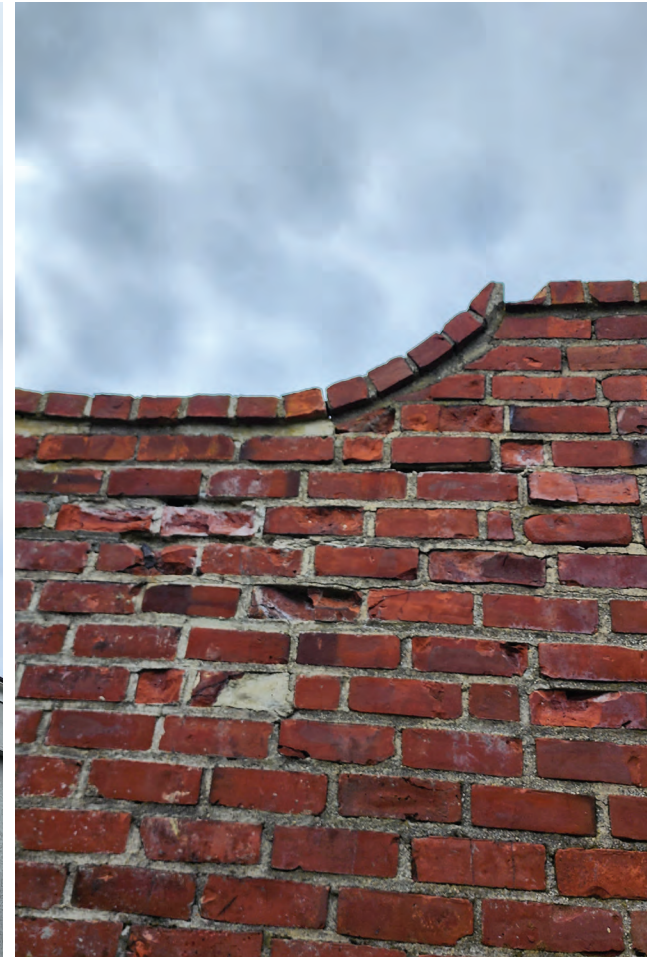
SPALLED BRICK

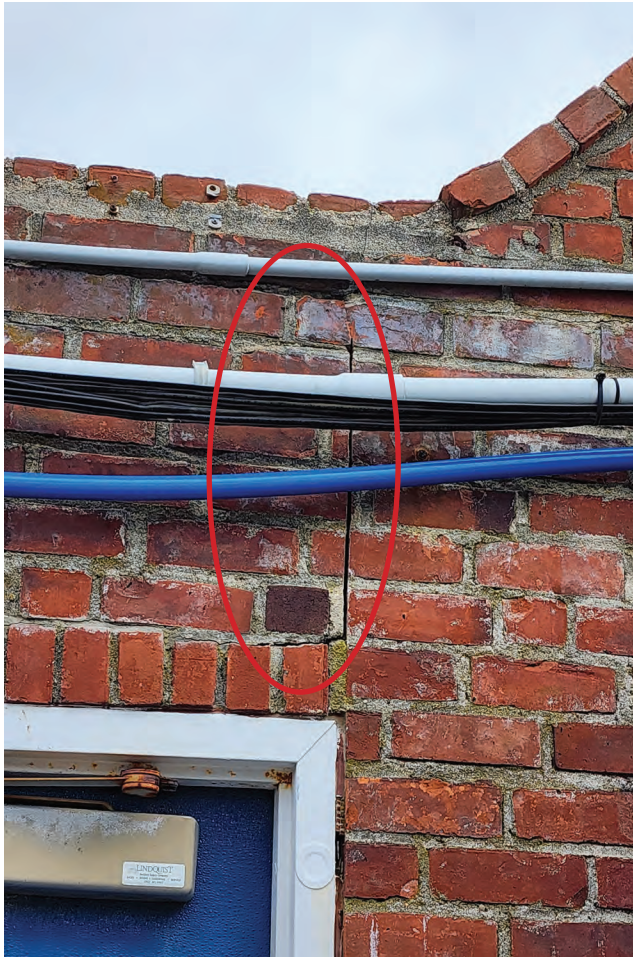
SPALLED BRICK

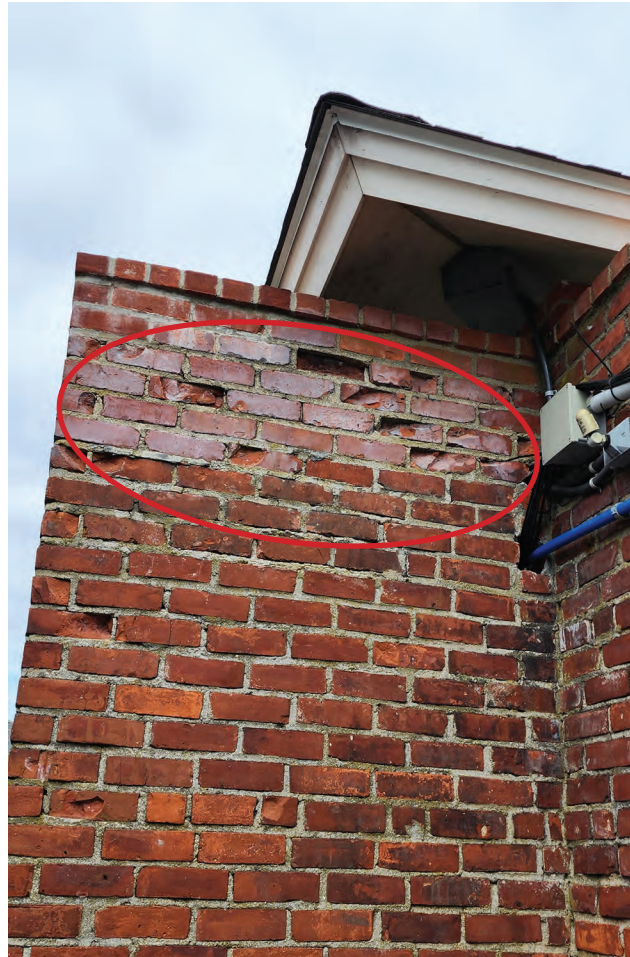
CRACK AT DOOR WALL

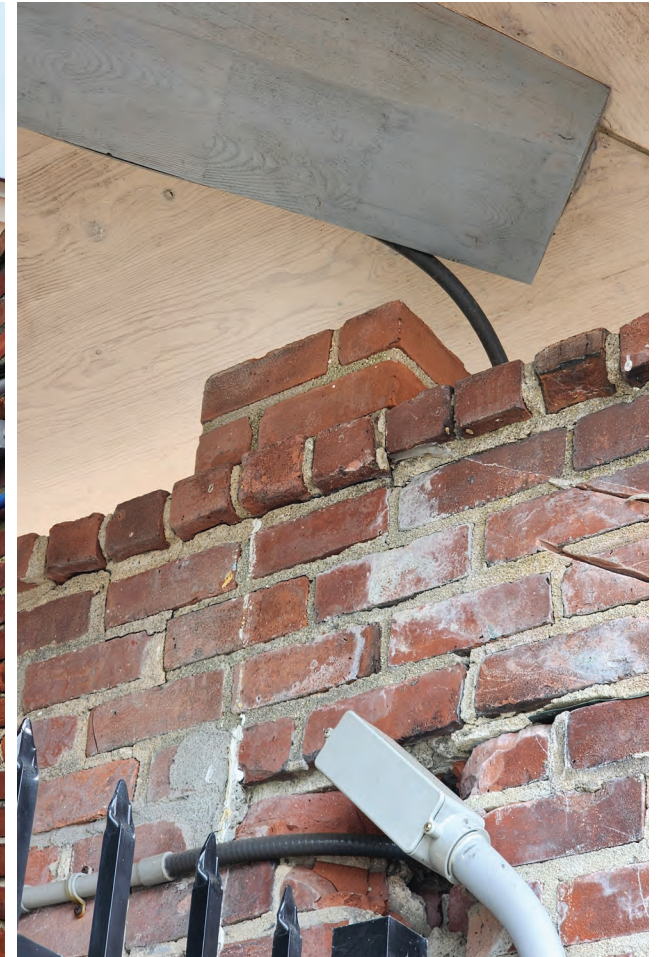
SAPLLED BRICK
