MAINTENANCE REPORT FOR RESIDENCE AT LONGSHORE COUNTRY CLUB

INSPECTION OF THE LONGSHORE COUNTRY SELECT CLUB BUILDINGS
PARKS & RECREATION BUILDING
MAINTENANCE SHED

A REPORT PREPARED BY:
First Selectman's Maintenance Study Committee
Town of Westport, Westport CT 06880

Report Prepared: July 18, 2023

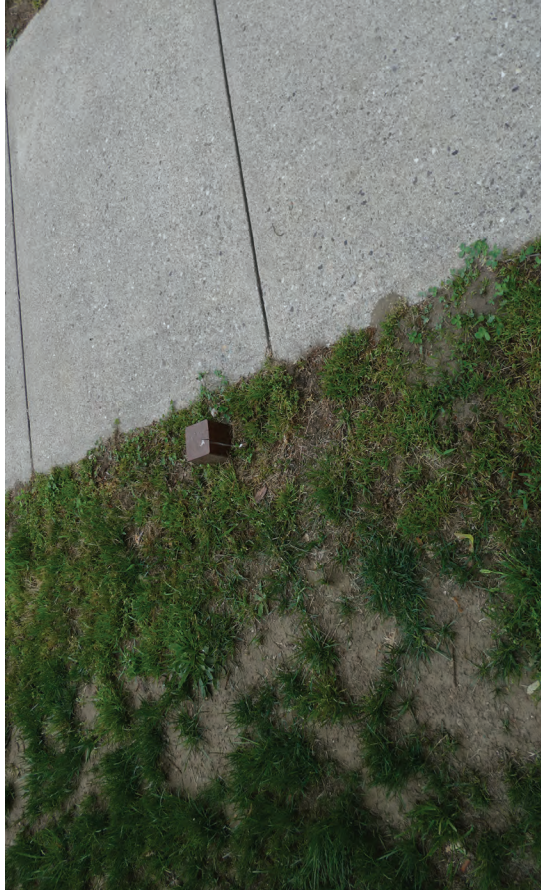
POTENTIAL TRIPPING HAZARD.

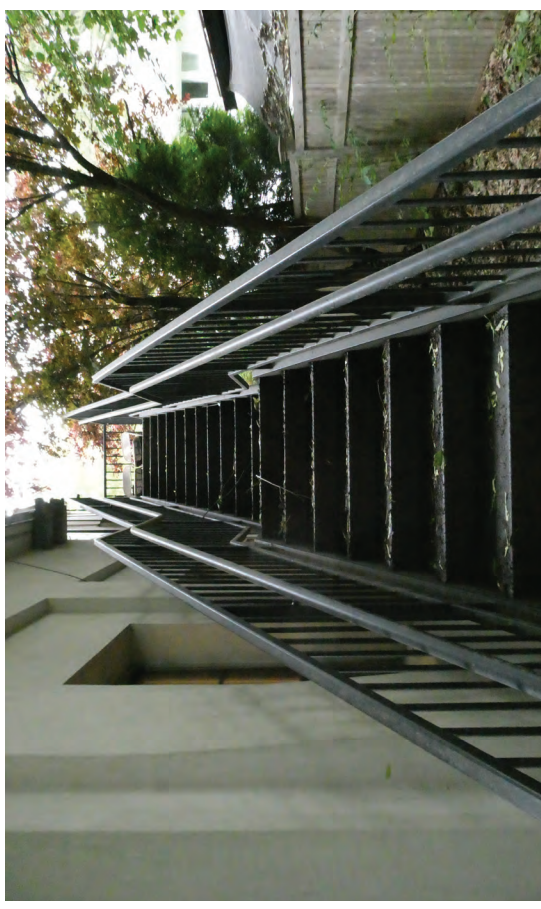
EMERGENCY STAIRS TO BE KEPT CLEAN.

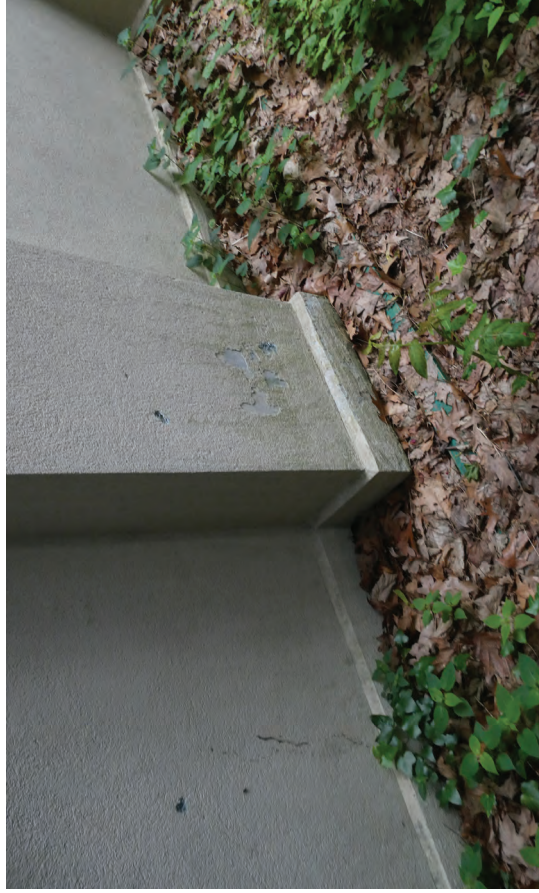
SOME EFIS PATCHING AND PAINTING NEEDED.

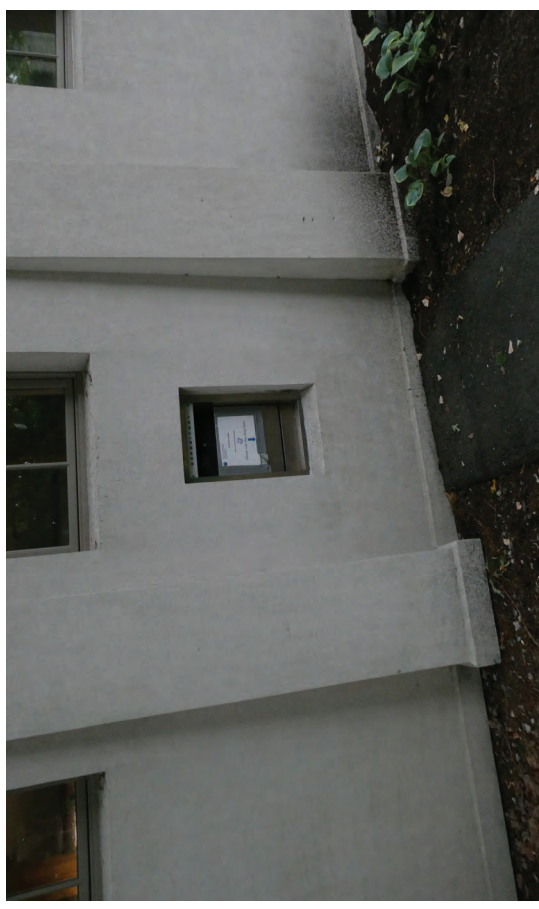
FACADE CLEANING REQUIRED.

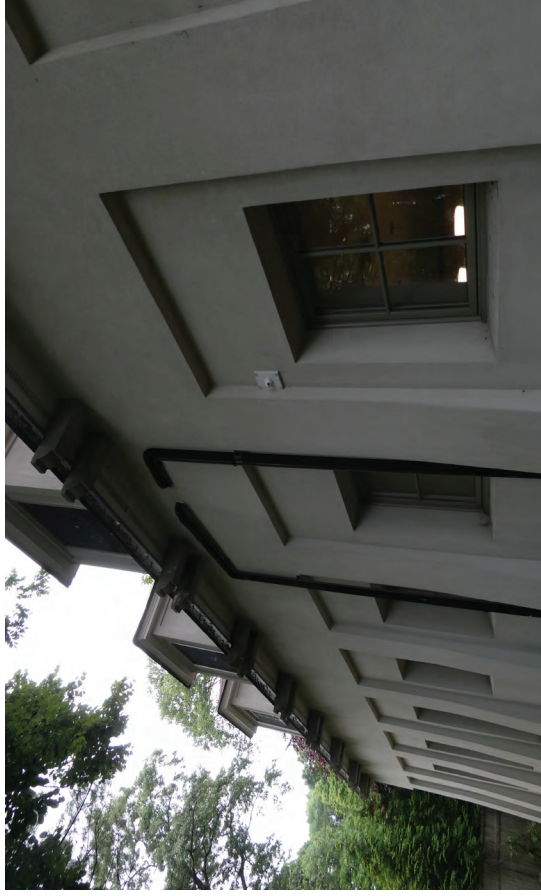
DRIP GUARD TO BE CLEANED.

Splashguards should be cleaned. Please refer to the attached photographs for these areas of work and others.

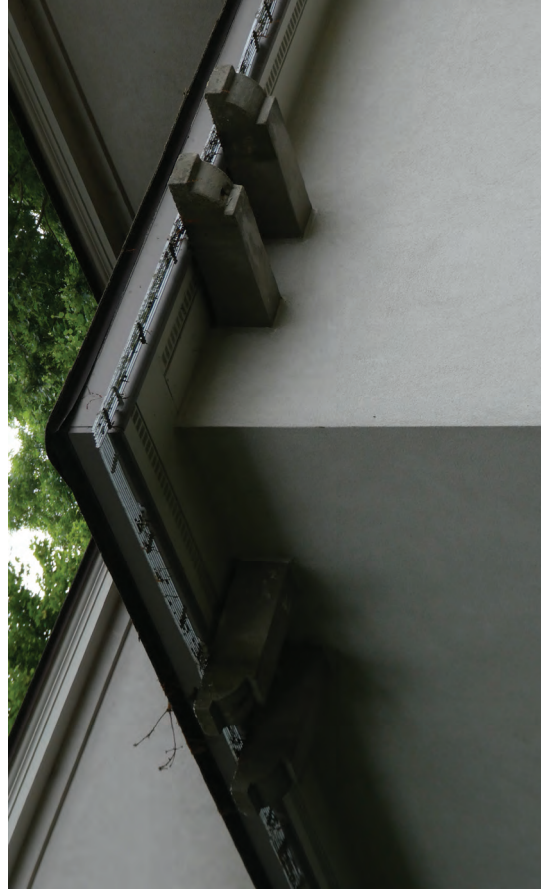
BEAM ENDS TO BE PREPARED AND PAINTED.

The fascia areas and exterior beams just under the roof eaves should be primed and painted as well, they again are peeling and this concrete work decaying slowly.

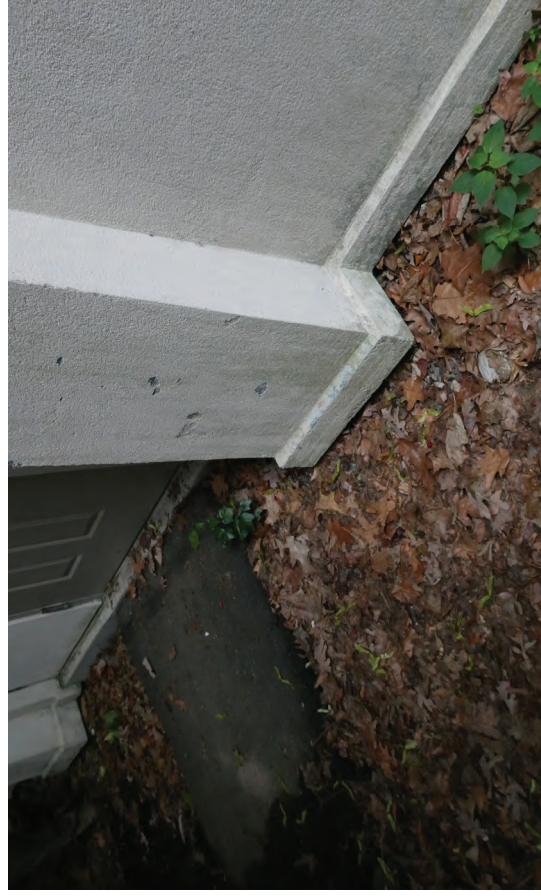
SOME EFIS PATCHING AND PAINTING NEEDED.

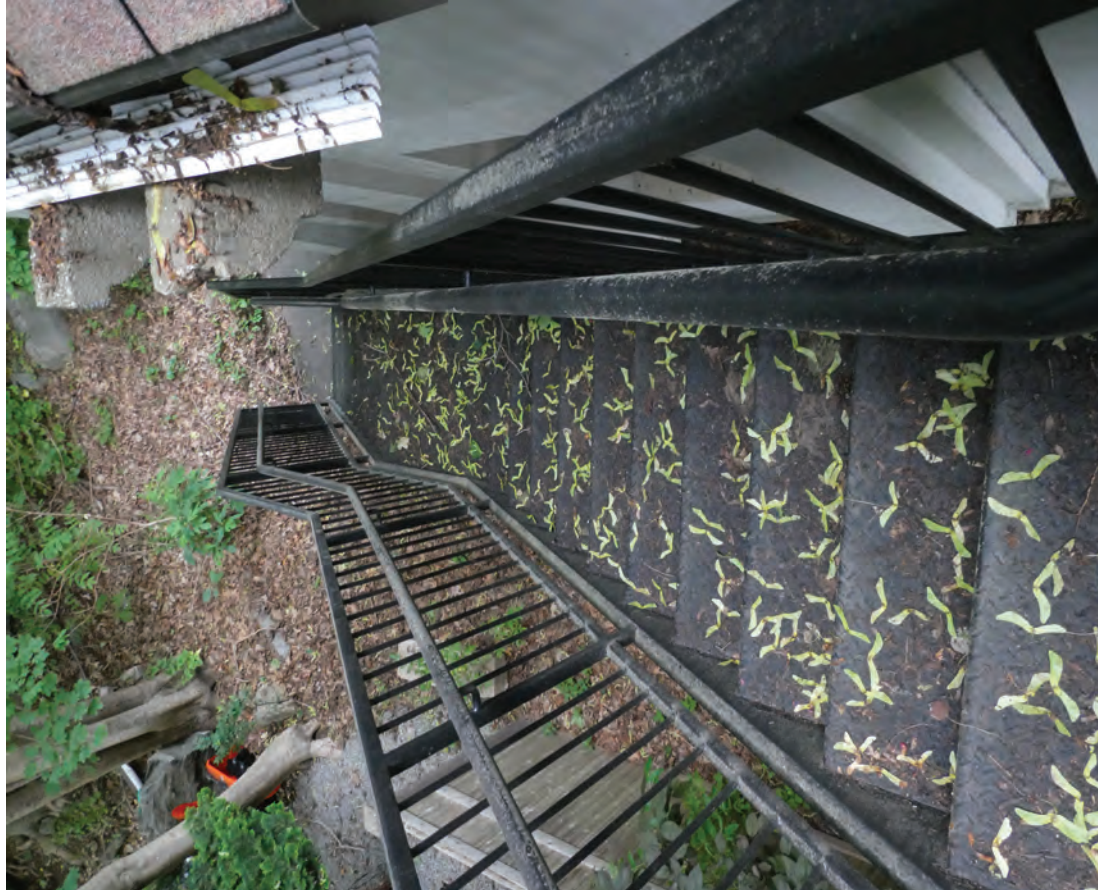
FIRE EXIT STAIR TO BE CLEANED.

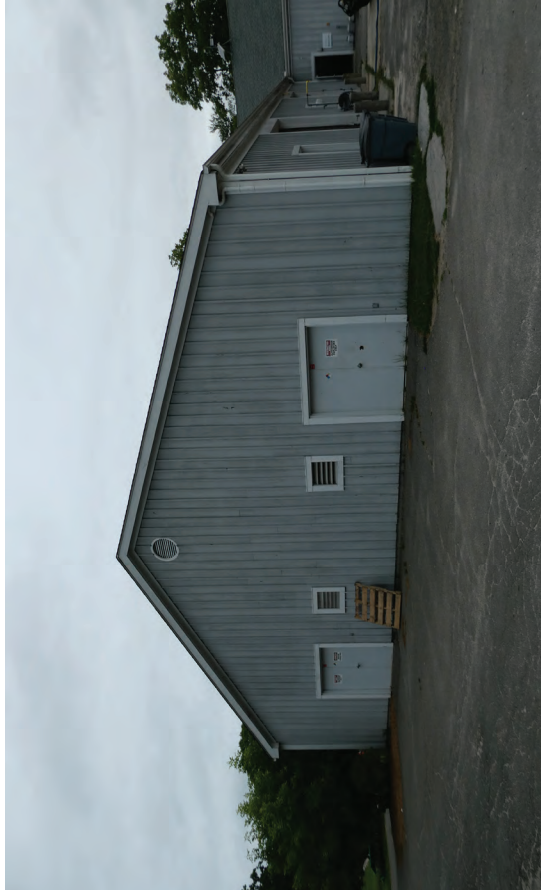
EAST FACED REQUIRES PAINT SHORTLY.

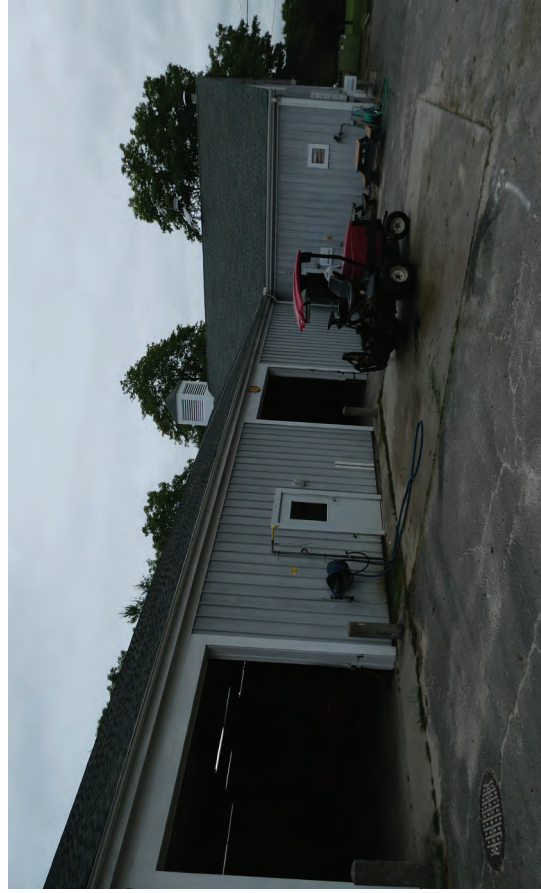
PREPARE AND REPAIR BUILDING SHORTLY.

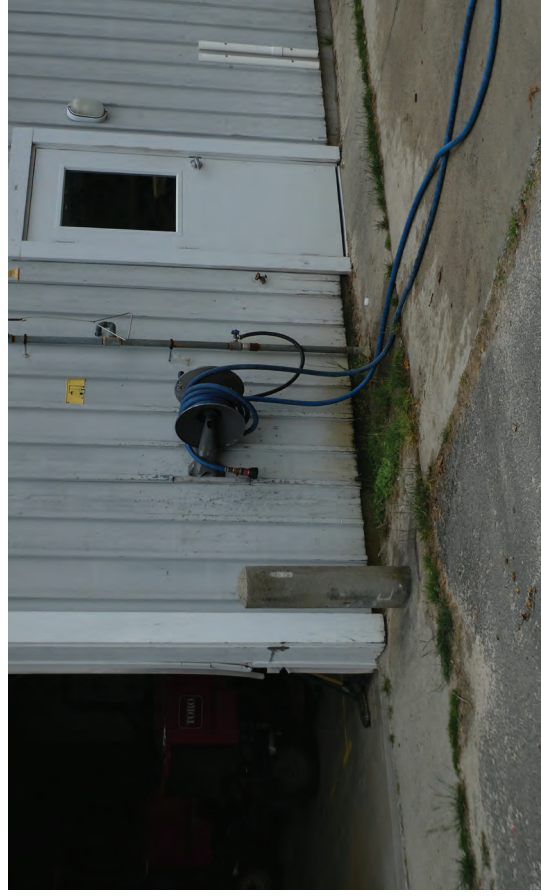
Exterior Board which are rotted under hose area require replacement.

ROTTED HOSE REEL TO BE REPLACED.

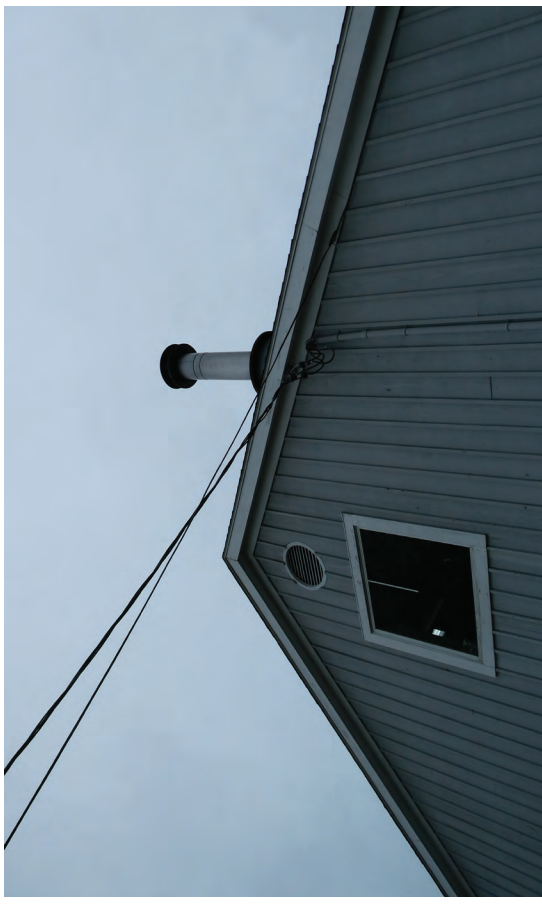
WINDOW TRIM BROKEN.

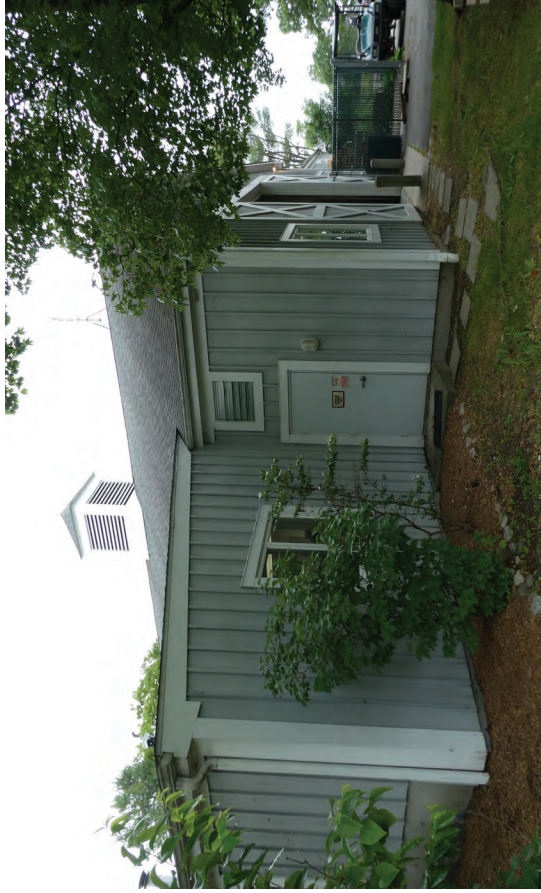
EXTERIOR WALL REQUIRES REPAINTING SOON.

All the siding of the building should be re-stained shortly, we noted this previously.

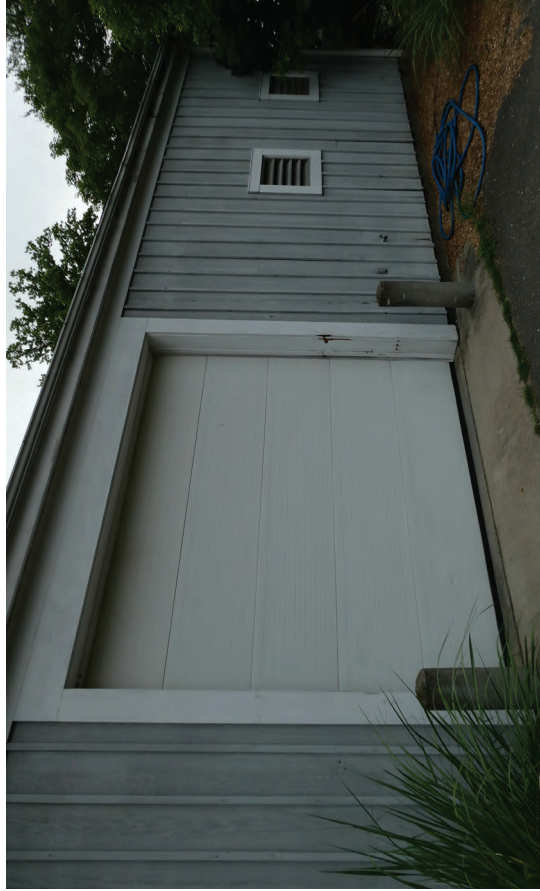
PAINTING OF TRIM AND SIDING REQUIRED.

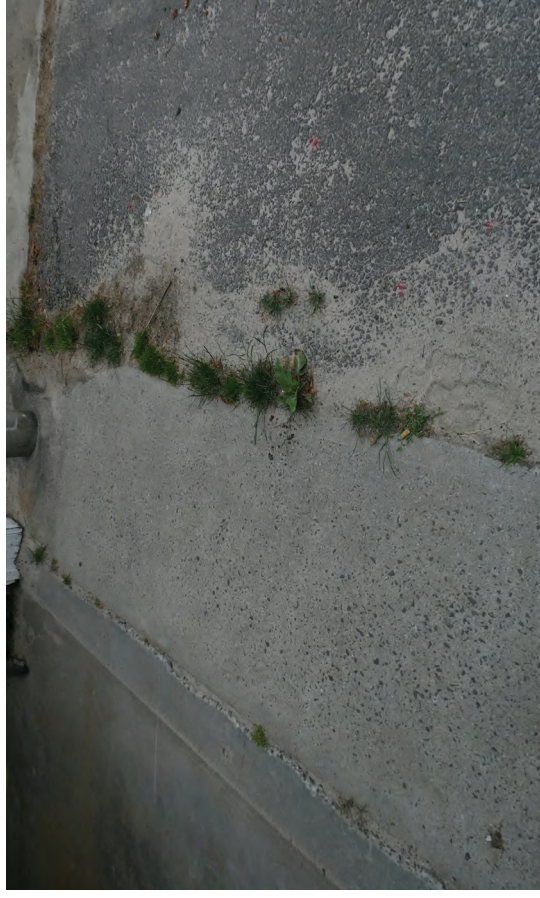
SOME PAVEMENT IMPROVEMENTS NEEDS.
