**MINUTE MAN MONUMENT
ASSESSMENT AND TREATMENT GUIDELINES
WESTPORT, CONNECTICUT**

MINUTE MAN MONUMENT CONDITION PHOTOGRAPHS

WESTPORT, CT
AUGUST, 2013

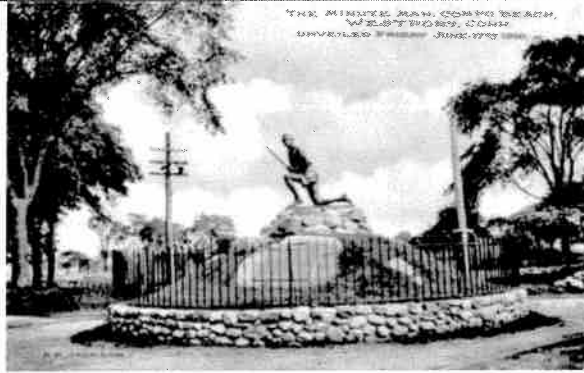
A. Historic postcard of the monument showing the original fence, fence post positions and the original fieldstone wall. Note the low ground cover; no shrubs were used in original landscape design.

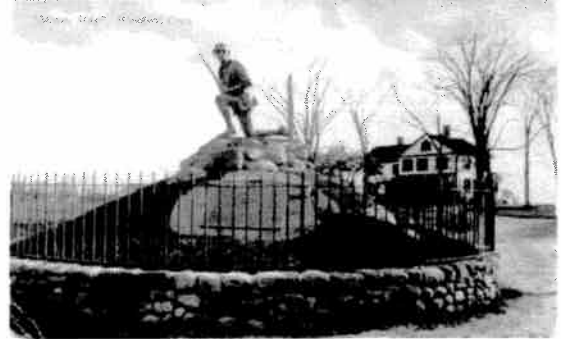
B. Historic postcard of the monument. The grade rises from just below the capstones and rolls up to the fieldstone base for the bronze sculpture.

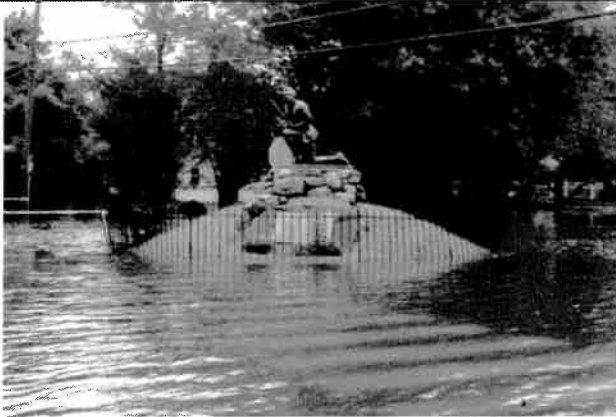
C. Historic image showing the site during a flood. The water level rose well above the outer stone wall and fence foundation.

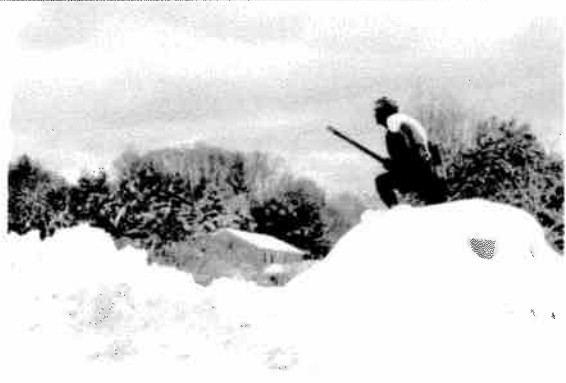
D. Historic image showing snow pile and drift well above the current fence.

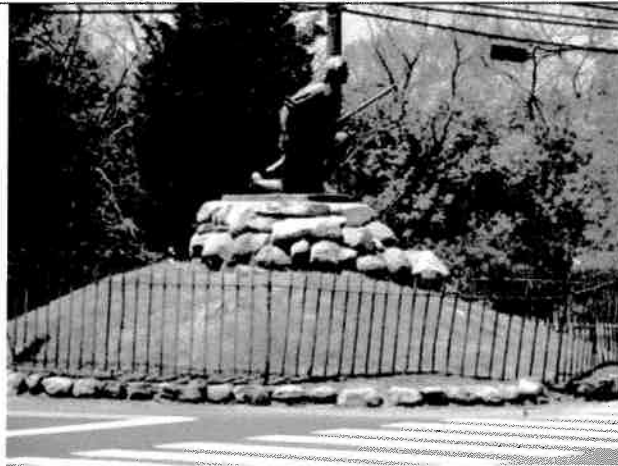
The iron fence was cut into sections for removal from the original site, presumably due to the damage caused by impact that bent long sections of rail and severely bent and cracked pickets.

E. Historic image showing the historic fence with damage to the front of the monument.

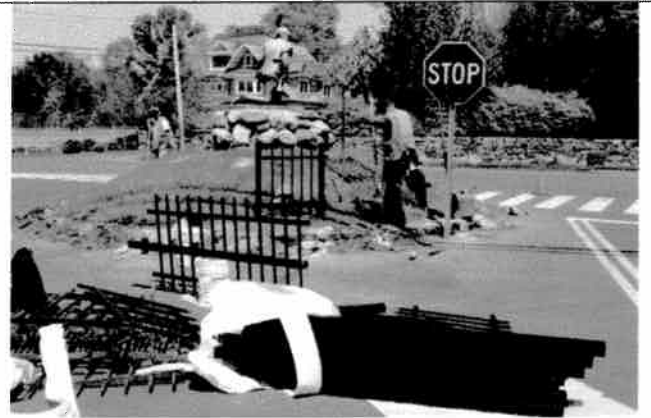
F. Image of the site during the setting of the current steel fence. Note the historic fence piled on the roadway in the foreground.

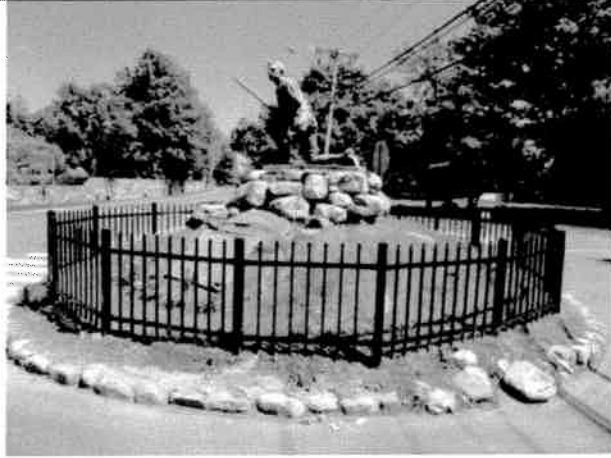
1. Overview of the monument from the proper left showing the sculpture, fieldstone base, new steel fence and capstones of the perimeter wall.

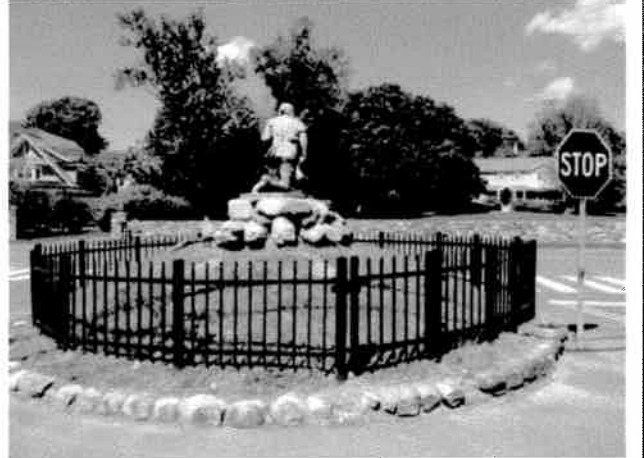
2. Overview of the monument from the back. Note the reduced perimeter of the current fence. The capstones at the gate are set in a soldiered pattern.

Add new fence to extend fence diameter to the original size of 24' 3" diameter (to be confirmed by contractor). Add additional fence to sections to achieve approximate original fence post spacing of 52" in direct line between fence posts and mid-rail supports, while maintaining the original picket spacing. This may require reducing long sections that had been previously altered for the addition of a post in the original location. Use like materials of same dimension and design. Join with welding as described in Repairs above where appropriate, and with original plate and bolt design at post ends.

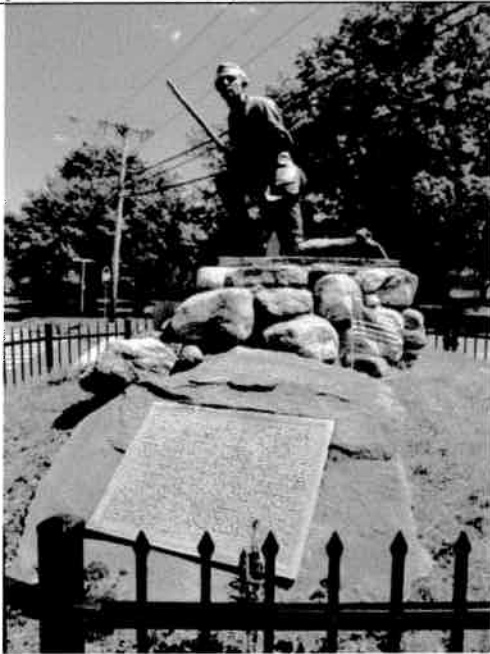
3. View of the bronze sculpture and bronze plaque from the proper left. Note that the fence moved inward causes obstruction of the plaque.

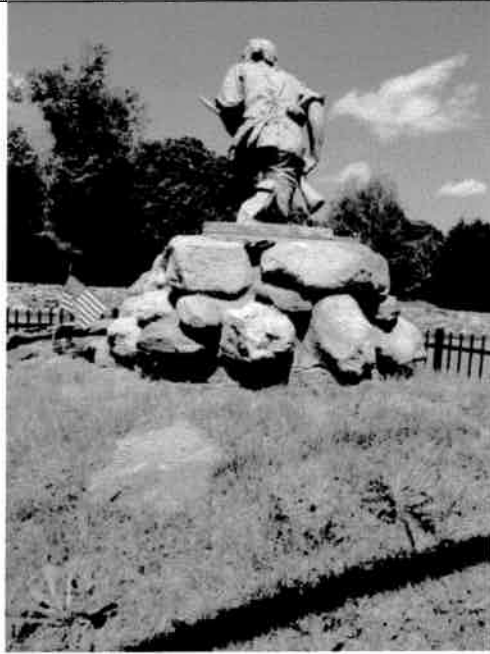
4. Back view of the bronze sculpture with loss of protective wax coating and view of the fieldstone base.

The bronze is in good condition and other than minor repairs, can be treated as typical cyclic maintenance. It is recommended to replace the missing anchors and the short section of strap at this time.

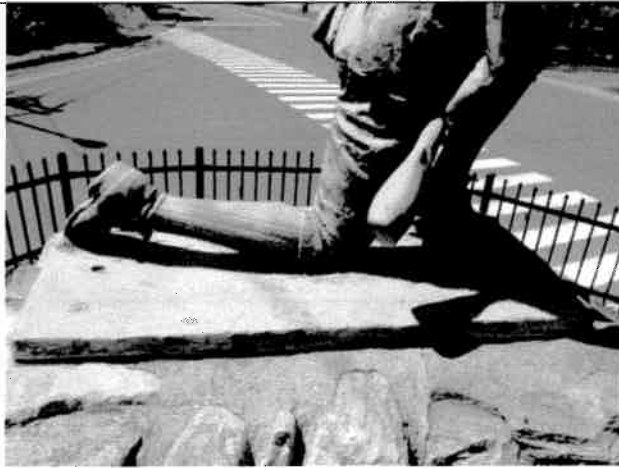
The self-base has two, open anchor holes, one to the front and one to the back; the bronze anchors are missing. The hollow of the self base appears to be filled with cement. There are no signs of damage to the bronze from the fill at this time.

5. View of the bronze self-base showing loss of protective wax coating and missing anchor heads at the front and back.

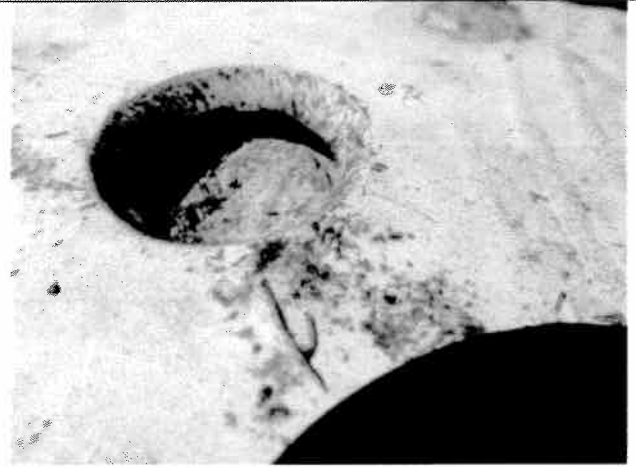
6. Detail of the missing anchor head to the back of the self-base.

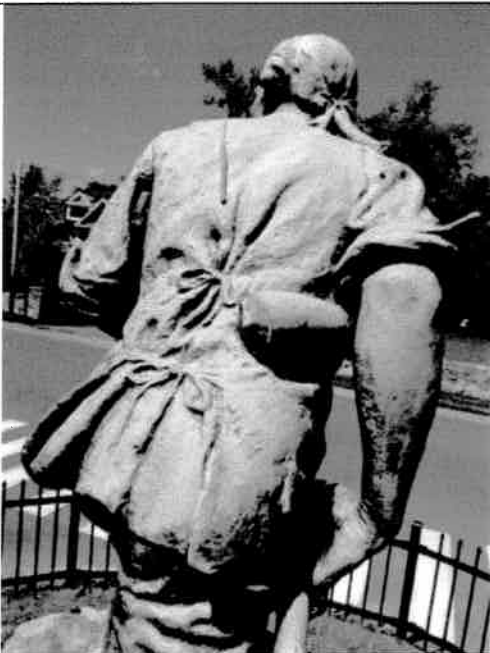
A section of strap for the figure's powder horn is broken and missing.

7. View of the back of the figure showing the missing strap for the powder horn.

Fashion missing bronze section using bronze bar stock. Present to client for approval. Patinate to match aged green appearance with non-chlorinated patination chemicals. Attach section with bronze pins using existing anchor locations with new threaded bronze pins, chased and finished to match surrounding contour and texture.

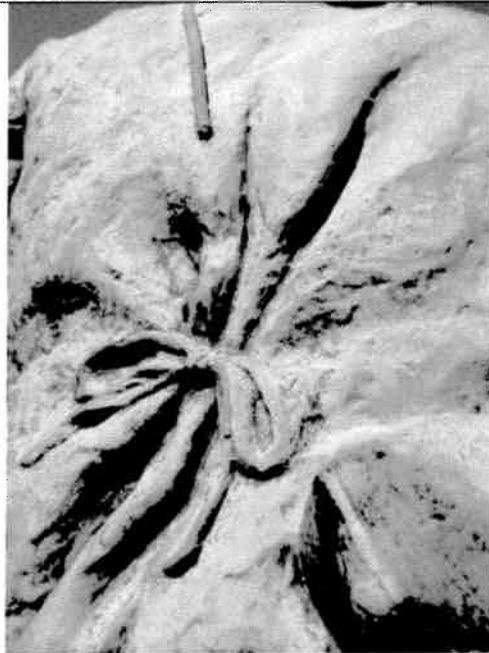
8. Detail of the missing section of bronze strap.

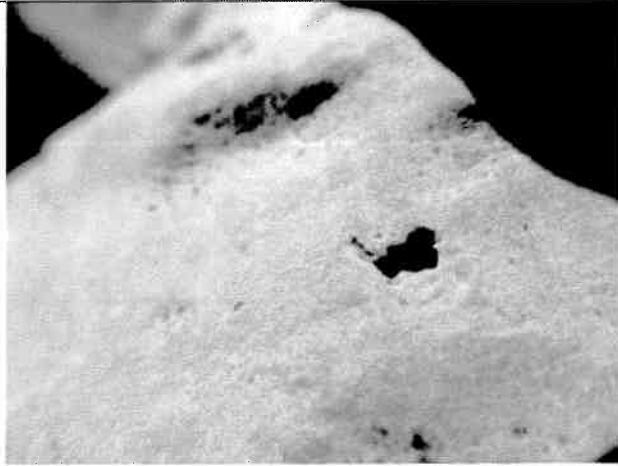
9. Detail of a casting flaw on the proper right side of the figure.

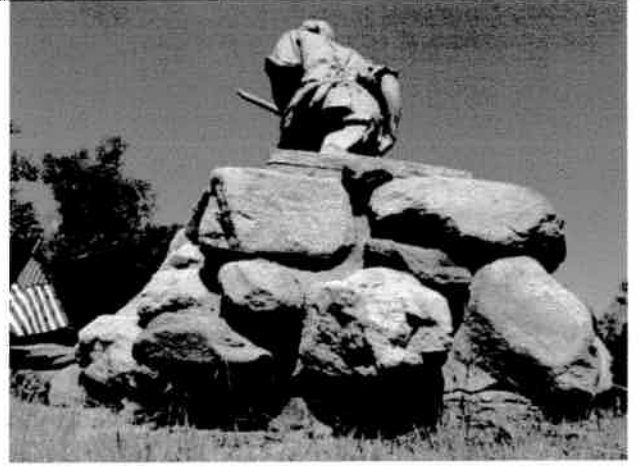
10. Back view of the fieldstone base showing loss of soil that causes the stones to appear as protrusions rather than a solid form.

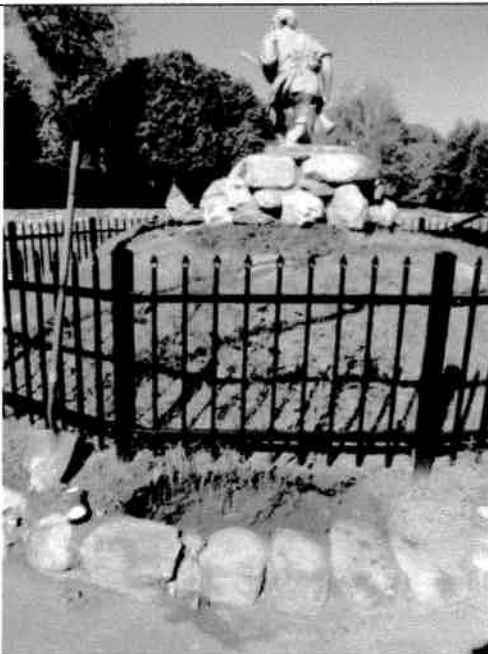
The regrading of the roadway for flood control has resulted in raising the surrounding "ground level", burying 2-3 courses of fieldstone in the circular wall; only the top capstone course is visible, which is approximately 8" high. Knowing that the picket heights are 36", the height of the wall in relationship to the fence in historic images give an approximate ratio of 2:3, which translates to 24". Natural erosion to the top of the earth mound has lead to the exposure of the foundation below the large fieldstones at the sculpture base and the over flow of soil onto the circular wall.

11. Removal of earth that has piled over the outer wall and distribution back to the top of the monument. The stones were solidly set. A lower foundation extended beyond the top footprint.

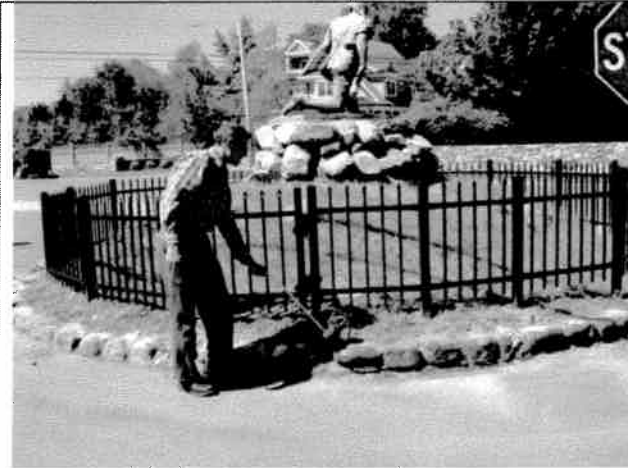
13. Measuring the circumference of the middle of the capstone.

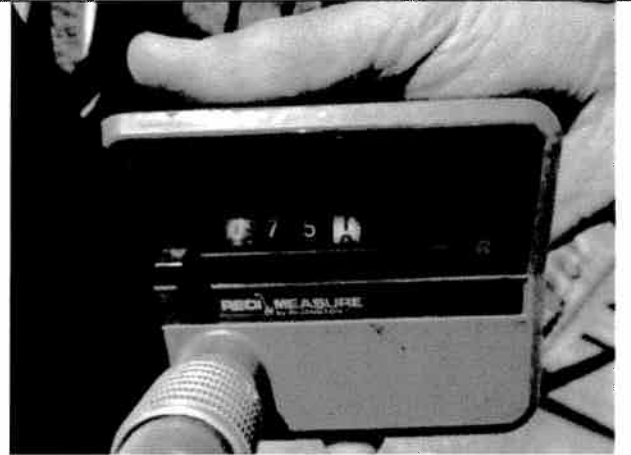
14. Detail of final measure of approximately 75 feet.

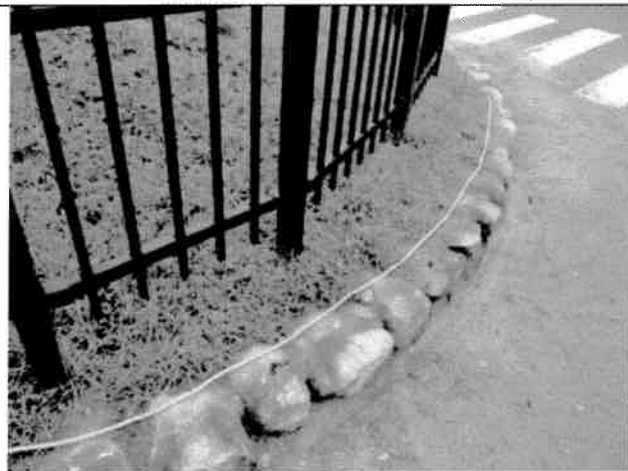
The fence was set upright using wood support stakes to review the condition of the wrought iron once assembled. It was confirmed that the fence diameter had been reduced from the original size and that additional fence would be needed to conform to the historic design.

15. View of rope used to measure the perimeter of the existing fence in storage. Note that the rope is short of original fence post anchors, and that the original fence cantilevers forward 3".

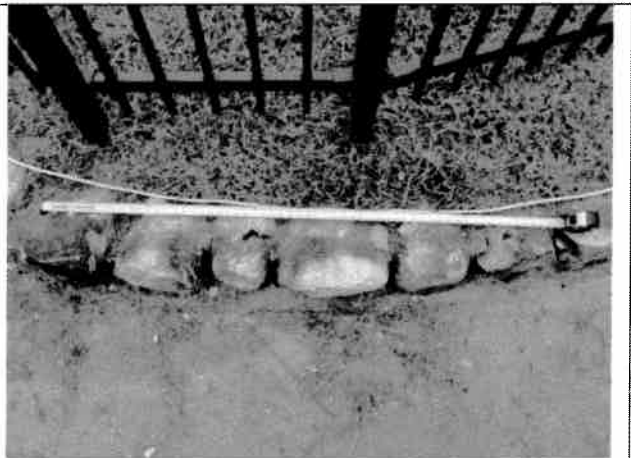
16. Measuring the distance of the original fence post anchor locations to the center of the mid-rail support anchor locations.

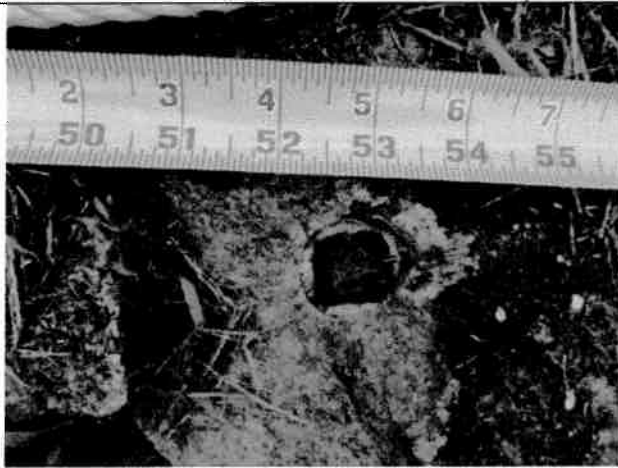
17. Detail of a measurement to a cut iron support. The measurements varied between 52-53”.

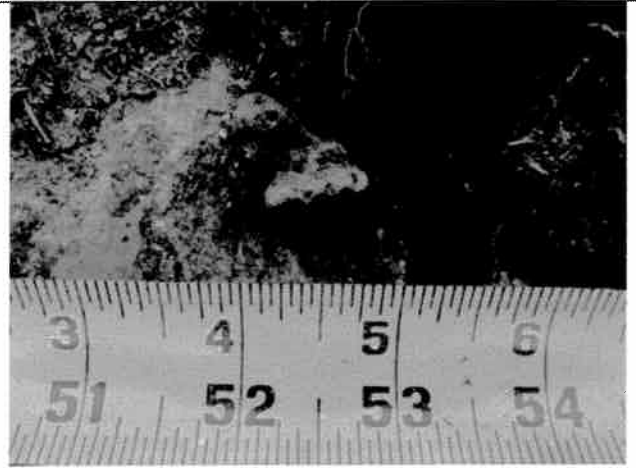
18. Detail of a measurement to a cut iron support. The measurements varied between 52-53”.

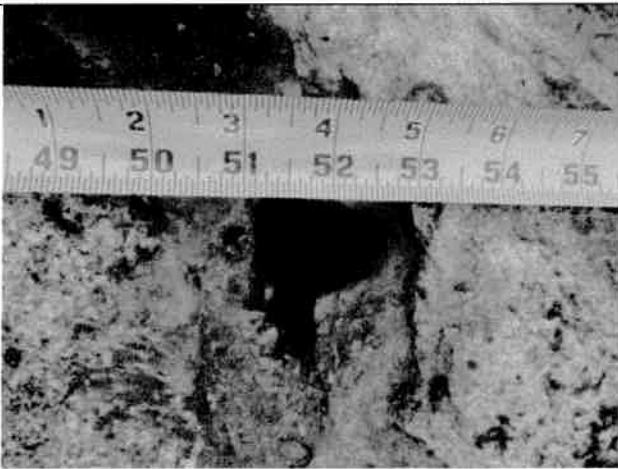
19. Detail of a measurement to an open anchor hole. The measurements varied between 52-53”.

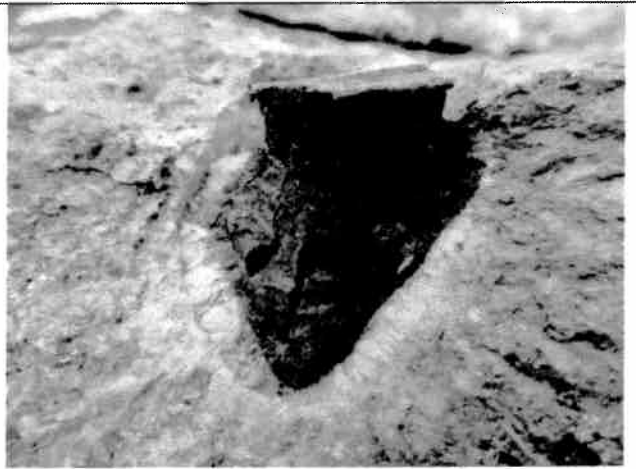
The anchoring portions of the posts and mid-rail supports have been either lost to corrosion or have been cut.

20. Detail of a cut wrought iron support that was set with molten sulfur. Note the tendrils of iron in the lower portion common to the wrought metal.

New stainless steel anchor system will be designed that is securely anchored into 8" of solid masonry just behind the capstones. The system will consist of 316 stainless steel, and will clamp to the bent, horizontal portion on the bottom of each post and mid-rail support. See attached drawing for details. The stainless steel will be sand blasted to a rough profile and coated with the same paint system as used for the iron.

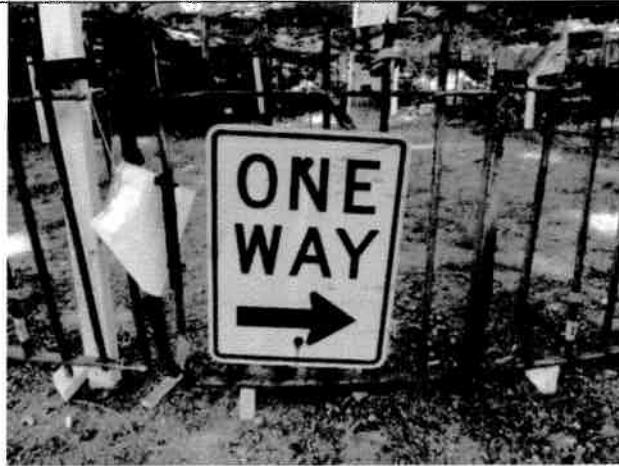
Section (counter clockwise)	Length (inches)	Notes
0. Gate	32	Gate Section. Failing paint, corrosion, bent, hinge post bent
1. Section	58	Bent, missing post clamp.

21. Overview of the gate, section 0, erected for review.

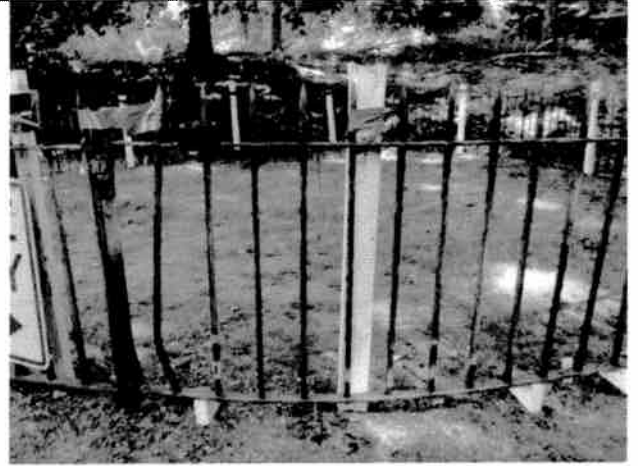
22. Overview of section 1 erected for review.

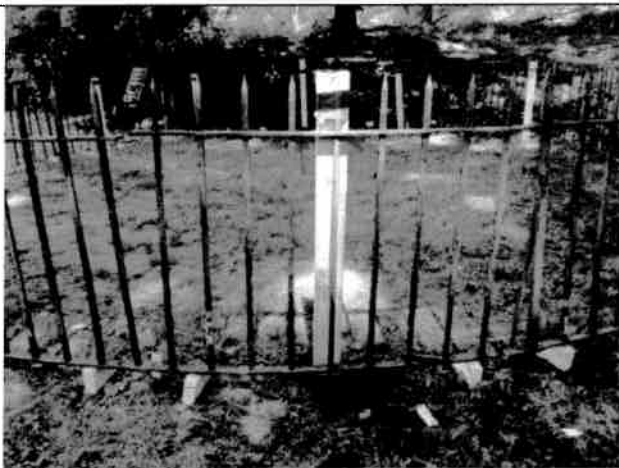
23. Overview of section 2 erected for review.

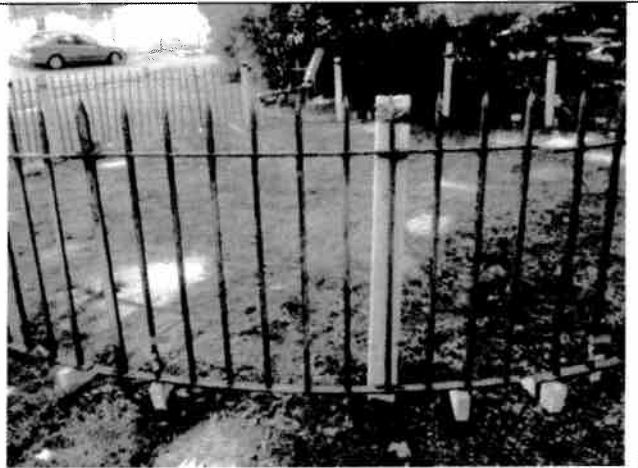
24. Overview of section 3 erected for review.

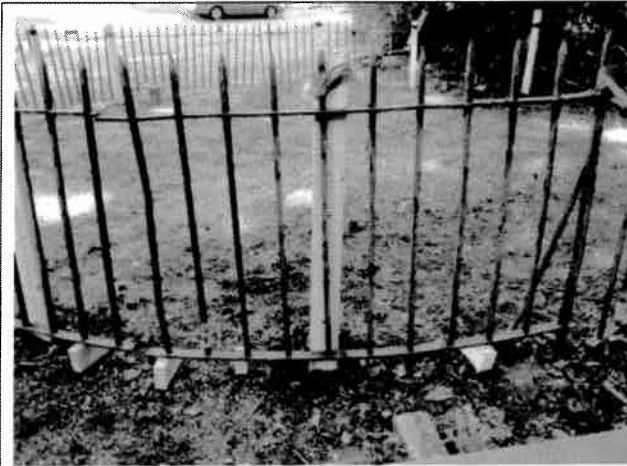
25. Overview of section 4 erected for review.

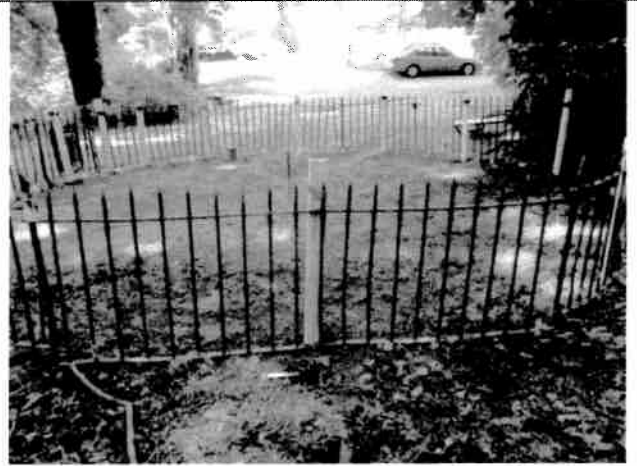
26. Overview of section 5 erected for review.

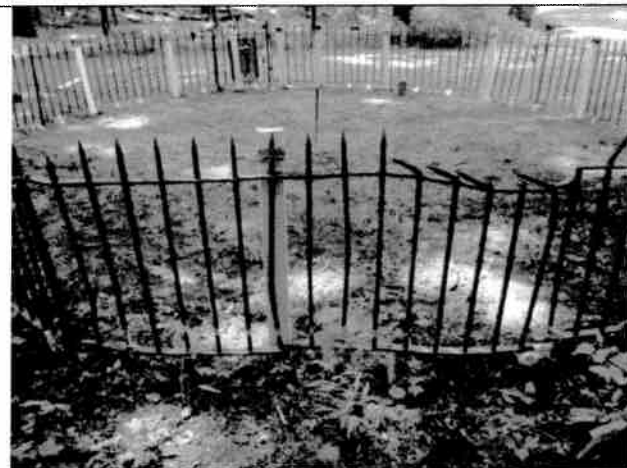
27. Overview of section 6 erected for review.

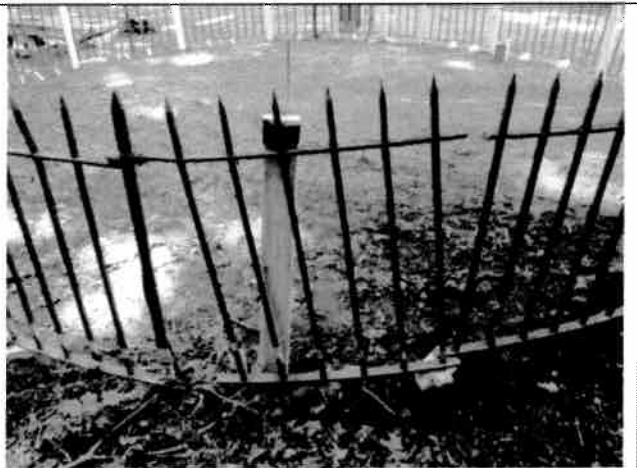
28. Overview of section 7 erected for review.

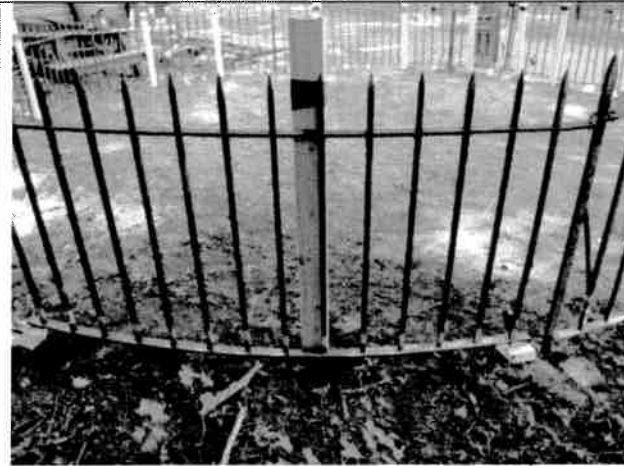
29. Overview of section 8 erected for review.

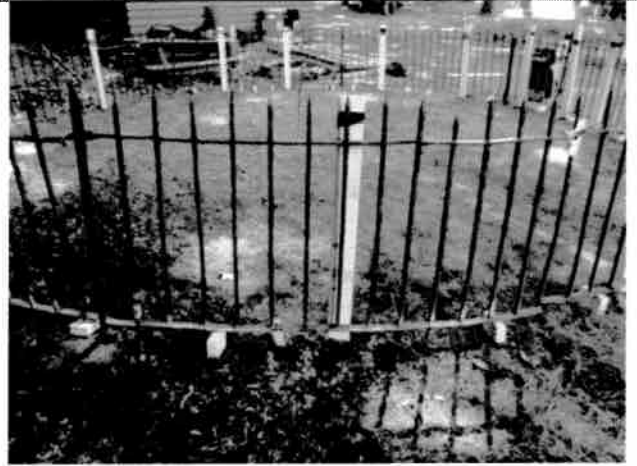
30. Overview of section 9 erected for review.

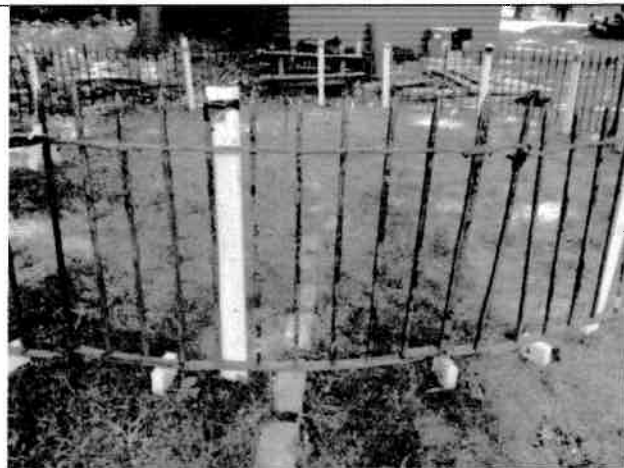
31. Overview of section 10 erected for review.

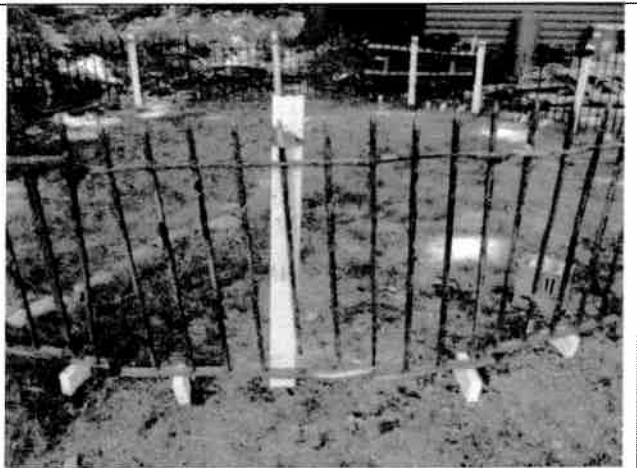
32. Overview of section 11 erected for review.

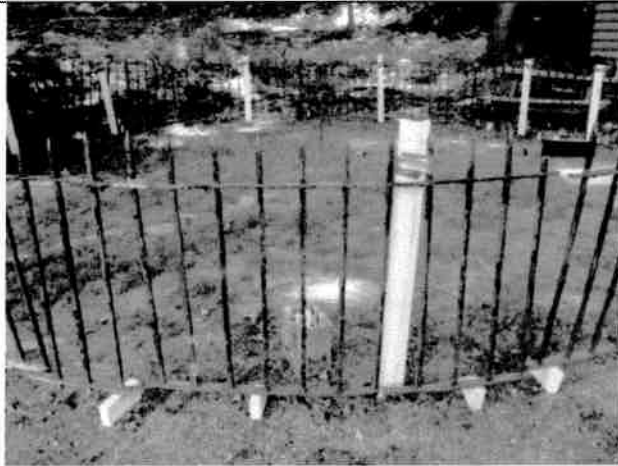
12. Section	55	Cut and failed ends, break in rail, old repairs.
13. Section	56	Cut rail ends, breaks in rails, bent.
	858 71.5'

33. Overview of section 12 erected for review.

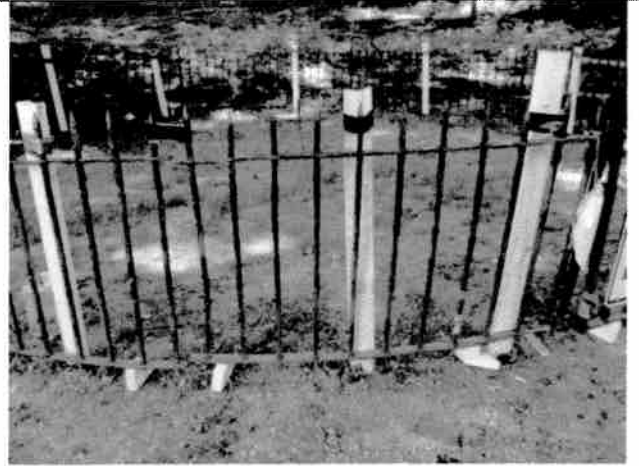
34. Overview of section 13 erected for review.

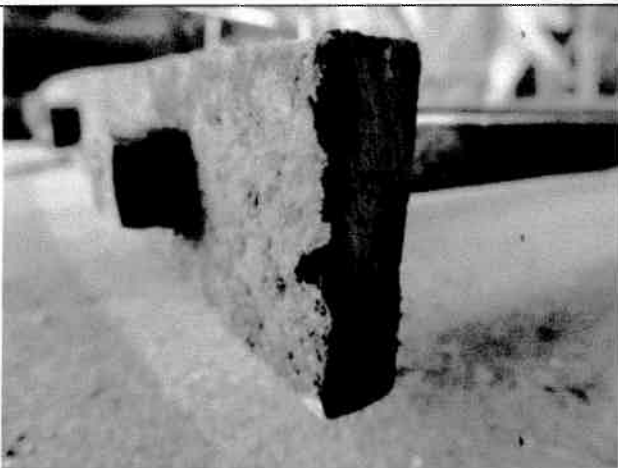
35. Detail of a cut rail.

If it is not possible to straighten rails to an aesthetically approved arc by the client, replace rails with like material and reuse historic pickets.

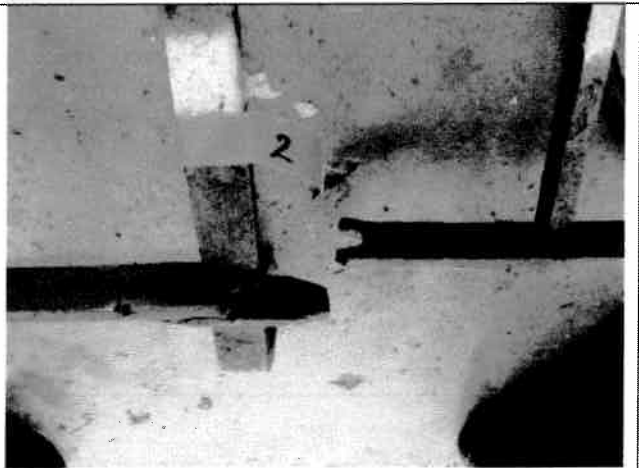
36. Top detail of an original fence post and rail plate joining two rail ends. One rail end is bent at notch and through bolt is broken. Note that the nuts are located on the upward side.

Replace all missing post braces, picket ends, and mid-rail support posts, failed and severely corroded joining post braces and hardware to match original in dimensions and design using like materials. Remove inappropriate old repairs and replace with like material to match original design.

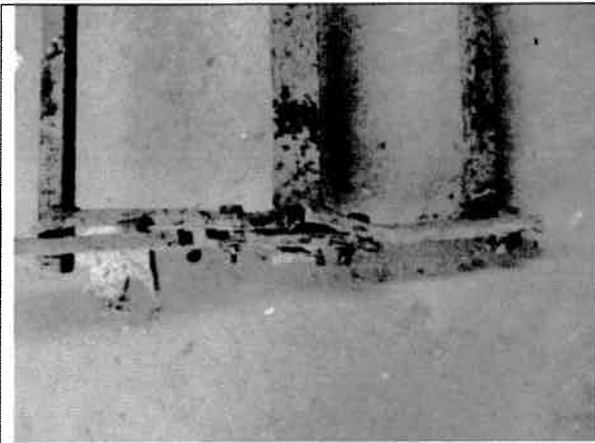
37. Side detail of an original fence post and rail plate joining two rail ends. The rails are bent and broken and existing repairs failing.

After realignment of bent elements, repair breaks and cracks by beveling repair area and filling proud with low carbon wire weld. Grind flush to match. Present weld sample to client for approval prior to proceeding with additional repairs.

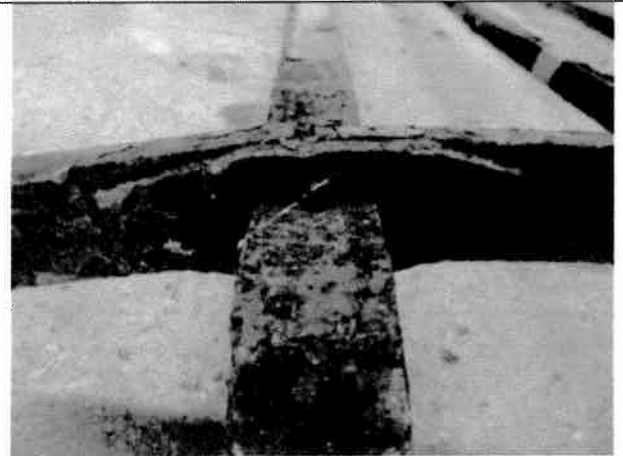
38. Bottom detail of an original fence post and rail plate joining two rail ends, in good condition. The plate is prevented from sliding down post by through pin. Note that the heads are located on the downward side.

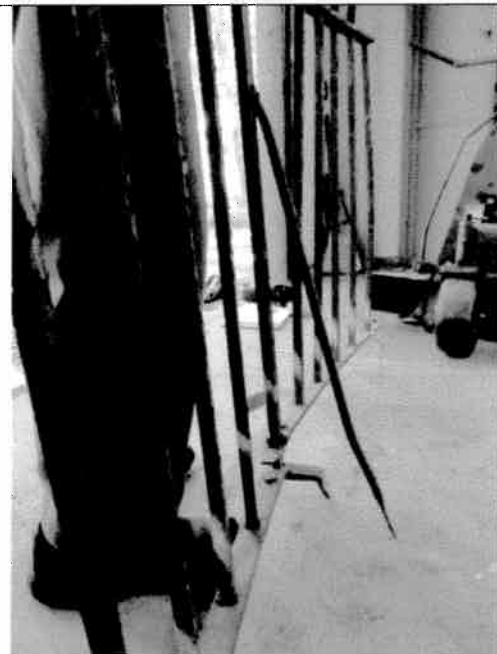
39. View of a fence post with original back brace. Note the cantilevered end on the post. The back brace is hammered flat and riveted to the post.

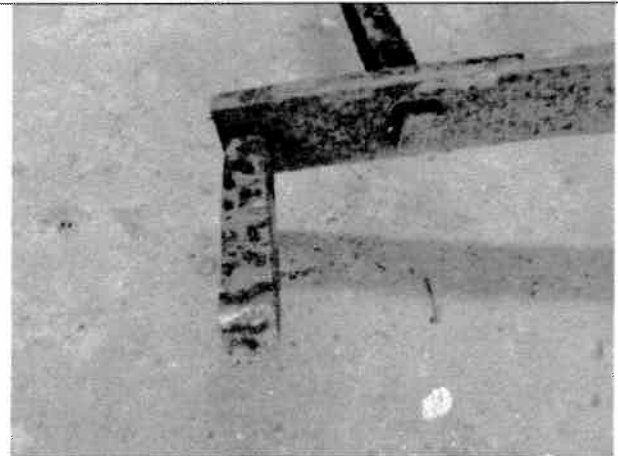
40. Detail of a mid-rail support cut at anchor point. The support ends with a round end that is press-fit into the rail.

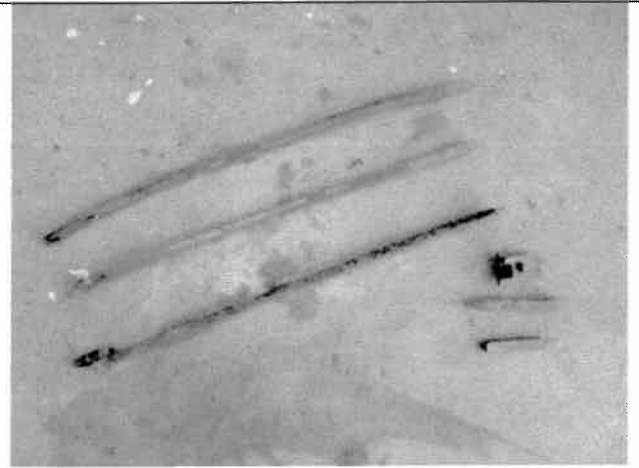
42. Overview of detached parts in storage. These are the only detachments retained.

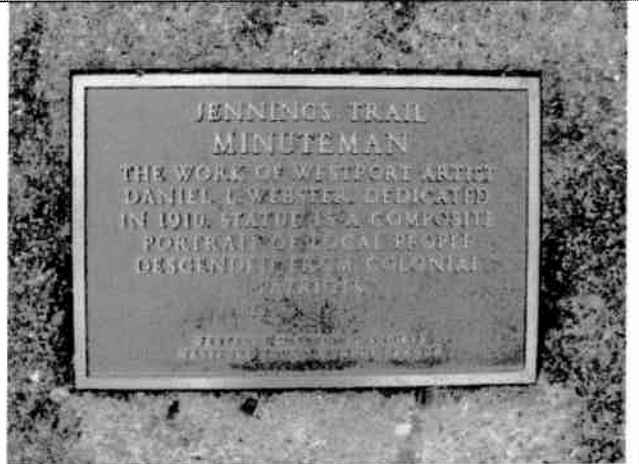
Detail of the commemorative plaque across the street from the monument. The marker is made of a concrete slab on a cobblestone base.
