Study Report for Proposed

Lincoln Street - Riverside Avenue Local Historic District Westport, Connecticut

June 25, 2018

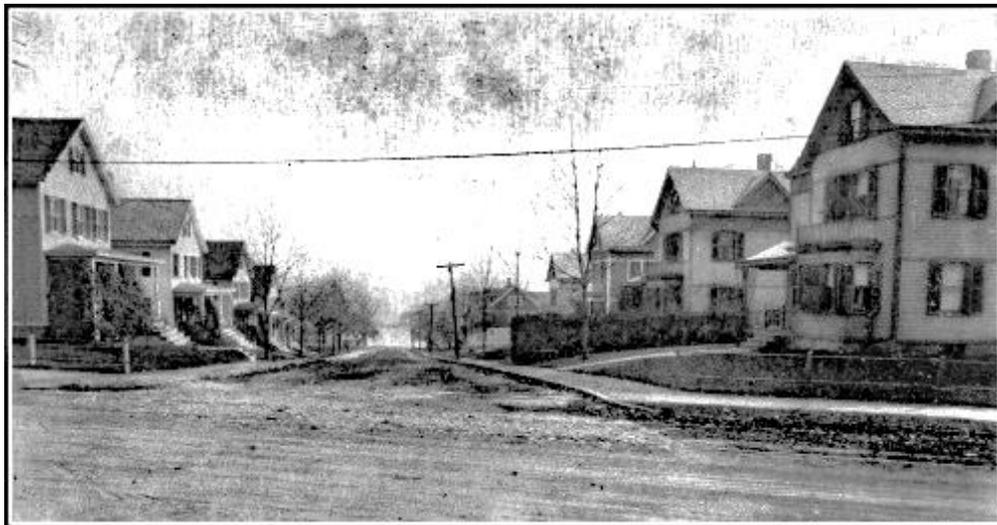
Figure 8. Undated early photo of the west end of Lincoln Street looking east from the Post Road. (<https://06880danwoog.com>)

The two rows of houses on the west end of Lincoln Street were built in 1899 in one of the most popular architectural styles of the era and one that was somewhat out of date by the end of the nineteenth century. Those on the south side of the street are in the Queen Anne style typical of that time, while those on the north side are in the Italianate style, which was near the end of its popularity. In both cases they are modest expressions of their respective styles, but they stand as examples of well designed and constructed buildings intended to be lived in by the growing middle class. The Queen Anne houses have lost architectural detail to residing, but they retain their basic form and are easily identifiable as late nineteenth century homes. Today, they are the only surviving example of an intact nineteenth century planned streetscape on the west side of the Saugatuck River. The west end of the street has changed very little since 1899 (Figures 8 and 9, Photos 1 and 2).

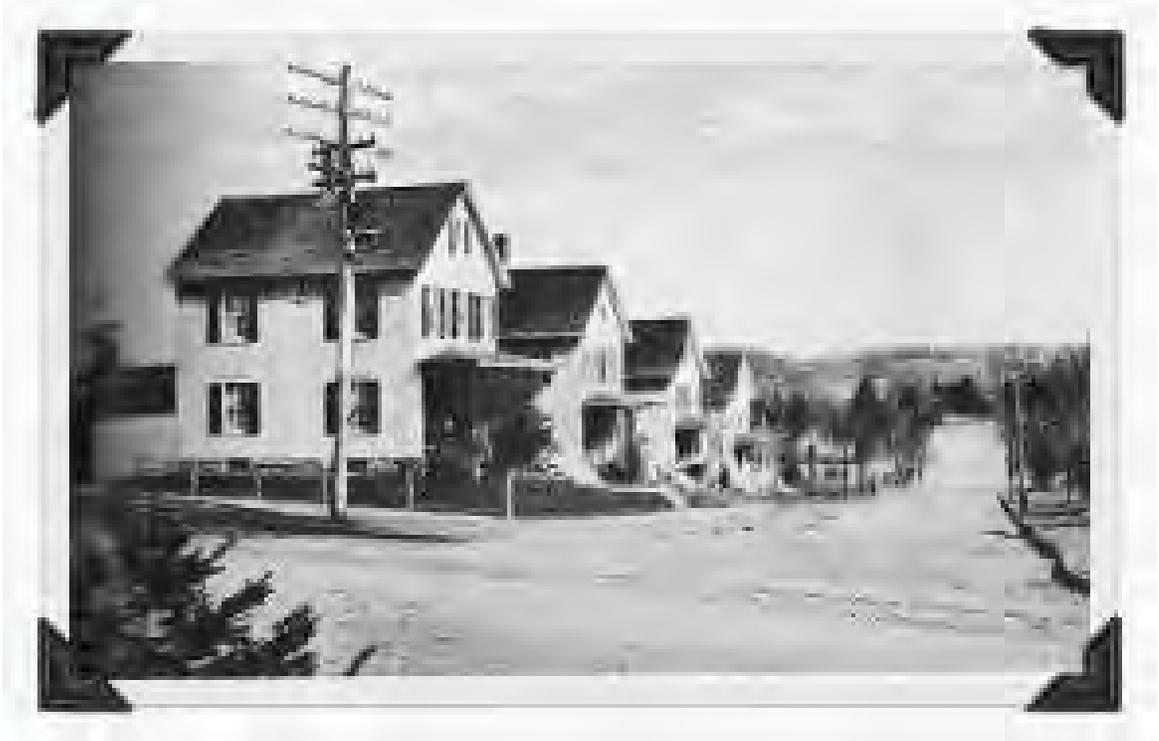
Figure 9. Undated early photo of the north side of the west end of Lincoln Street.
(<https://06880danwoog.com>)
