HISTORIC RESOURCES INVENTORY - BUILDING AND STRUCTURES

Building Name (Common) _____
 Building Name (Historic) Solomon Taylor House/Ferraro's/Gray's Drugstore
 Street Address or Location 7 Main Street
 Town/City Westpor Village _____ County Fairfield
 Owner(s) Wonkai Associates LLC Public Private

7 Main Street, Westport, CT

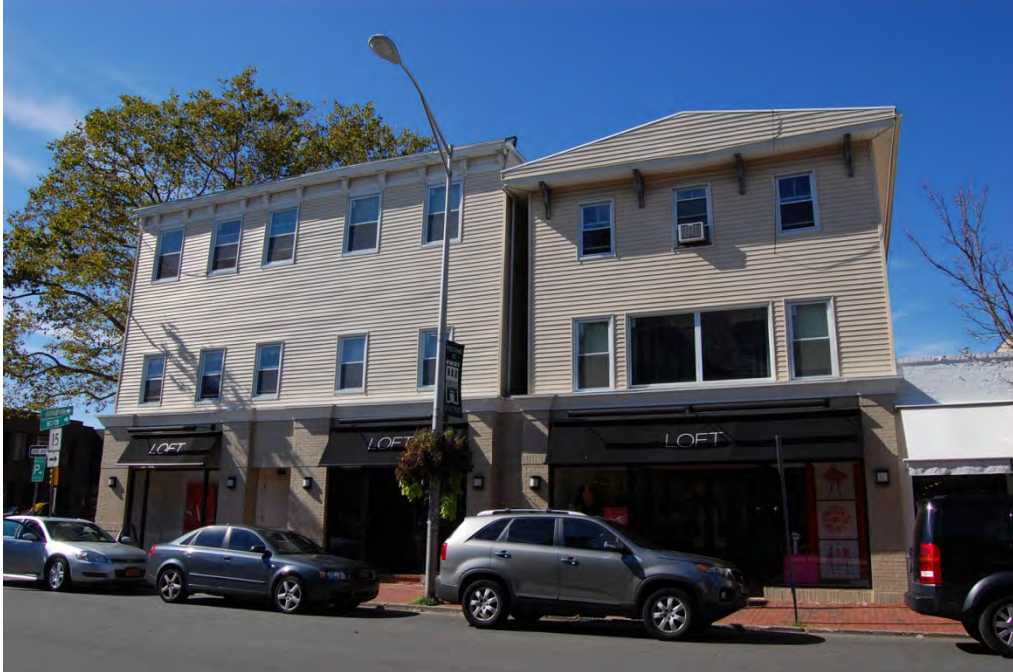
View of the east elevations.

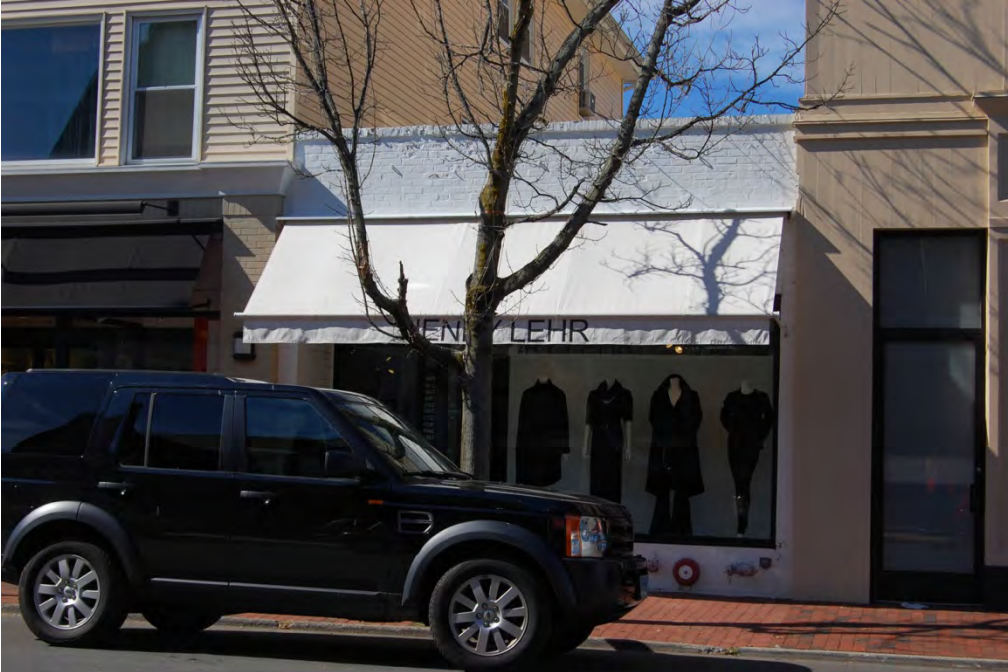
View of the east elevation.

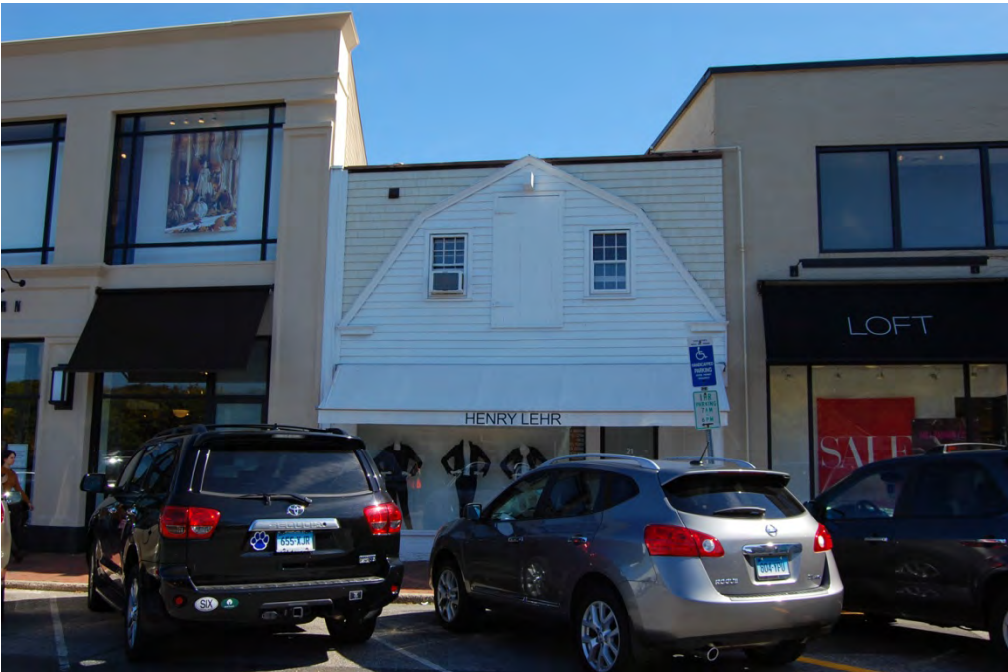
View of the west elevation.

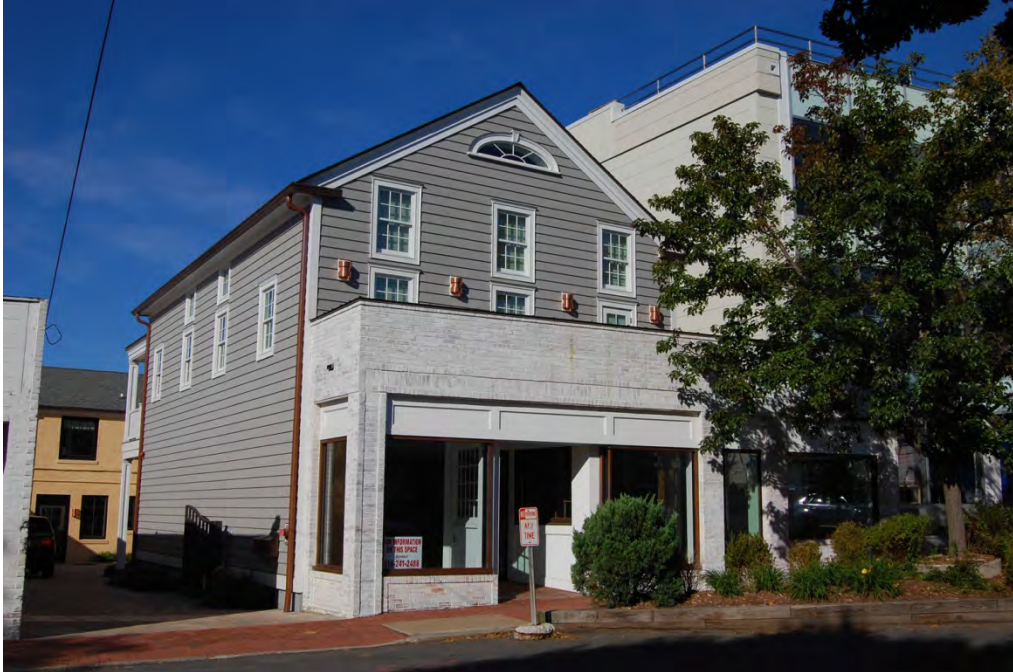
The primary commercial building is a two-and-one-half-story, three-bay-by-five-bay former residence constructed in the Federal style. The asphalt shingle-clad, front-gable roof has a wide molded rake and shallow gable returns. A brick chimney rises from the center of the ridge. The walls are clad in clapboard and rest on a parged fieldstone foundation. A two-story enclosed staircase is located on the west (rear) elevation and was built after 1940. A two-story porch is attached to the south end of the west elevation. A brick storefront extends across the east (facade) elevation and wraps around the north elevation. The storefront projects out from the facade and has a shed roof with standing-seam copper roofing. It contains an off-center entrance in a recessed bay consisting of a panel door with a six-light window in the top half and large, plate-glass display windows. The windows have brick panels below and wood panels above. An original secondary entrance in the north end of the facade was filled with a plate-glass window. The entire storefront addition replaced an earlier full-width porch ca. 1929. Windows primarily consist of six-over-six, double-hung, late-twentieth-century replacement sash with wood trim and slightly protruding lintels. Two four-light, square, fixed windows sit below the overhang on the south elevation. An elliptical fanlight with wide trim and keystone is located in the gable on the facade. The building was remodeled in 2010. Alterations are comprised of replacement siding and windows, the removal of the original window lintels, and the infill of the windows on the first story of the south elevation. A second commercial building is located at the west end of the property and connected to the main building by a one-story addition along the north end of the property.

View of the east and south elevations.

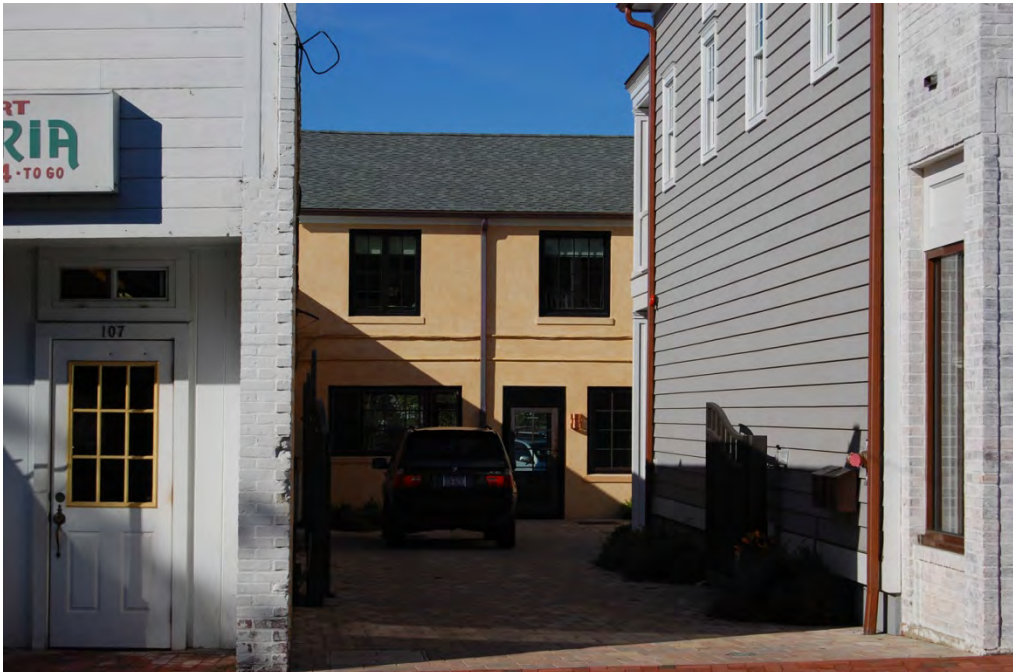
The second commercial building is a two-story, six-bay-by-two-bay former garage with an asphalt shingle-clad, side-gable roof and stucco-clad, concrete-block walls. Brick chimneys rise from the northwest and southwest corners of the building. It has an entrance off-center on the east (facade) elevation that replaced an earlier window opening. The entrance consists of a wood panel door with a window in the top half in a recessed entryway. Secondary entrances to the north side were filled with fixed windows. Two storefronts are evenly spaced on the lower level of the west elevation and consist of glass doors in aluminum frames flanked by plate-glass display windows. Windows consist of sixteen- and thirty-light fixed sash with projecting sills on the facade. The west elevation contains pairs of eight-light casements and three-light fixed windows with projecting sills. The building was remodeled in 2010. Alterations are comprised of the stucco cladding, replacement of all the windows, and the infill of some openings.

View of the south elevation and the east elevation of the rear building.

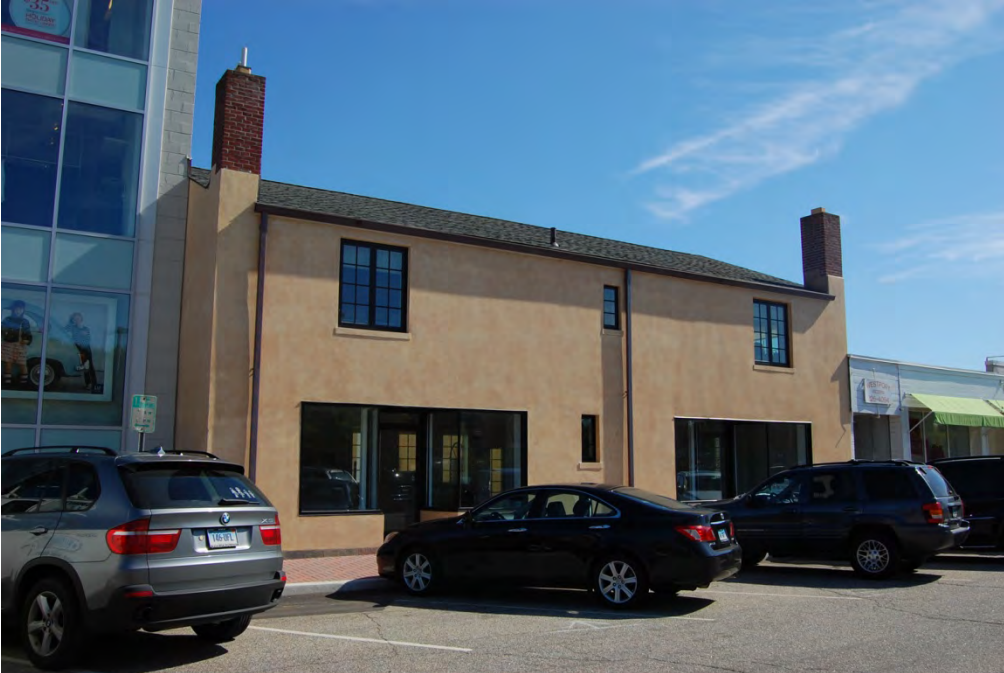
View of the west elevations of the rear building.

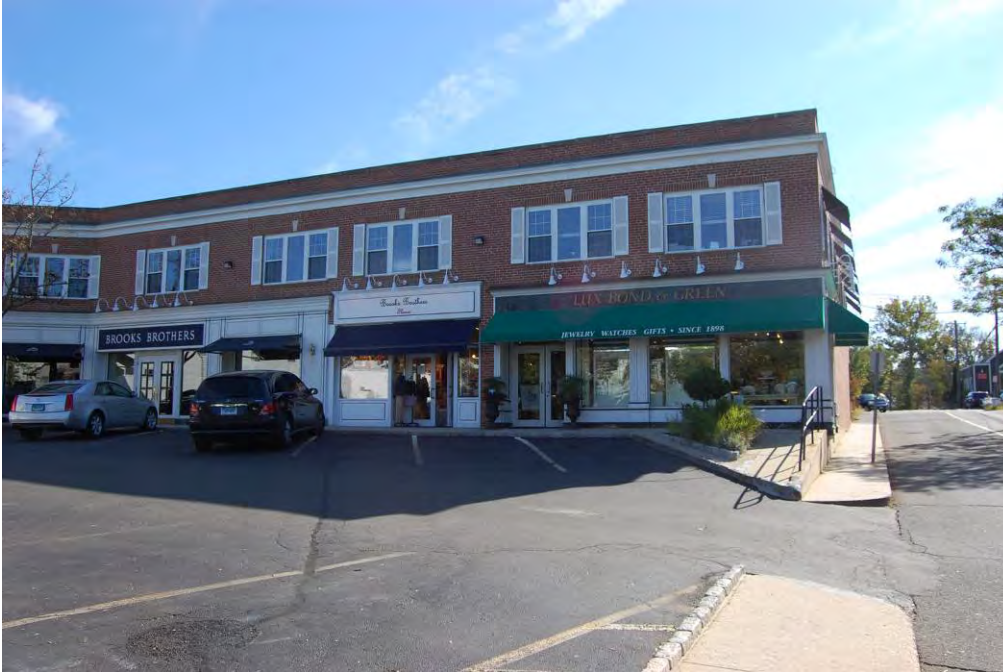
The building is a roughly L-shaped, two-story, ten-bay-by-six-bay commercial space constructed in the Colonial Revival style. The flat roof is edged by a brick parapet on the north, south, and west elevations with five brick chimneys. The walls are brick in Flemish bond with a wide cornice running below the parapet and rest on a concrete foundation. The building is a late incarnation of the two-part commercial block, a type originating in the 1850s, consisting of stores on the ground floor and offices on the upper floor. The building has five storefronts on its west (facade) elevation comprised of two to five sections divided by panels or pilasters. They each have at least one plate glass window, wide friezes for signage, and canvas awnings. Three of the storefronts are ornamented by molded panels above and beneath the windows. The entrances in the storefronts consist of glazed, wood, double doors. A recessed bay near the center of the facade with a fully-glazed, wood door flanked by five-light sidelights and ten-light transom leads to second story offices. Secondary entrances to the stores on the east elevation consist of solid metal doors with brick lintels. Windows on the second story of the facade and south and east elevations have single-light fixed sashes flanked by six-over-six, double-hung sash. The windows on the facade and north and south elevation have brick sills and splayed lintels with prominent, concrete keys. Windows on the first-story of the east elevation consist of a three-over-three, fixed sash windows with brick sills and lintels. Several of the storefront windows and all of the windows on the south elevation are sheltered by canvas awnings. The original plan of the building is intact; however the windows and doors appear to have been replaced.

View of the west elevation.

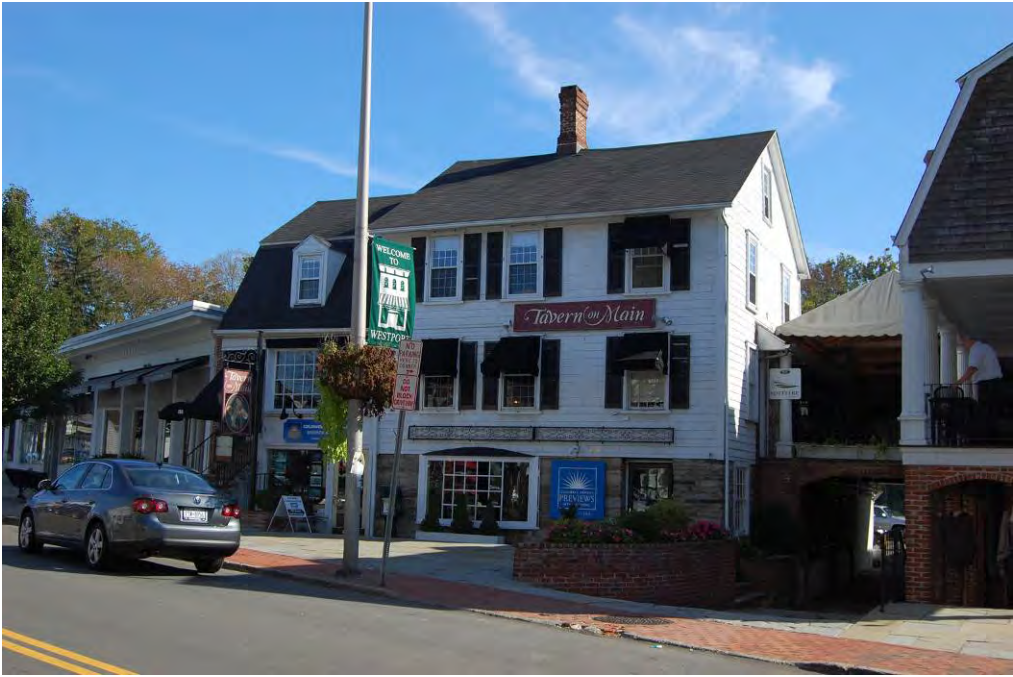
View of the east and south elevations of 142 Main Street.

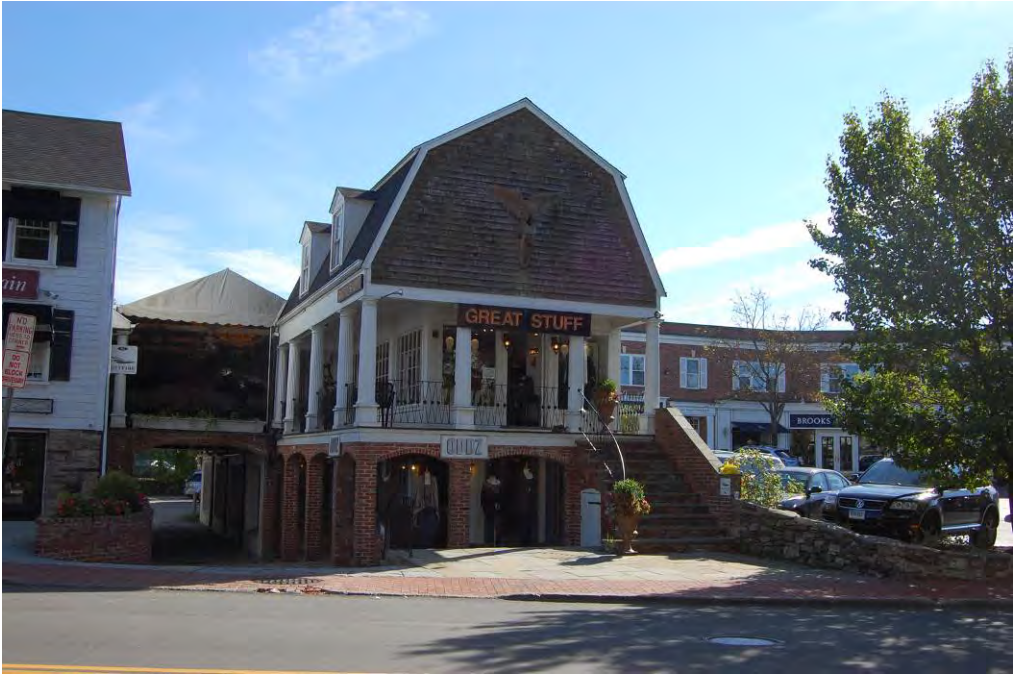
View of the west and north elevations of the addition at 146 Main Street.

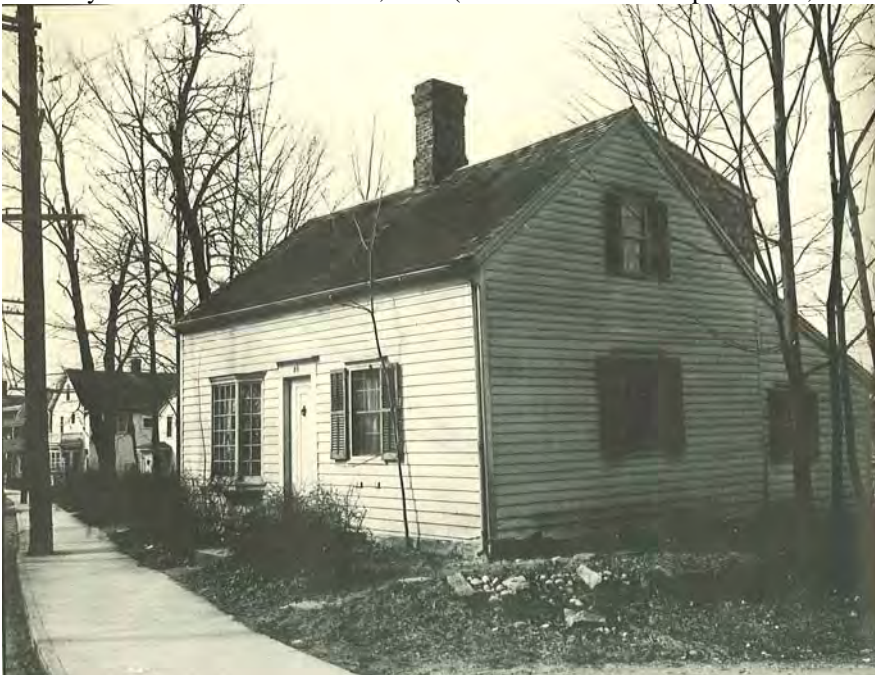
The building is a one-and-one-half-story, three-bay-by-two-bay, Cape with side and rear ells that was formerly a residence. A ca. 1930 photograph view shows the north and east elevations of the main block at that time. The wood shingle-clad, side-gable roof of the main block has no overhang and molded rake boards on the south and north elevations. A tall, narrow brick chimney in the center of the ridge was removed ca. 1996. The walls are clad in clapboard and rest on a granite block foundation. A one -story ell dating from the nineteenth century is integrated into the west (rear) gable slope creating a "saltbox" profile. A one-story side ell with a wood shingle-clad, side-gable roof and clapboard siding was constructed on the south elevation in the late nineteenth century. A one-and-one-half-story, gambrel-roof rear ell with clapboard and wood shingle siding, and a brick foundation was constructed on the west (rear) elevation in the mid to late twentieth century. The steep slope of the lot allows for a full-height basement level on the west elevation of this ell. A large shed dormer is located on the north roof slope of the rear ell. The building's main entrance is located, as originally, in the center of the east (facade) elevation of the main block and consists of a single door with multiple lights and simple, flat wood molding. The entrance is flanked by full-height, 16-light, fixed sidelights and large, plate-glass windows installed in the 1970s and reworked ca. 1996. A second entrance was added on the south elevation of the main block ca. 1996 and is accessed by a concrete pedestrian ramp. Additional entrances are located beneath a flat-roof porch on the north elevation of the main block and in the basement level on the west elevation of the rear ell, both dating to ca. 1996. A pair of wood panel doors was removed from the center of the east elevation of the south ell ca. 1996 and replaced with a plate glass window flanked by 16-light fixed sash similar to the main entrance. Windows in the main block of the ca. 1790 building include three original windows on the north and south gable ends with six-over-six, double-hung wood sash with slightly projecting wood lintels. The ca. 1996 west ell has one-over-one and twelve-over-twelve, double-hung windows, and a bay window in the center of the west elevation. Despite the rear additions, and the alterations to most windows and entrances, the original main block and features of the main block and nineteenth century rear and side ells are still intact and visible.

177 Main Street ca. 1930 (source: *Westport...A Special Place*, Eve Potts, 1985).

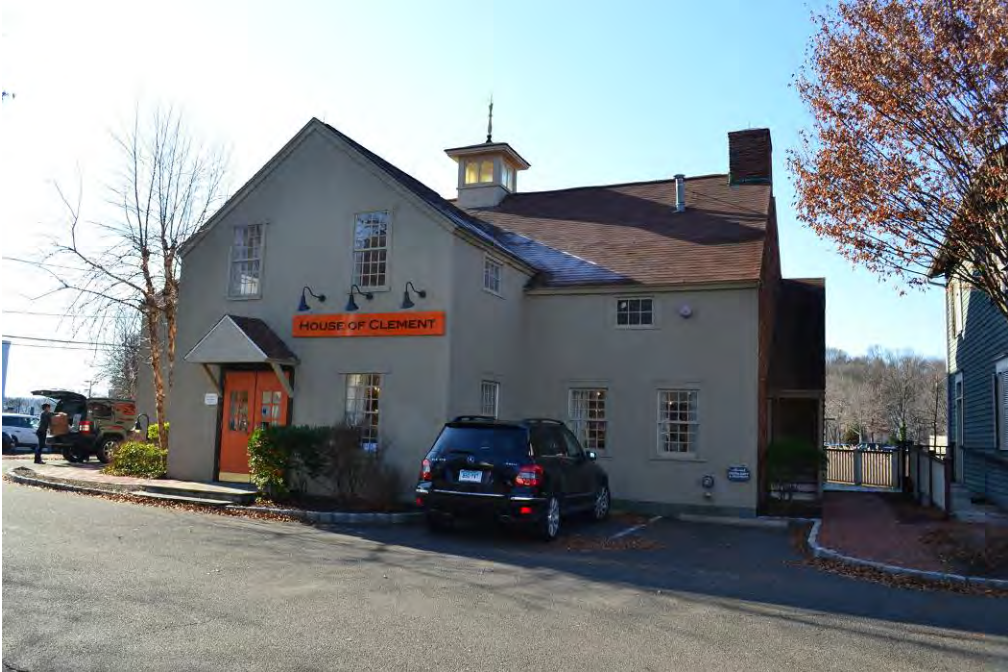
The building is a one-and-one-half-story, four-bay-by-three-bay former warehouse. The asphalt shingle-clad, cross-gable has a cupola at the center of the ridge and a brick chimney on the north elevation. The walls are clad in vertical board siding on the south, east, and west elevations and brick on the north elevation. The building rests on a concrete foundation, partially covered with brick veneer. A one-and-one-half-story, gable-front addition projects from the center of the east (facade) elevation. A second, one-and-one-half-story, gable-roof ell was added on to the north end of the west elevation. The main entrance is located on the east addition and consists of wood panel, windowed double-doors. A gable-roof supported by brackets shelters the entrance. A secondary entrance, accessed by an exterior stairway is located on the second story of the north elevation. The windows primarily consist of wood, sixteen-over-sixteen, double-hung sash and three-over-three, awning sash on the facade, south, and west elevations. Bay windows were added on the south elevation and diagonally at the southeast junction of the facade and east addition. Pairs of vinyl casement windows are located on the west elevation. A large, square, fixed window with diagonal muntins is located on the south elevation below a small, octagonal fixed sash in the south gable eaves. The original plan of the main block is relatively intact; however, the building was moved from its original location in the 1930s onto its current foundation. Alterations include the replacement of the siding and some of the windows and the addition of the bay windows.

View of the west elevation.

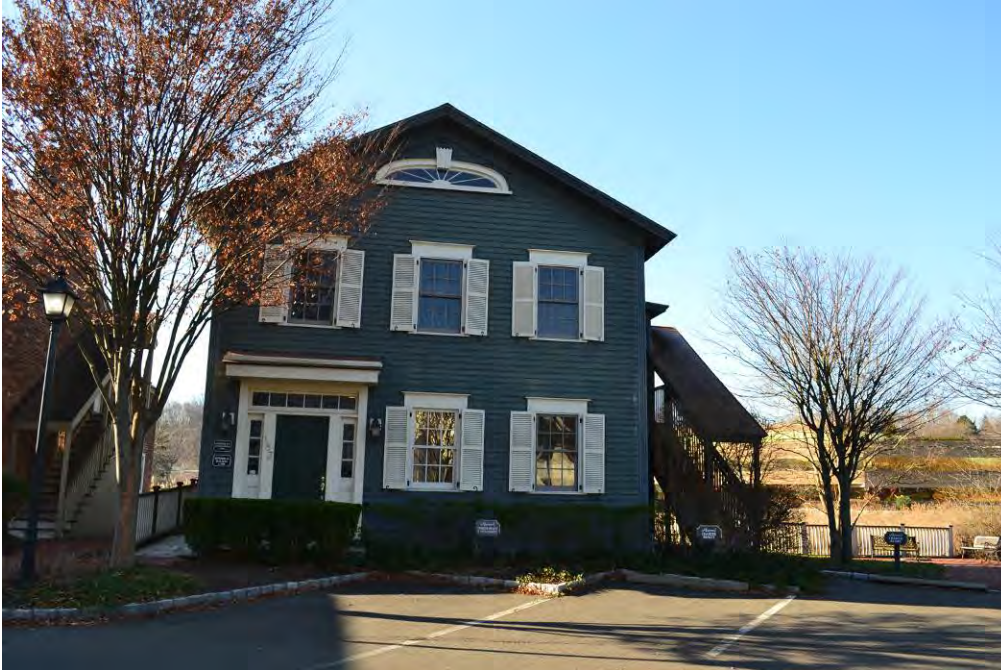
The building is a two-story, three-bay-by-two-bay former residence constructed in the Federal period with later Greek Revival details. The asphalt shingle-clad, front-gable roof has deep overhangs and wide rake boards. The walls are clad in clapboard, with fluted corner pilasters and rest on a parged concrete foundation. A two-story, one-bay addition and exterior staircase attached to the north elevation were constructed in the mid-twentieth century. The main entrance is located in the south bay of the east (facade) elevation and consists of a wood paneled door flanked by three-light sidelights and a six-light rectangular transom. A heavily projecting lintel shelters the entrance. Secondary entrances are located in the west bay of the north elevation and the second story of the north elevation and consist of a glazed wood frame door with wide wood trim and transom. The windows primarily consist of six-over-six, double-hung mid-to-late-twentieth-century sash set in wood frames with wide lintels. Segmental-arch fanlights with prominent keys are located in the gables on the facade and west elevation. The building's plan is relatively intact; however, the building was moved from its original location in 1930 on a new foundation. Minimal alterations to the materials include the replacement of some of the windows and doors.

View of the east elevation.

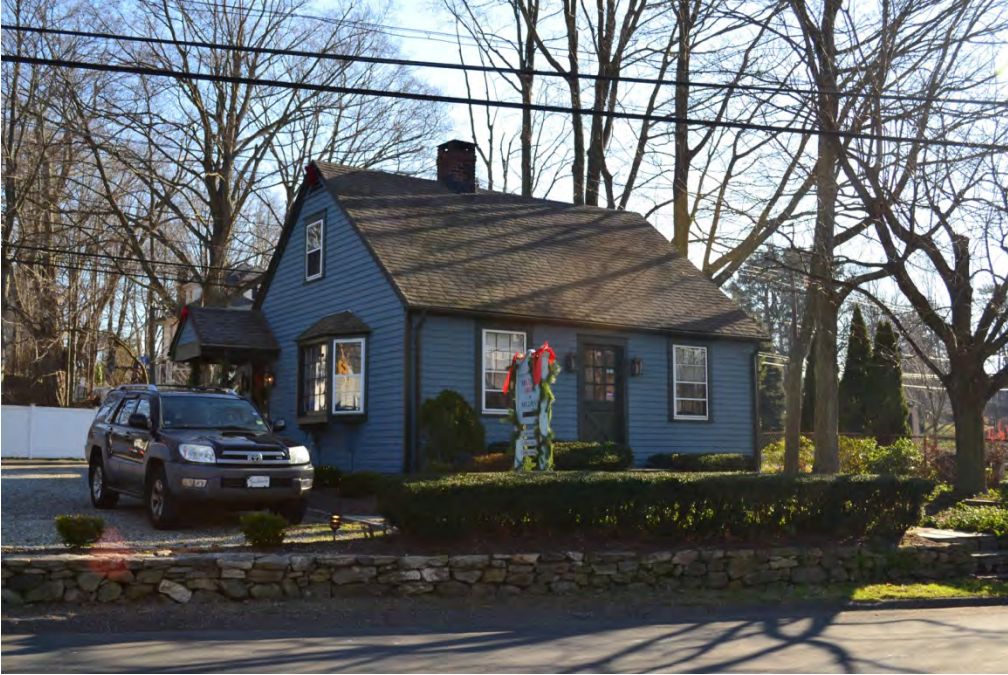
The building is a one-and-one-half-story, three-bay-by-two-bay former residence built in the Colonial Revival style. The asphalt shingle-clad, side-gable roof has a shed dormer across the east (rear) elevation and a brick chimney at the ridge. The walls are clad in clapboard and rest on a concrete foundation. A gable roof garage was converted into living space after 1940 and is attached to the east elevation of the main building by a gable-roof ell. The primary entrance is located in the center of the west (facade) elevation and consists of a wood panel door with a nine-light window in the top half surrounded by simple wood trim. A secondary entrance is located in the west end of the north elevation and contains an identical door covered by a gable porch roof supported by square columns. Windows consist of six-over-six, double-hung sash in varying sizes with simple wood trim. The double-hung windows appear to be original to the early-twentieth century design. Matching bay windows with hip roofs and scroll brackets are located on the north elevation of main building and former garage. Alterations are comprised of the addition of the shed dormer, the inclusion of the garage into the plan, the installation of the bay windows, and the replacement of some materials such as the exterior cladding.

View of the east and north elevations.

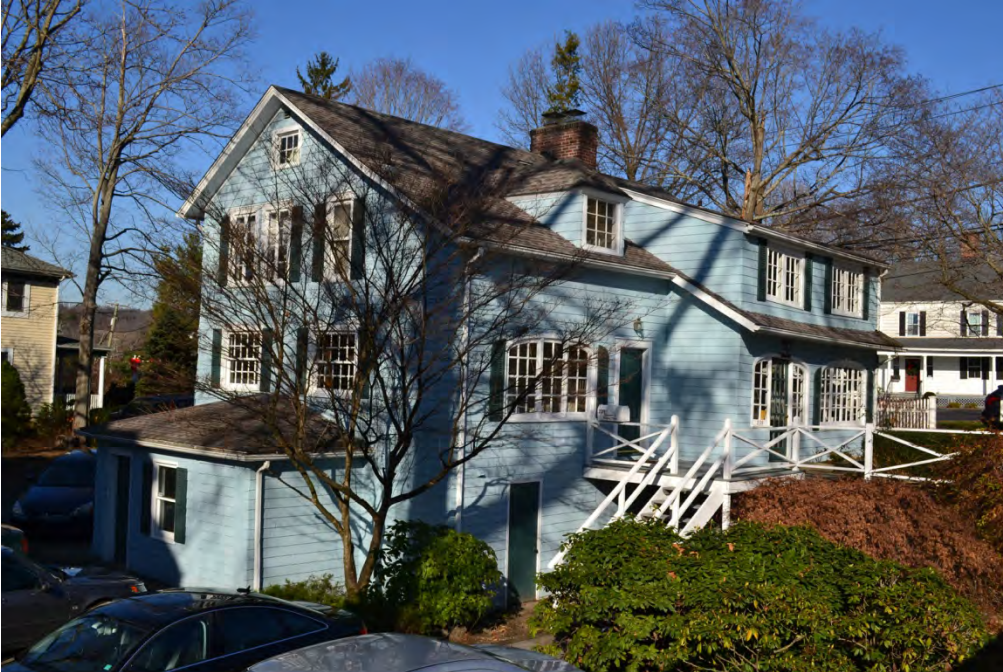
The building is a one-and-one-half-story, four-bay-by-two-bay residence with later Colonial Revival style details. The asphalt shingle-clad, side-gable roof provides one-story on the facade (east) elevation and two full stories on the west (rear) elevation. The north end of the east slope extends over an enclosed porch. A shed dormer was built on the roof extension. A hip roof dormer is located south of the shed dormer. A brick chimney rises near the center of the ridge. The walls are clad in wood shingle and rest of a stone foundation. The building was constructed into a steep slope exposing a full-height basement on the south, west, and half of the east (facade) elevations. A one-story, hip-roof addition is attached to the basement level of the south elevation. The primary entrance is located off-center on the facade and consists of a panel door with simple wood trim. It is accessed by a raised wood walkway off Main Street and a wood exterior staircase that runs between the lower level and first story. A secondary entrance is located on the facade of the enclosed porch and has a fifteen-light door in a wood frame flanked by eight-light, fixed wood sash windows all encompassed beneath a segmental arch with a keystone. Additional entrances are located in the south elevation of the south addition and basement level on the facade. Windows primarily consist of eight-light, wood casement sash arranged in pairs and groups of three in varying sizes. Other windows consist of a six-over-six and a eight-over-eight, double-hung sash on the west elevation; ten-over-ten and one-over-over, double-hung and a six-light fixed sash on the south elevation; and a nine-light fixed sash in the shed dormer on the east slope. The enclosed porch has 24-light fix sash window in segmental arch openings with a keystone. A similar window is located on the south end of the facade, but has only 21-lights. All the windows, except for the one-over-one double-hung sash on the south elevation, appear to belong to the original design and the subsequent, early twentieth-century alterations. An 1878 image of the house depicts a significantly different footprint from the present plan, but by 1923, the next time the house is depicted on a map, the current plan is presented. Since 1923, the only alterations to the design consist of enclosing the porch between 1923 and 1931, constructing the dormers in the early-to-mid-twentieth century, and minimal replacement of windows, doors, and exterior cladding.

View of the south and west elevations.
