Potential 2023 Preservation Awards

Thursday, May 4, 2023, 7PM in the auditorium

Building Name (Common) Mills Farmstead Record No. 35994
Building Name (Historic) Mills, Hezekiah Allen and Charity / Mills, Betsy Taylor, Farmstead
Street Address or Location 29 North Avenue
Town/City Westport Village Greens Farms/Coleytown County Fairfield
Owner(s) Ellen Jones, 29 North Avenue, Westport CT 06880 Public Private

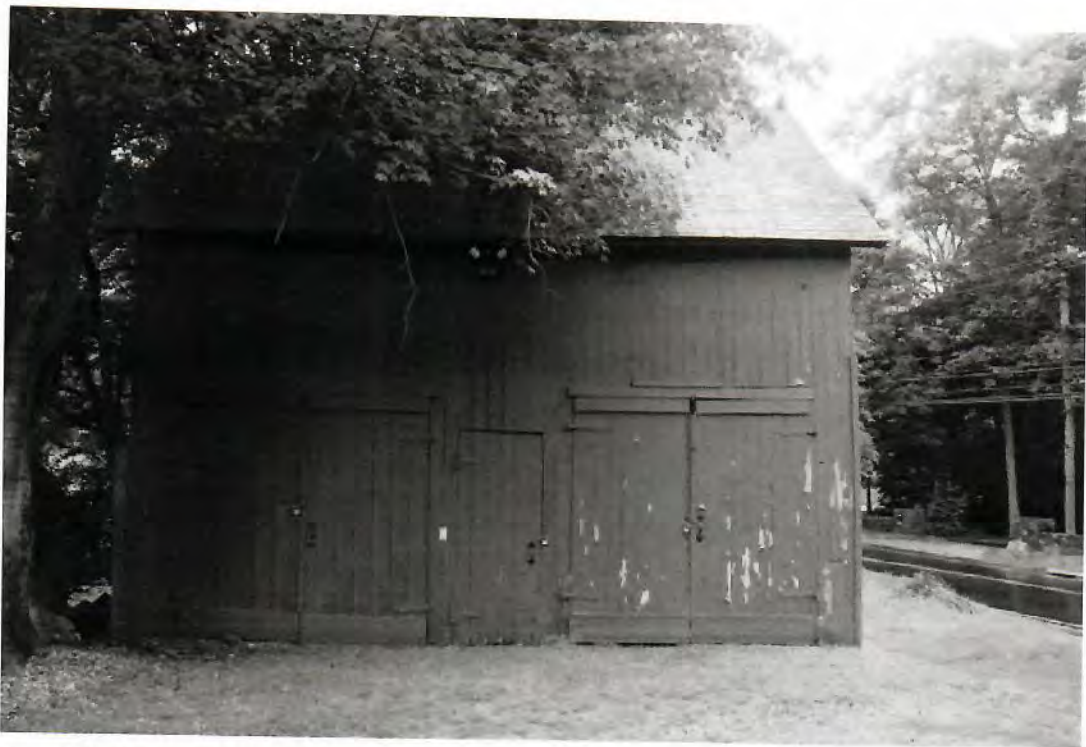
The south eave-side of the barn has three entries; two pairs of Z-braced hinged doors, each in front of a corresponding bay, and a centered pass-through door. Above the east pair of doors is a side-hinged hay door. The east gable-end of the barn has a four-pane window with trim in the main level towards the north corner, a dropped girt siding divide, and a four-pane window with trim just beneath the apex of the roof.

6. South view of Barn, camera facing north.

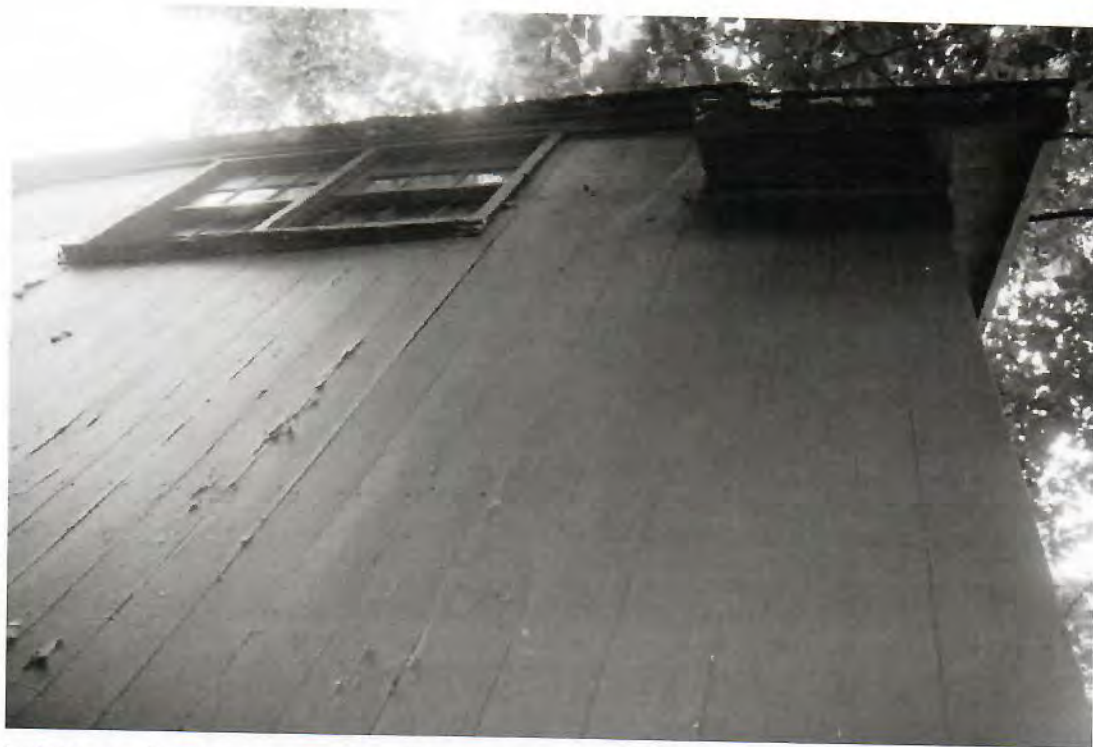
The north eave-side of the barn has a wide shed-roofed wall dormer that encompasses most of the north pitch of the roof. Within the wall dormer are two sets of two six-over-six double-hung windows. The rest of the side is blank except for a boarded over four-pane window with trim. The west gable-end of the barn has a stone pier for a foundation at the northwest corner and another beneath the barn. Loose brick are found in the crawl space beneath the barn. The west gable-end of the barn has a four-pane window with trim in the main level towards the south corner, a dropped girt siding divide, and a four-pane window with trim just beneath the apex of the roof.

10. Detail of the exterior, north eave-side wall dormer, east corner, camera facing south.

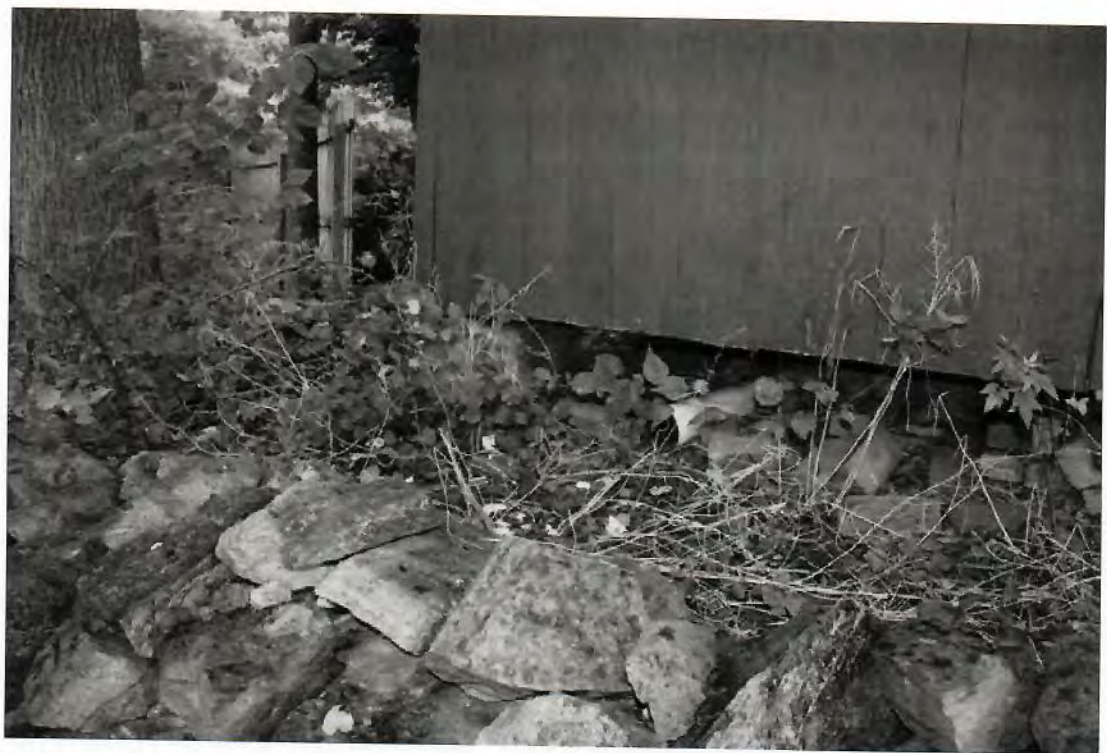
This is a 1 ½-story two-bay English barn. The barn measure 24' wide by 20' deep. The main façade is the south eave-side of the barn. The barn is sheathed in vertical wood siding painted red. The frame sits on stone piers, at the northwest corner where the foundation is visible; the rest of the foundation is beneath grade.

12. Detail of the exterior, northwest corner of the barn. Note the single stone pier at the corner.

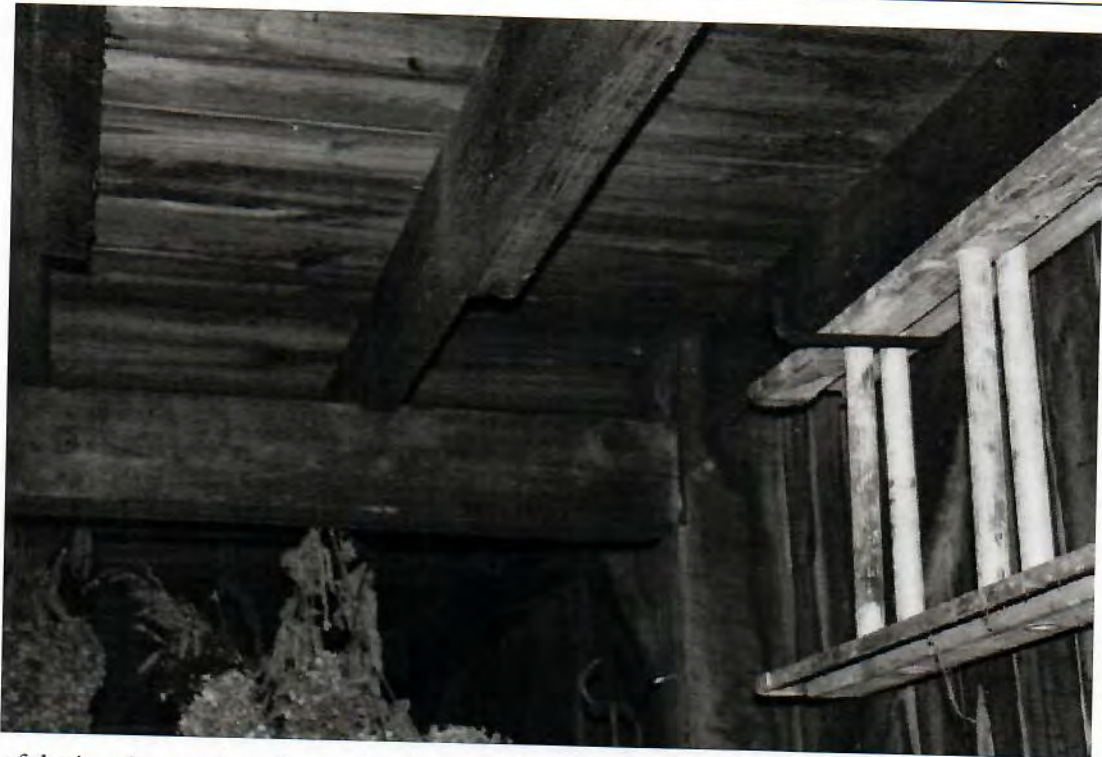
The barn is a typical example of a small English barn once used for agriculture. Its circular-sawn timbers suggest its construction in the second half of the 19th century, later than the Farmhouse. The association with a possibly pre-Revolutionary War house, which was in the same family for five generations, adds to the significance. The barn is built using square rule timber framing construction, with pegged mortise and tenon joinery, and dropped girts. Most of the barn, except the wall dormer, south eave-side doors and added center pass-through door are original. The Farmhouse and Barn are survivors in an area that has been heavily developed.

13. Detail of the interior, north wall, main level, square rule construction and circular sawn posts, camera facing east.

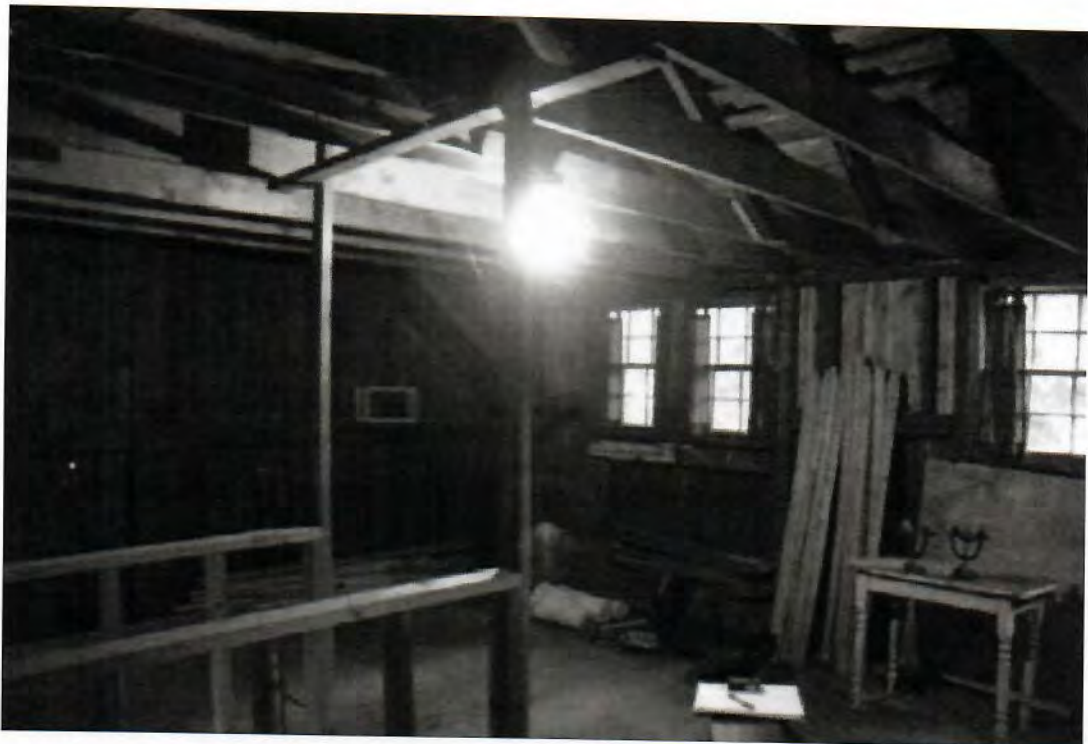
The attic level has a wide wall dormer added to the north pitch of the roof and north eave-side of the barn. It has two sets of two six-over-six double-hung windows. The north rafter plate was partially removed to accommodate the dormer. The attic level is constructed of square rule mortise and tenon timber framing, with 5" x 6" post and beams with circular saw marks with dropped girts at the gable-ends. The ceiling has common rafters and tongue-and-groove ceiling boards mixed with random-width boards under asphalt shingles.

14. Attic level of barn, camera facing northwest.

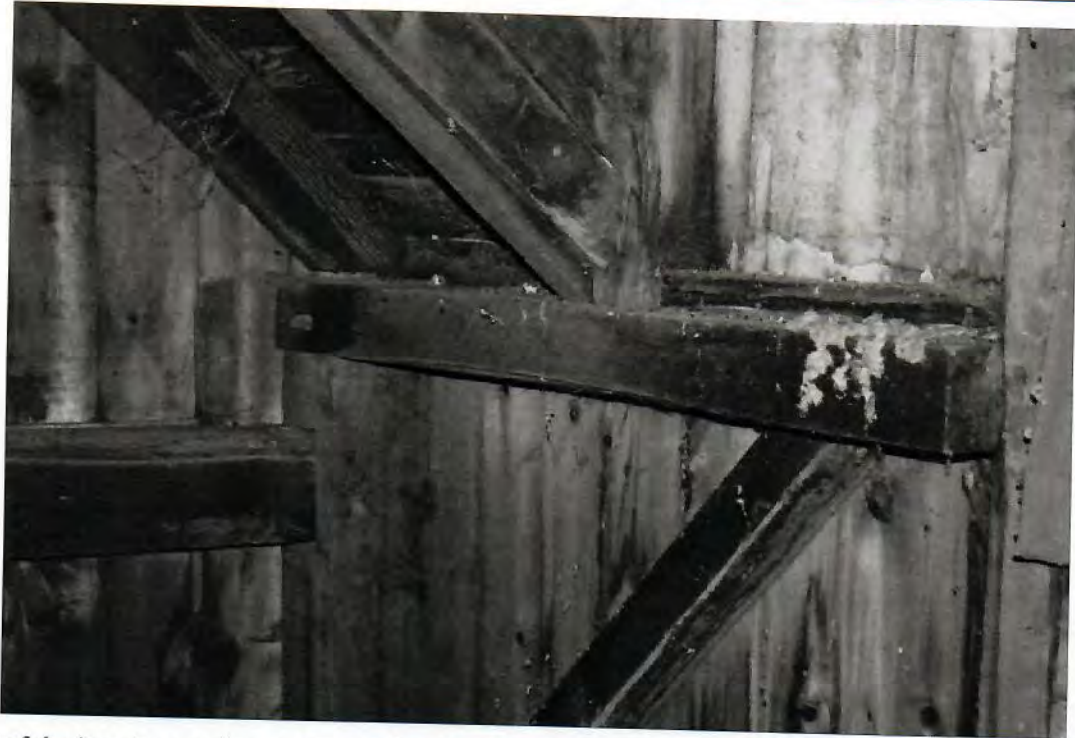
15. Detail of the interior, northwest corner, showing dropped tie-girt in end wall. Note how the rafter plate is truncated for the shed dormer.

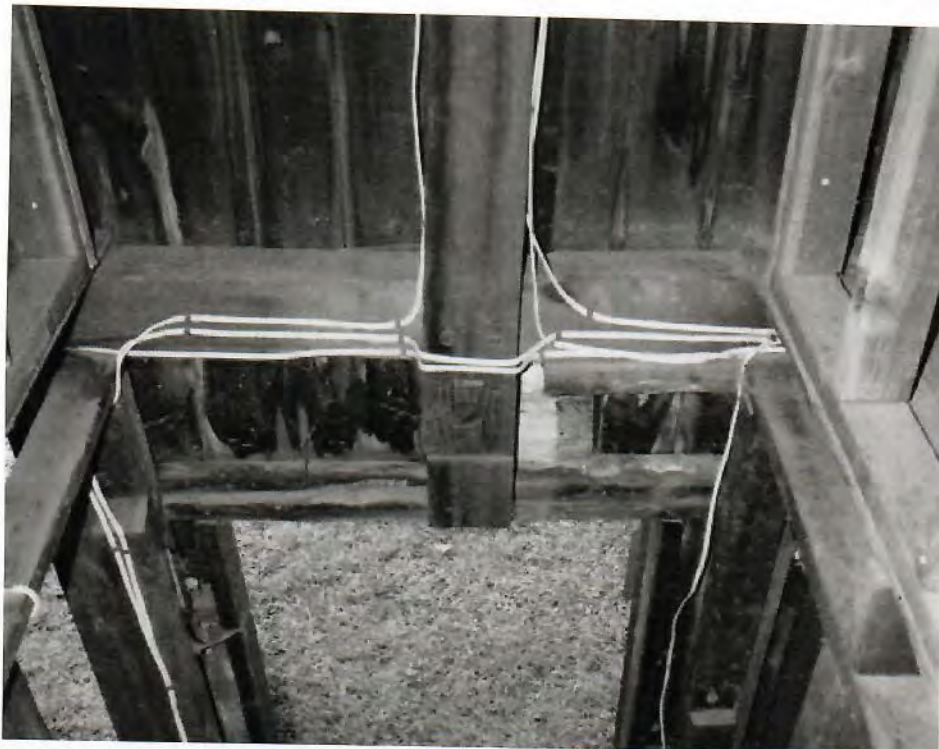
Alterations? Yes No If yes, explain: South center post partially removed, wall dormer added.

16. Detail of interior, severed post where center entry on south eave-side now is, camera facing south.

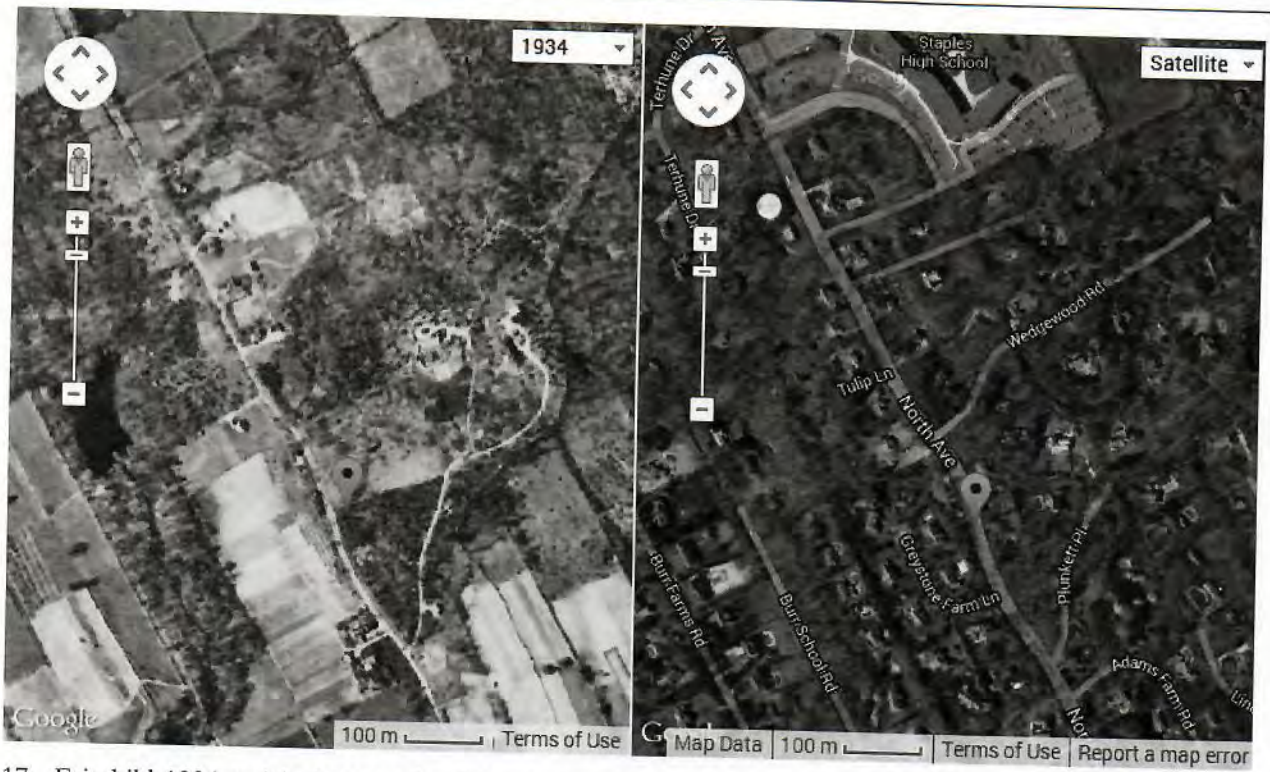
17. Fairchild 1934 aerial photograph of the site compared with modern Google Map view, showing the extent of farmland remaining in 1934 and the fully developed residential neighborhood of the present.
