# CONSERVATION RESTRICTION AREA AND ADJACENT WETLAND - IMPACT ANALYSIS OF THE PROPOSED SITE IMPROVEMENTS

**50 ROSEVILLE ROAD  
WESTPORT, CT**

PREPARED BY:  
**ALEKSANDRA MOCH**  
SOIL & WETLAND SCIENTIST  
LANDSCAPE DESIGNER  
GEOLOGIST/HYDROGEOLOGIST  
CPESC

**JUNE 4, 2023**  
REVISED  
**AUGUST 9, 2023**

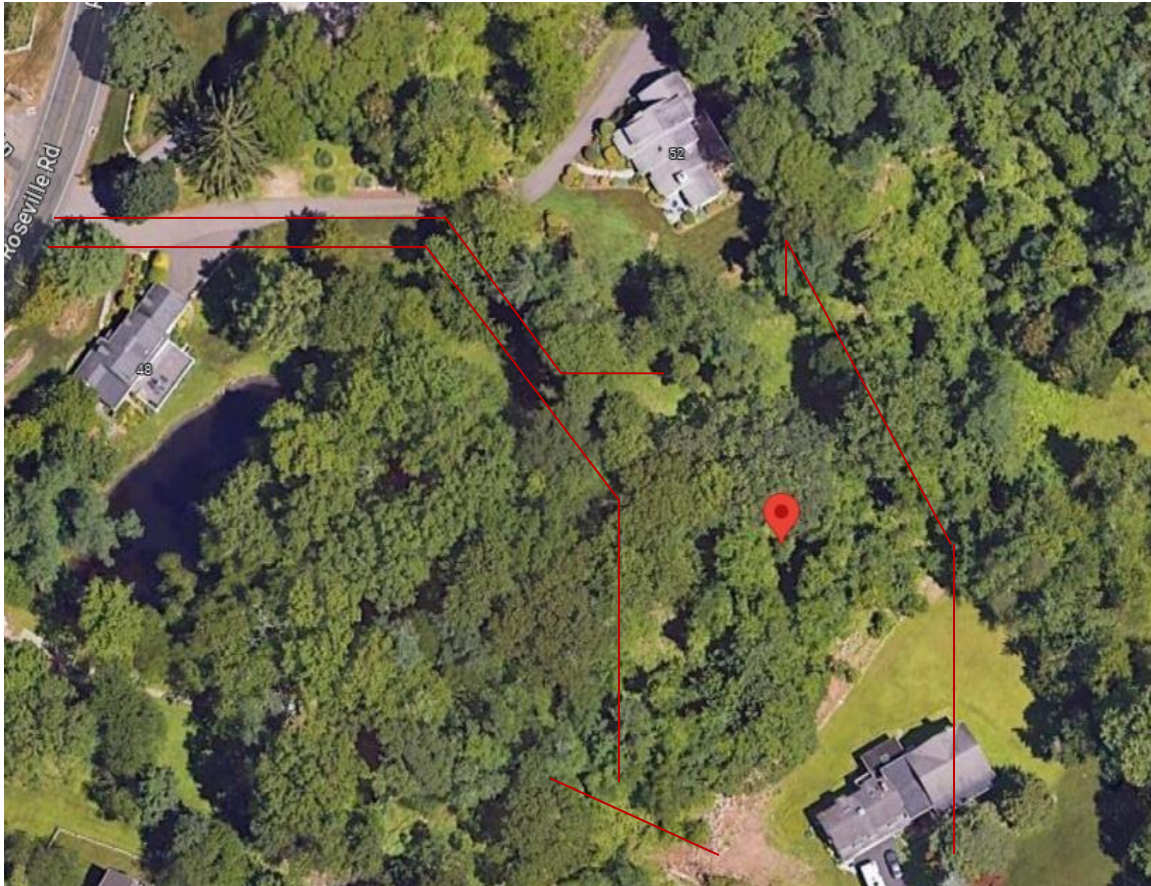
Google, aerial photograph of the site taken in 2023

This 0.95-acres site is an undeveloped flag-lot located on the eastern side of Roseville Road in Westport, CT. The access to the site is gained via a 325-foot long and 20-foot wide strip of land which is partially paved. This access is being shared with two other properties. The first 90 feet is paved. Further east, the access forks-off the pavement into an area which is partially improved but maintained as a lawn with several trees growing along the edge. At its terminus, the access opens up to a wide area of the lot. The area is divided into a wooded southern section protected as a Conservation Restriction Area (CRA) and a cleared northern area prepared to accommodate the new development. The terrain transitions from a moderate slope containing the most of the clearing into a steep and very steep gradient dominating the CRA. Even though the area is surrounded by wetland/watercourse systems; no wetland/watercourse was found at the site. The property is located within the Muddy Brook watershed and residential zone A.

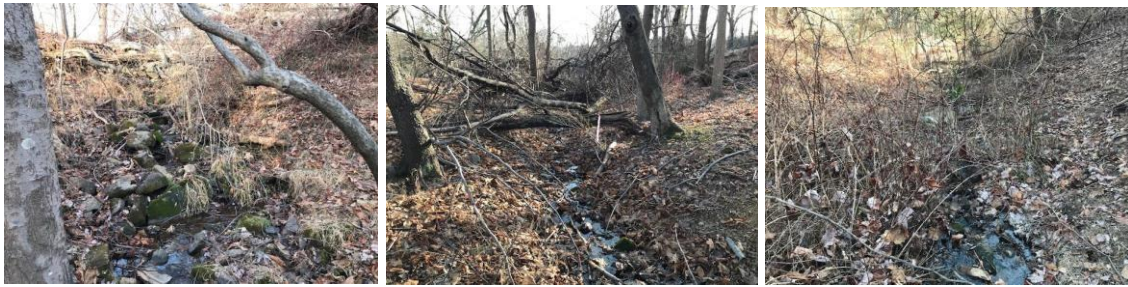
Upstream

Mid-stream

Downstream

There are three regulated areas surrounding the site. All of them are part of a single wetland/watercourse system which was separated by an access created during the development associated with the approved subdivision. One of the elements of this corridor is located off-site along the eastern property line. This intermittent watercourse receives overflow from a wetland located to the north. The area of the channel is wooded and carved into the ledge. The slope here is very steep so the flow velocity creates a strong erosional force resulting in a deep and well-established channel. Heavily armored stream bed with stone, boulders and pebbles help to dissipate the energy of the flow and moderates the velocities. This stream was flagged in the field by Aleksandra Moch, on March 18, 2023. The channel is located more than 50 feet from the proposed development.

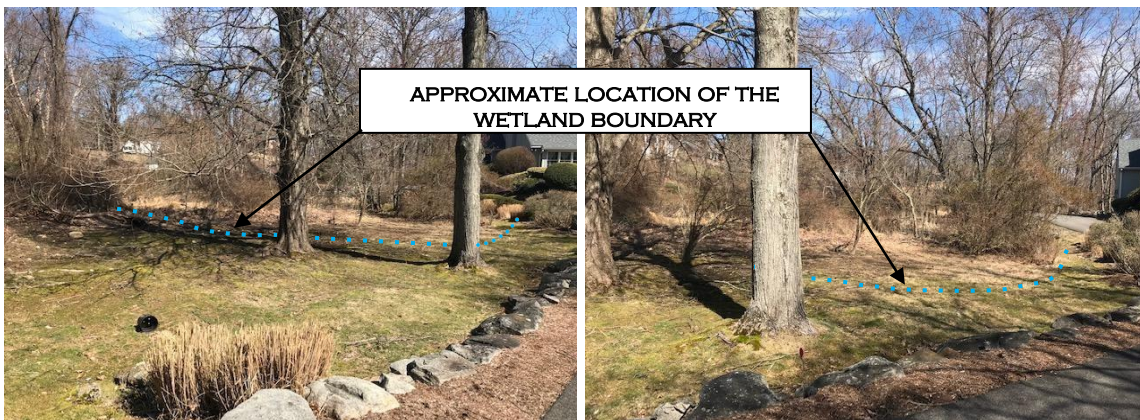
A view from the proposed driveway

The second component of this wetland/watercourse system is situated off-site on the northern side of the access. This seasonally flooded marsh is surrounded by a wetland fringe. The distance to this wetland exceeds the width of the regulated 50' upland review area.

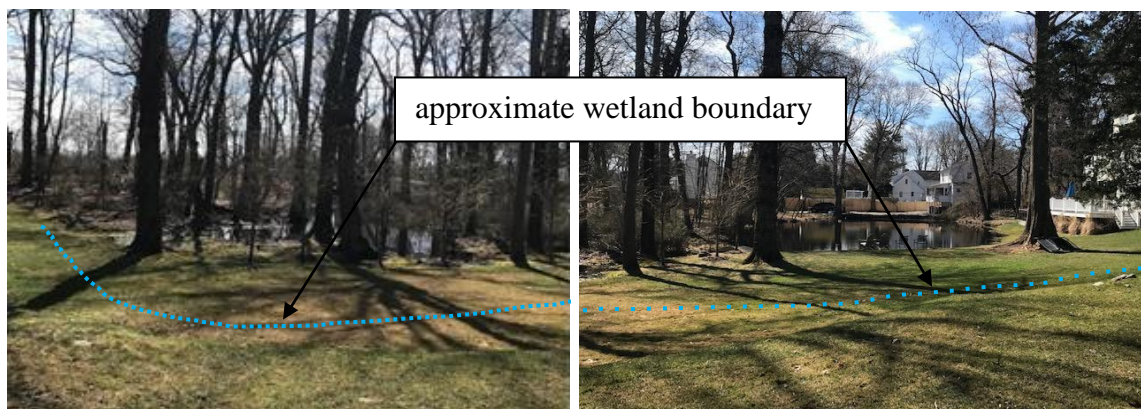
A view of the wetland/watercourse area from the proposed driveway.

The third component of this wetland/watercourse system is situated off-site along the southern edge of the access. This area consists of a man-made pond and associated wetland fringe. The proposed access driveway and associated in-ground detention system falls within its regulated upland review area, therefore it will be focused on in this report.
