**Village District Overlay (VDO) Zone / Westport Center
REVIEW and RECOMMENDATION**

CHRIST & HOLY TRINITY CHURCH, 75 Church Lane, Westport CT 06880

#65 Myrtle Ave. Rectory front porch and rear deck repairs

65 Myrtle Ave. Associate Rectory rear deck repairs

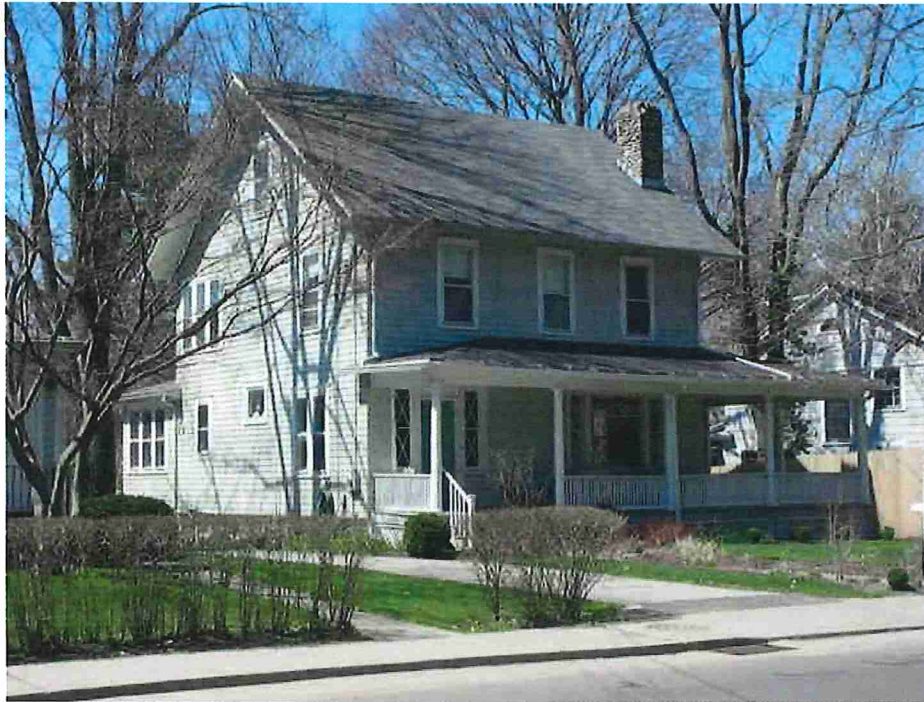
The front edge of the porch facing Myrtle ave., has dropped significantly as the supporting posts under each of the round columns have sunk sinking and or deteriorated over time and the supporting posts are sitting on stones without anchors. There are 8 to be replaced with concrete sonotube foundations., see attached section drawing.

The existing wood railing is non code-conforming – it is 8” too low and dangerous, needs repair, adding top rail and raising the bottom rail to 4” above the deck will make the railing height 36” above the porch floor and strengthen the whole railing.

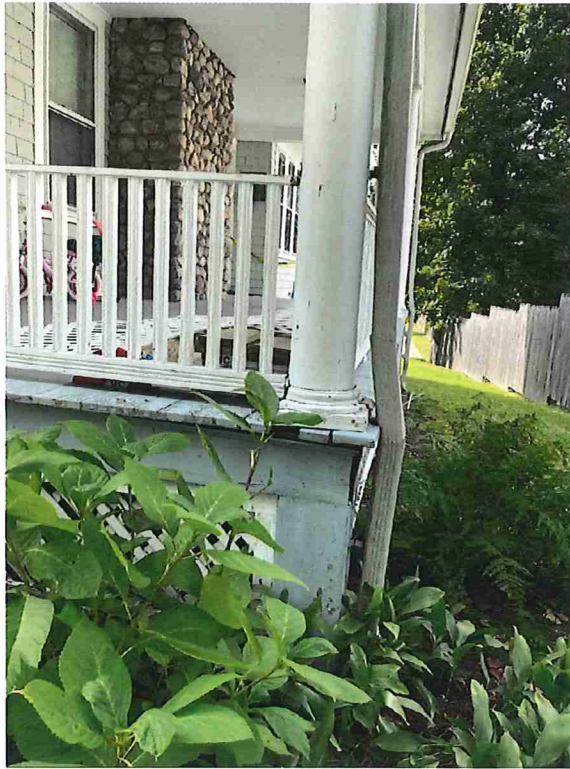
Existing Corner post

The new 6x6 PT posts need to be anchored to the conc. foundations to prevent uplift and to the load-bearing wood columns holding up the roof above.

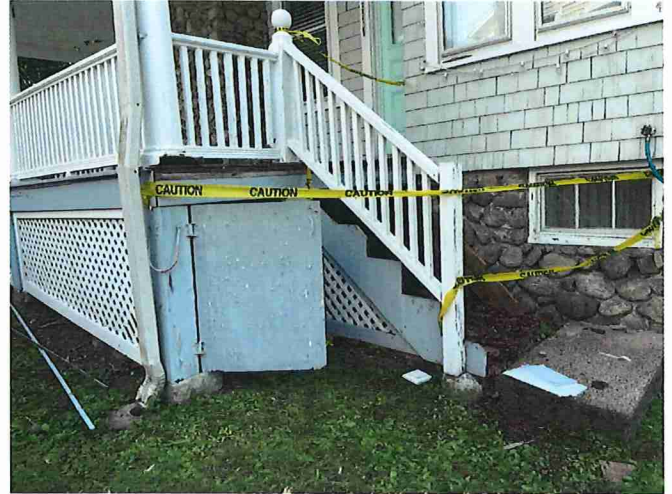
The rear stair has collapsed altogether and has no foundation – note the railing post left sitting on a stone and needs to be rebuilt on a solid foundation.

Rear stair has collapsed.

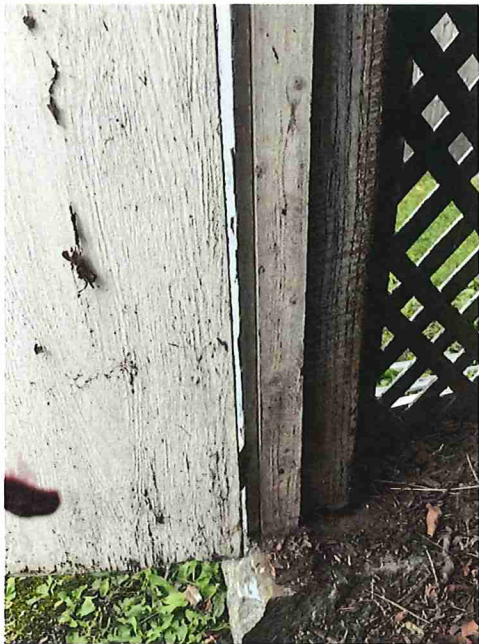
Posts sitting on stone foundations

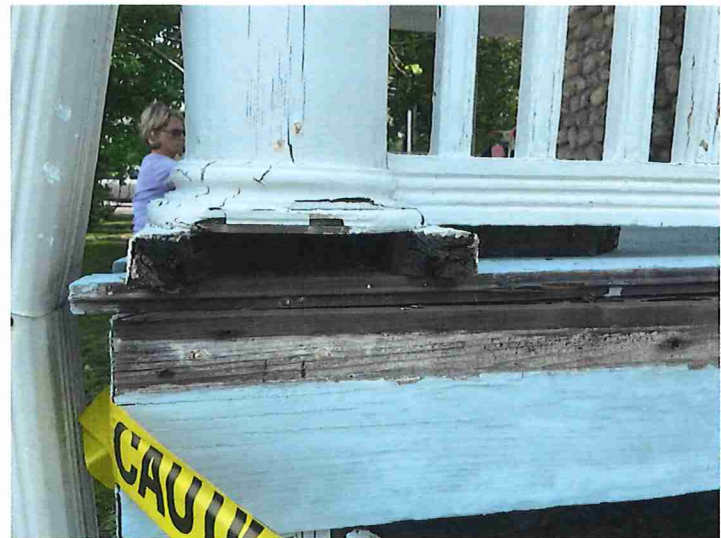
The white round wood columns are in good condition but some of the bases need to be replaced.

Deterioration of load bearing base of corner post.

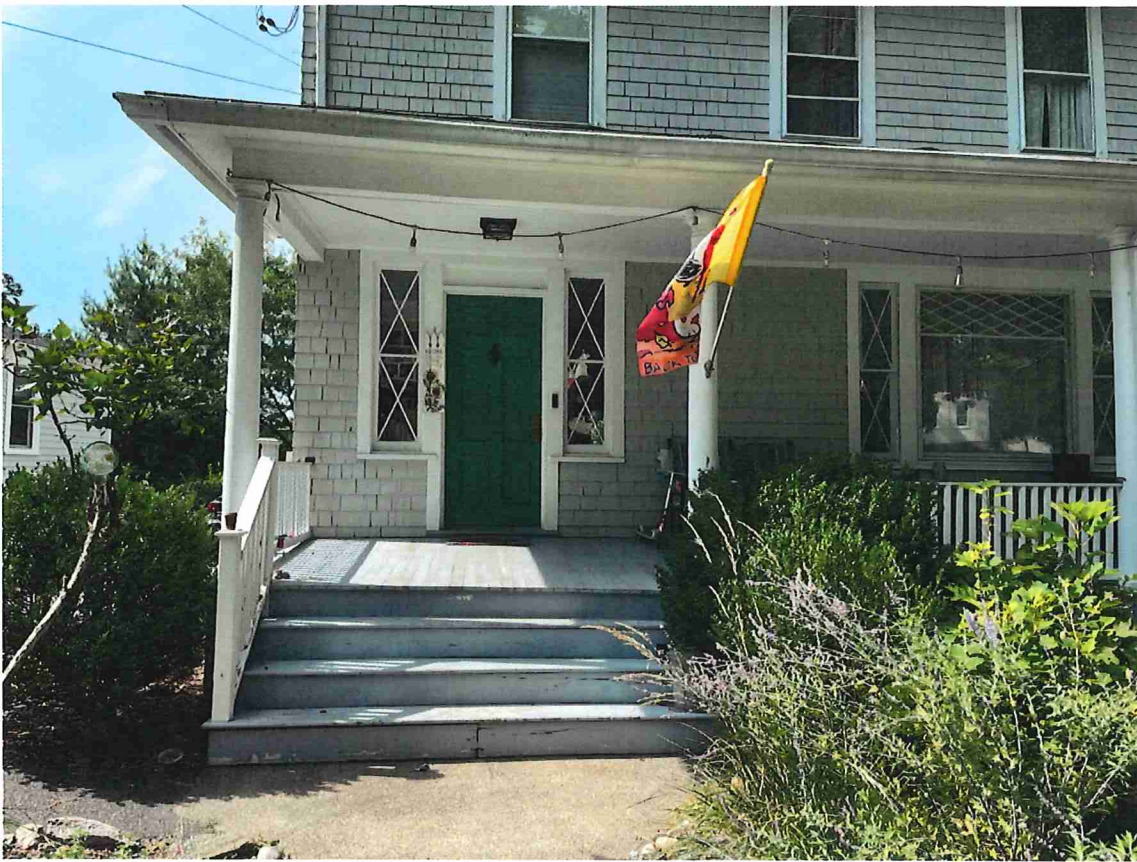
The front stairs have sunk on the right handside and need to be rebuilt with new foundations.

Front steps are collapsing on the right side & require foundations under the existing circular columns.

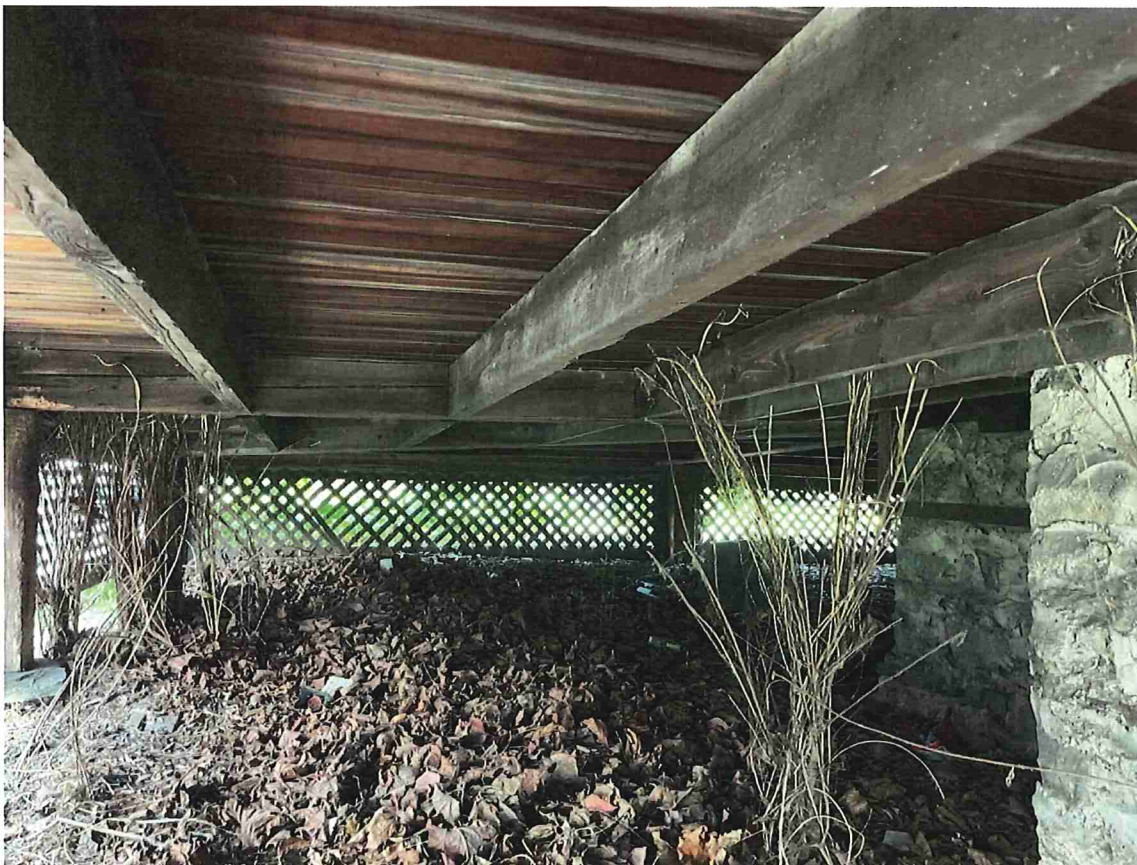
The framing below the deck is good but needs to have joist hangars installed to stiffen the structure.

Framing under the deck

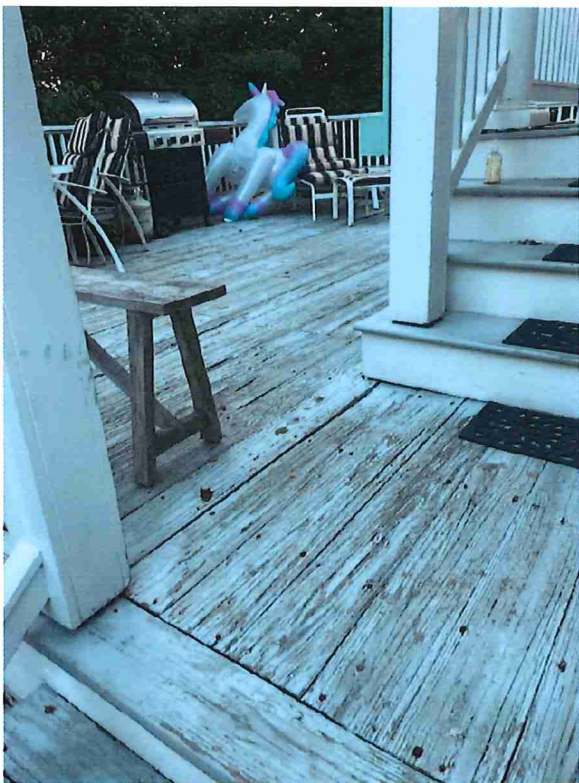
The deck framing is in good condition and has sonotube foundations supporting the posts. Timbertech, light grey, boarding is suggested to replace the deteriorated decking and stairs, additional joists will need to be added as they are spaced at 16" and need to be at 12" for Timbertech.

Deteriorated decking is splintered.

The upper landing and stair to the deck at the Mudroom door will be replaced with timbertech and the two steps of steps to grade will be replaced with timebertech.

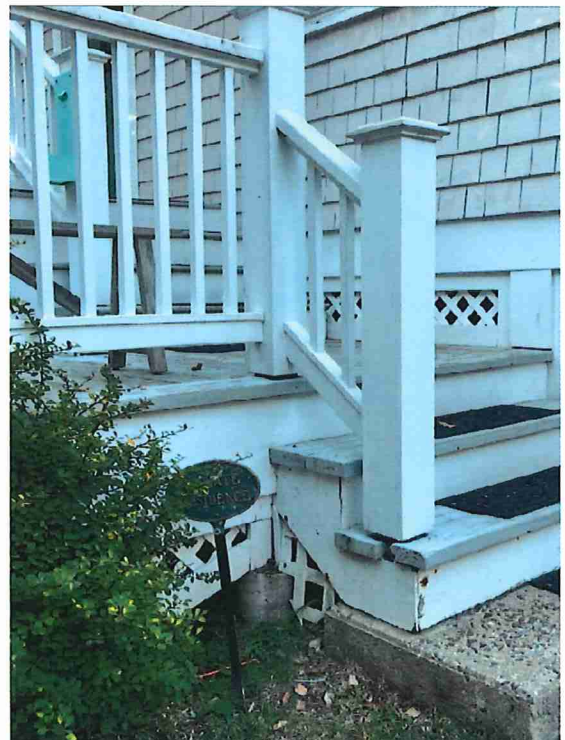
Concrete sonotube foundations, railing & posts to remain.

The existing railing and posts are to be protected and maintained.
