2024 Preservation Awards Nominations

May 9, 2024, 7:00 PM, Auditorium

90 Hillandale Road

29 North Avenue

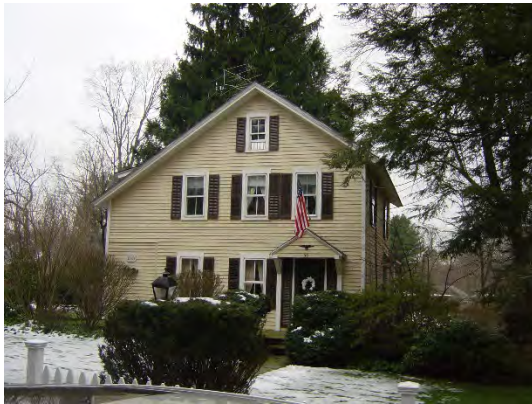
Photo of house for sale in 2021:

Note the framing at the left part of the front of the house appears to be a potential one car garage entry from the 1930s but closed many years later. The enter area was re-sided, as well, as other areas of damaged siding after purchase in 2021.

The house was a candidate for a teardown but instead was restored, both exterior and interior, and then resold.

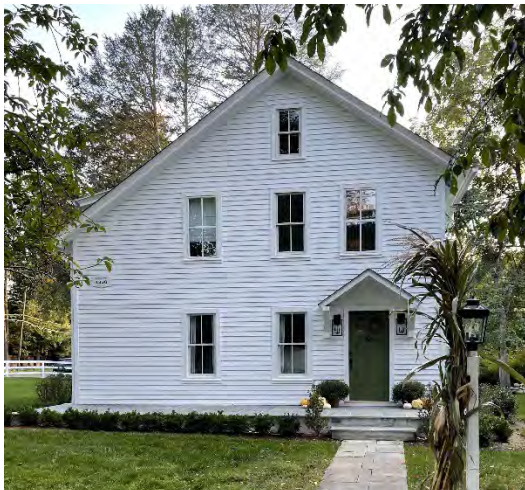
Photo taken January 2023:

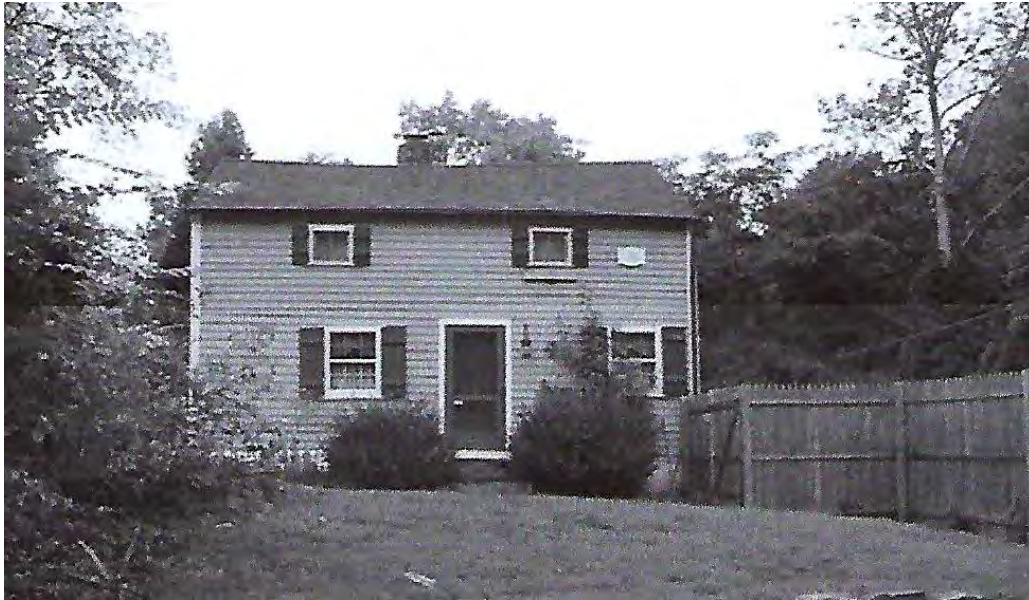
Prior to 2023 from Barn Survey – Stockade Fence on North Avenue Side and windows

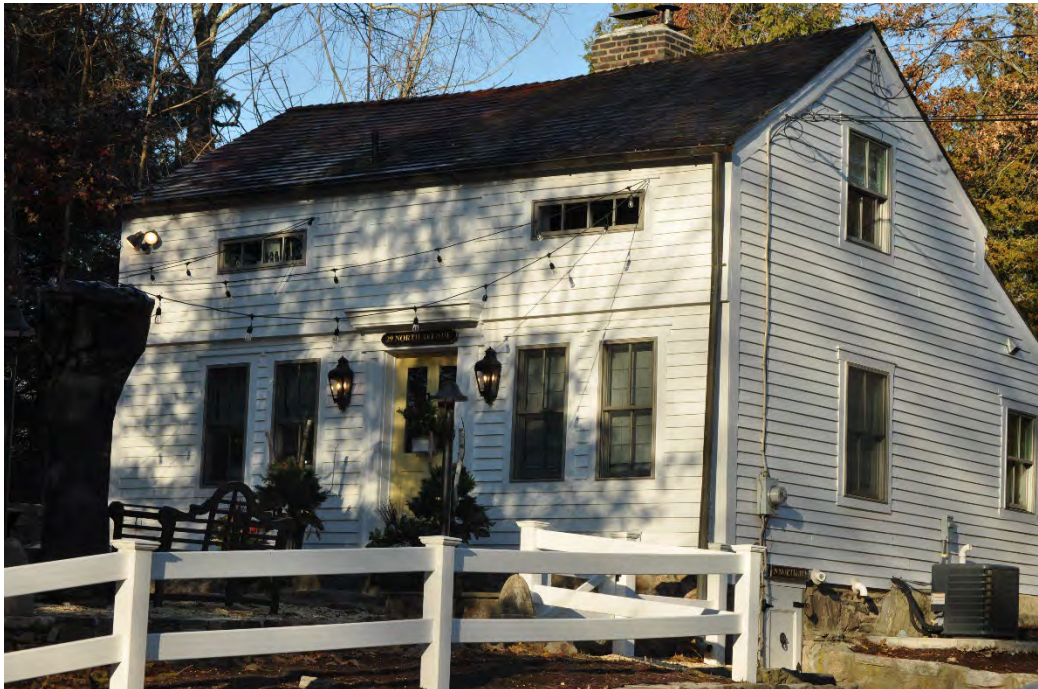
Photograph 1-2023: Post and Rail fence from North Avenue, tandem windows on top and two windows on each side of front door.

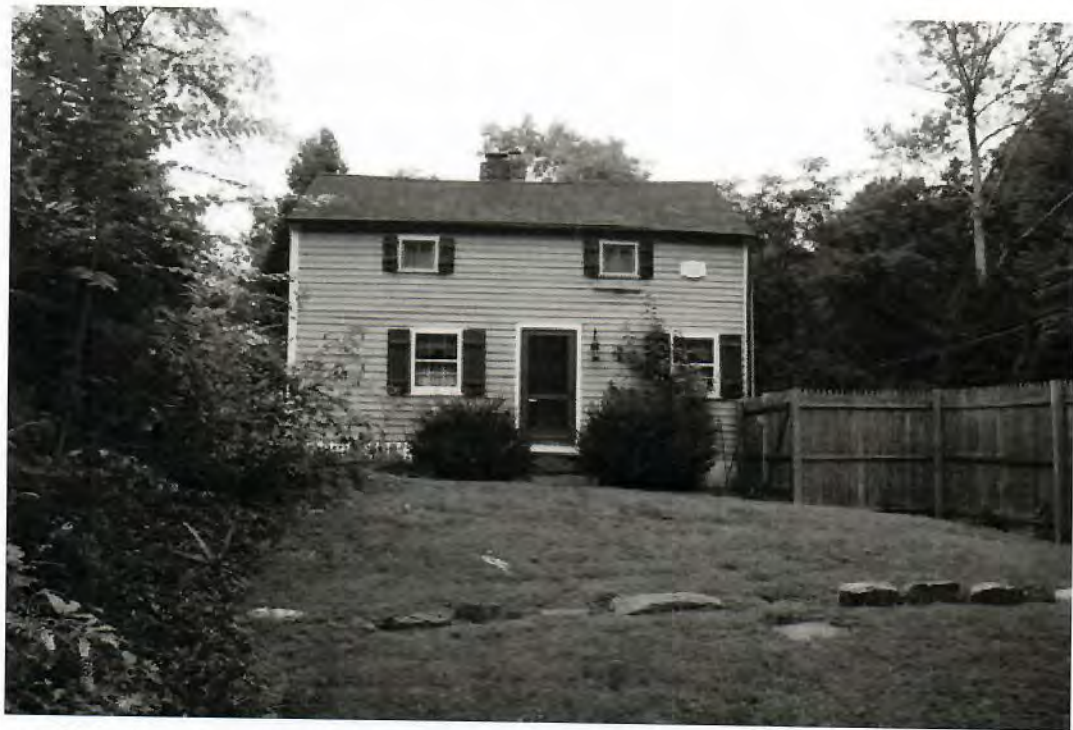
4. South view of Farmhouse, camera facing north.

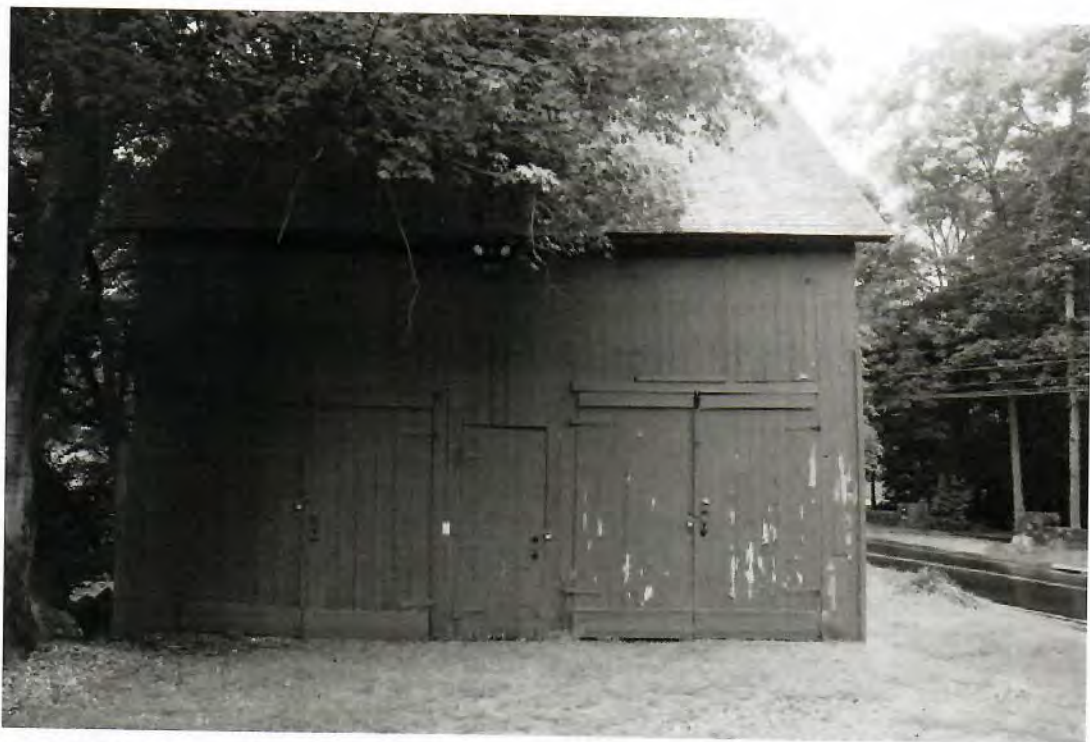
The south eave-side of the barn has three entries; two pairs of Z-braced hinged doors, each in front of a corresponding bay, and a centered pass-through door. Above the east pair of doors is a side-hinged hay door. The east gable-end of the barn has a four-pane window with trim in the main level towards the north corner, a dropped girt siding divide, and a four-pane window with trim just beneath the apex of the roof.

6. South view of Barn, camera facing north.

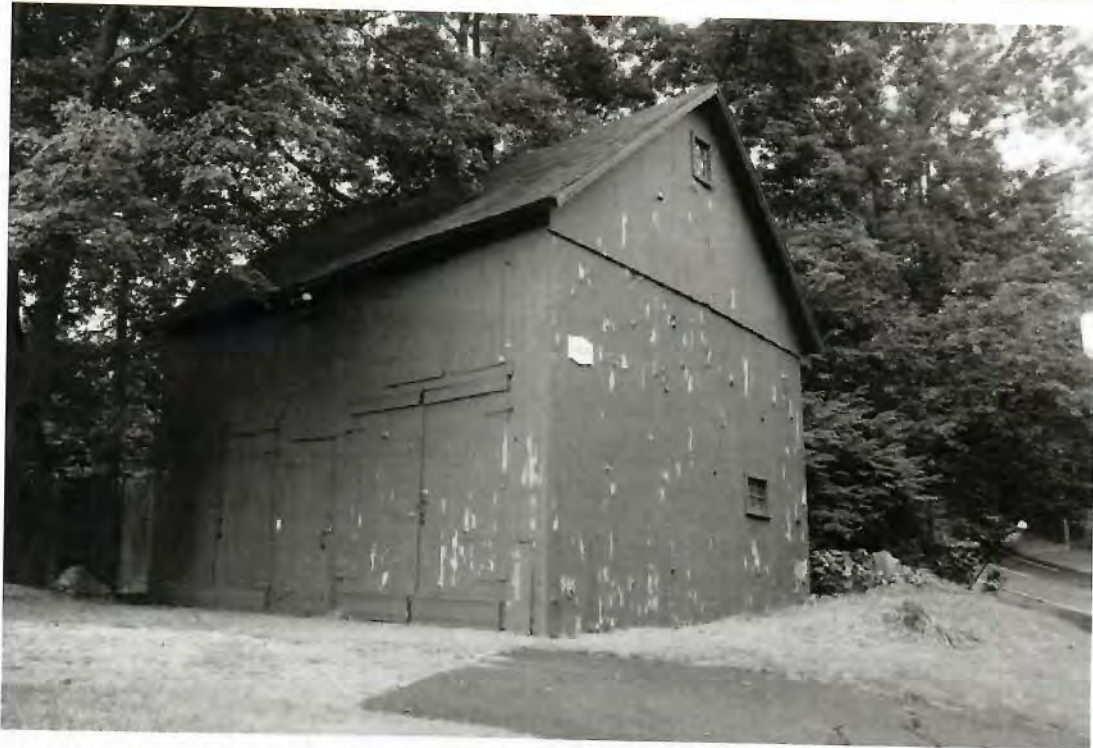
7. Southeast corner view of Barn, camera facing northwest.

This is a 1 ½-story two-bay English barn. The barn measure 24' wide by 20' deep. The main façade is the south eave-side of the barn. The barn is sheathed in vertical wood siding painted red. The frame sits on stone piers, at the northwest corner where the foundation is visible; the rest of the foundation is beneath grade.

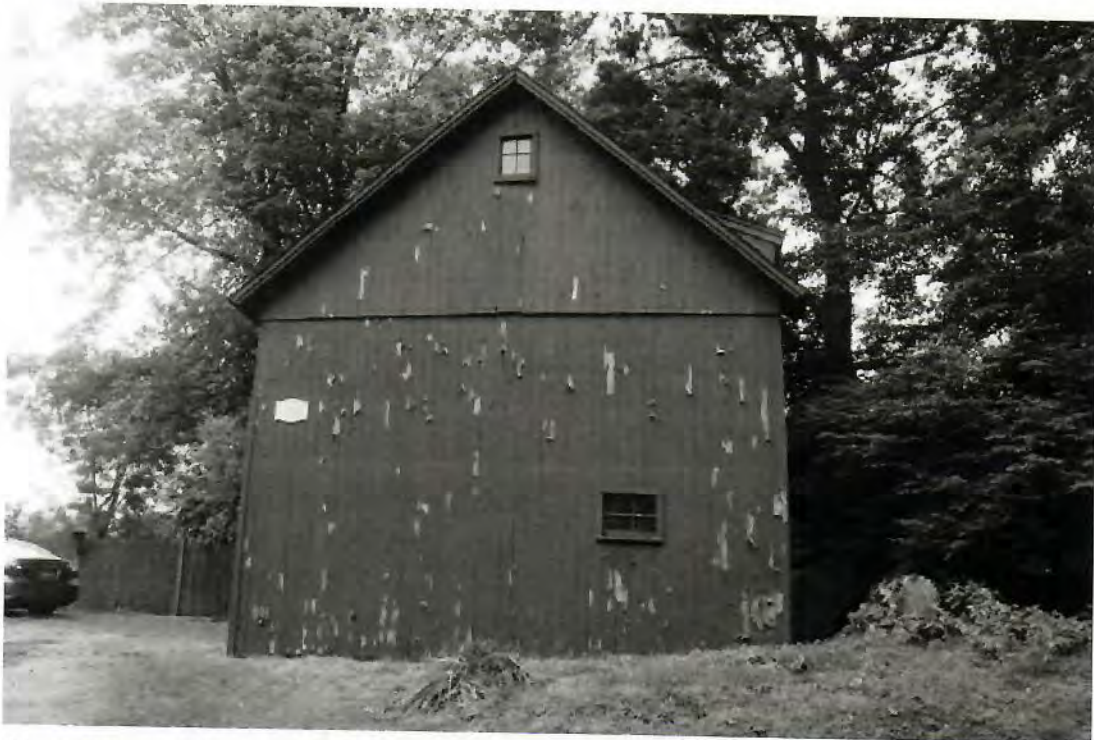
8. East gable-end view of Barn, camera facing west.

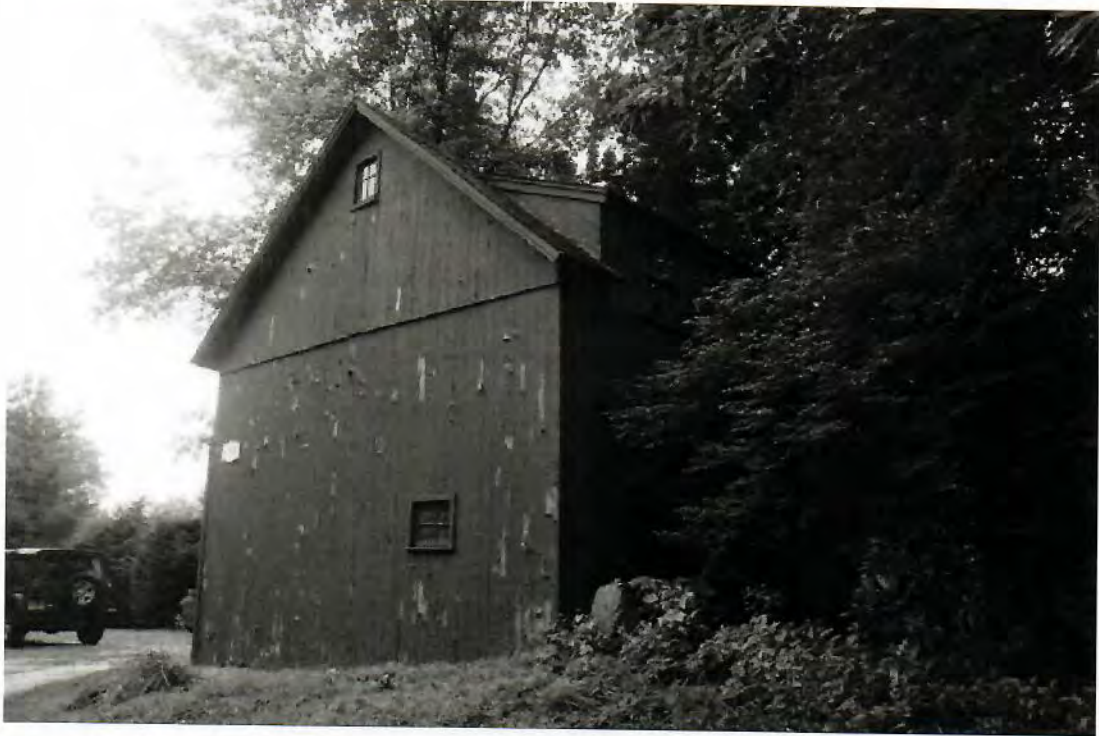
9. Northeast corner view of barn, camera facing southeast.

The north eave-side of the barn has a wide shed-roofed wall dormer that encompasses most of the north pitch of the roof. Within the wall dormer are two sets of two six-over-six double-hung windows. The rest of the side is blank except for a boarded over four-pane window with trim. The west gable-end of the barn has a stone pier for a foundation at the northwest corner and another beneath the barn. Loose brick are found in the crawl space beneath the barn. The west gable-end of the barn has a four-pane window with trim in the main level towards the south corner, a dropped girt siding divide, and a four-pane window with trim just beneath the apex of the roof.

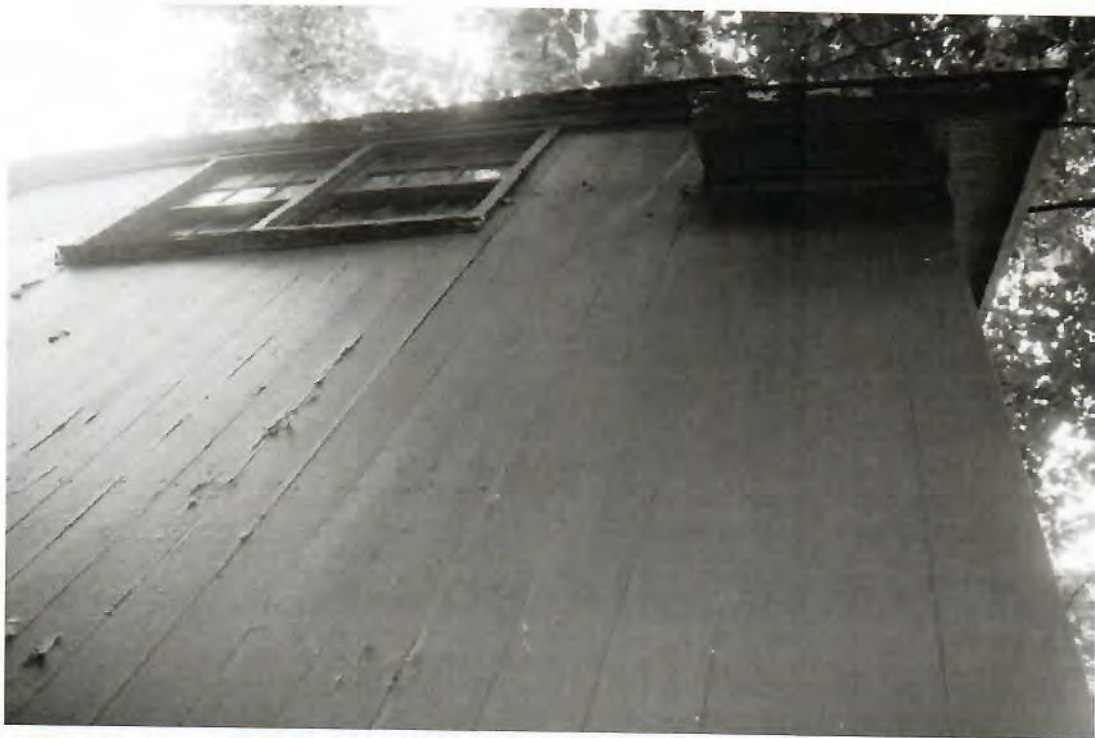
10. Detail of the exterior, north cave-side wall dormer, east corner, camera facing south.

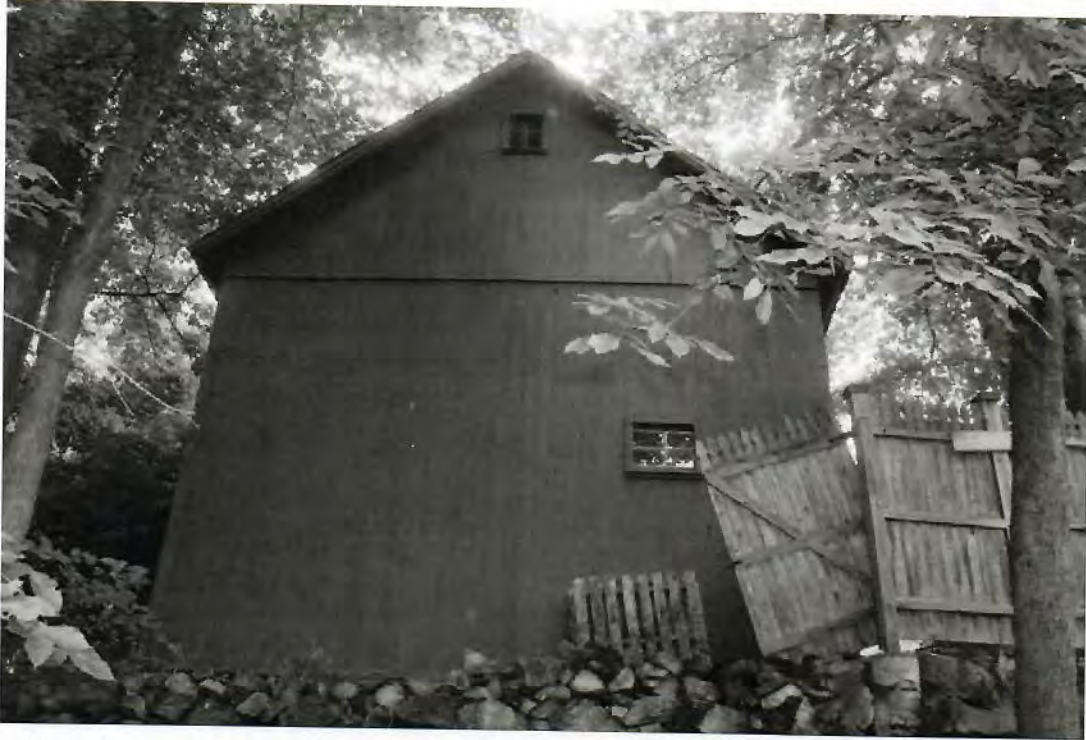
11. West gable-end view of the barn with stone wall on the west property line, camera facing east.

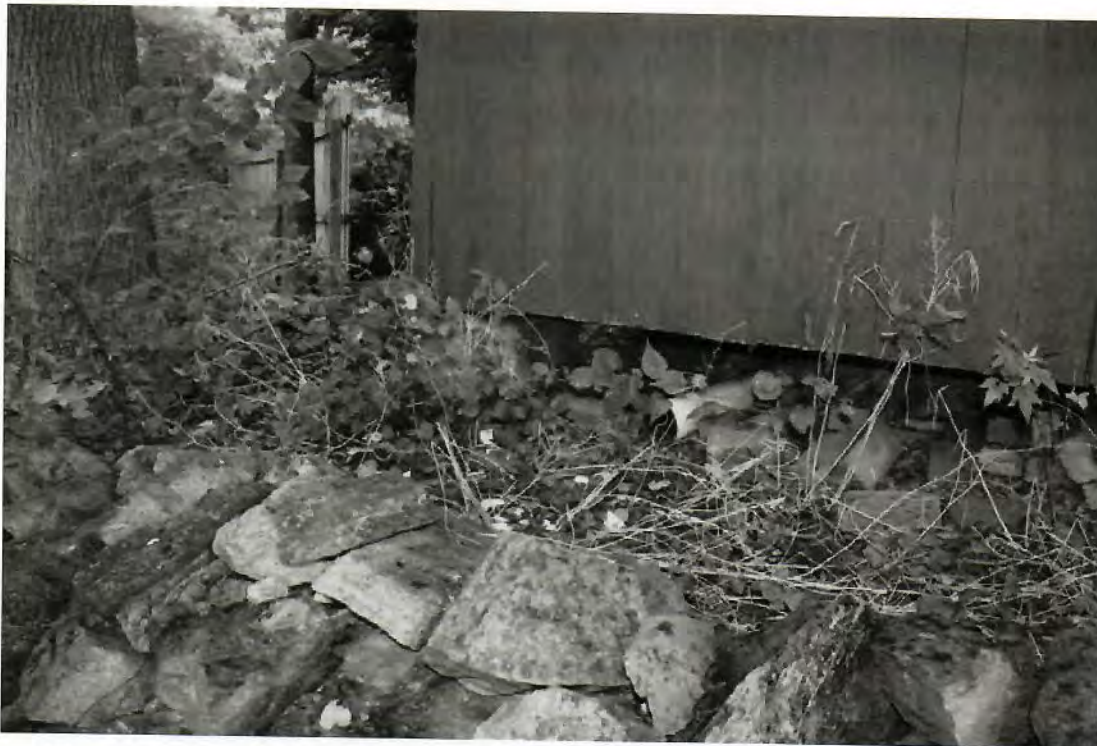
12. Detail of the exterior, northwest corner of the barn. Note the single stone pier at the corner.

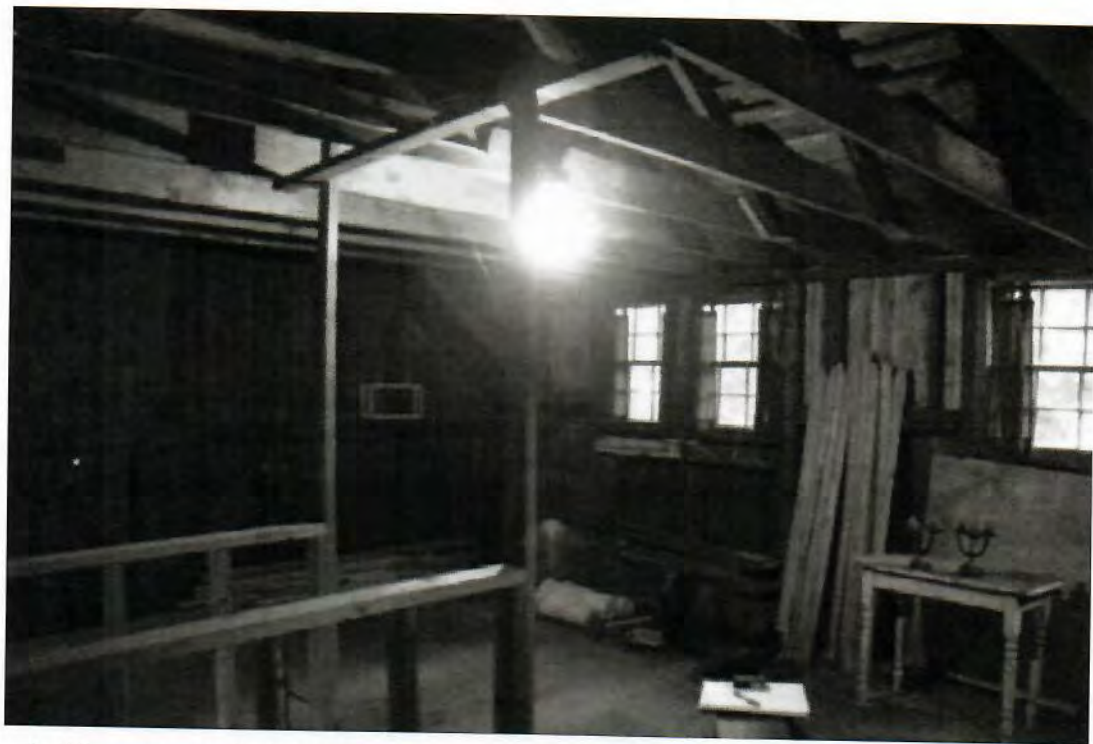
The attic level has a wide wall dormer added to the north pitch of the roof and north eave-side of the barn. It has two sets of two six-over-six double-hung windows. The north rafter plate was partially removed to accommodate the dormer. The attic level is constructed of square rule mortise and tenon timber framing, with 5" x 6" post and beams with circular saw marks with dropped girts at the gable-ends. The ceiling has common rafters and tongue-and-groove ceiling boards mixed with random-width boards under asphalt shingles.

14. Attic level of barn, camera facing northwest.

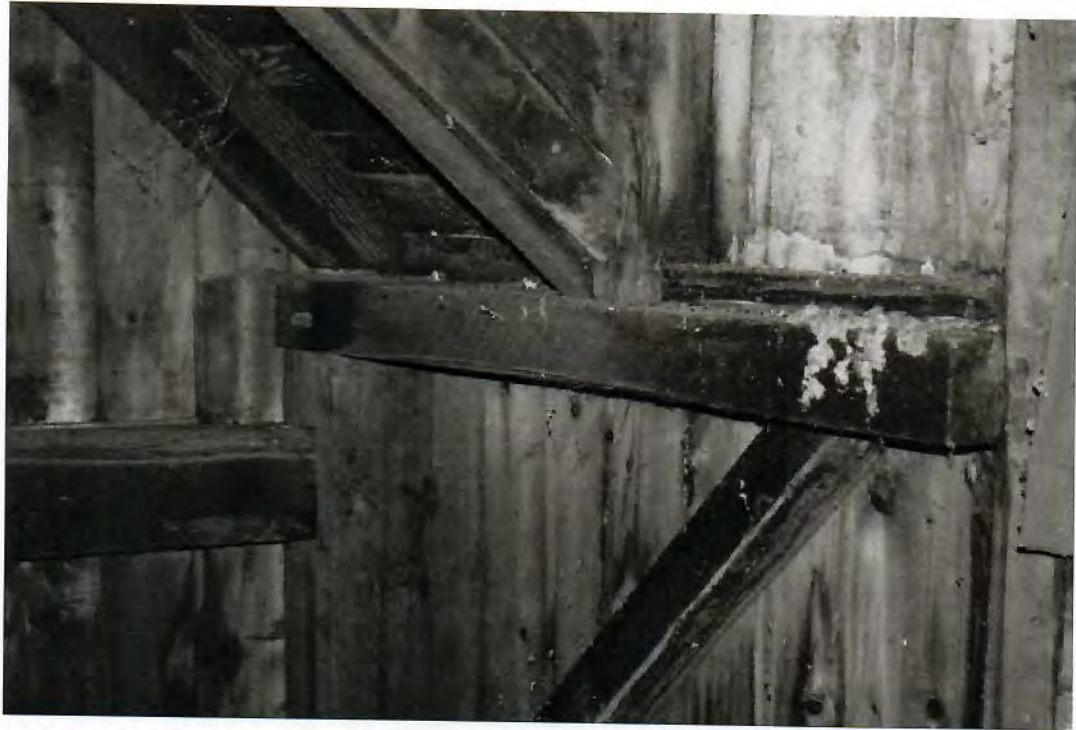
15. Detail of the interior, northwest corner, showing dropped tie-girt in end wall. Note how the rafter plate is truncated for the shed dormer.

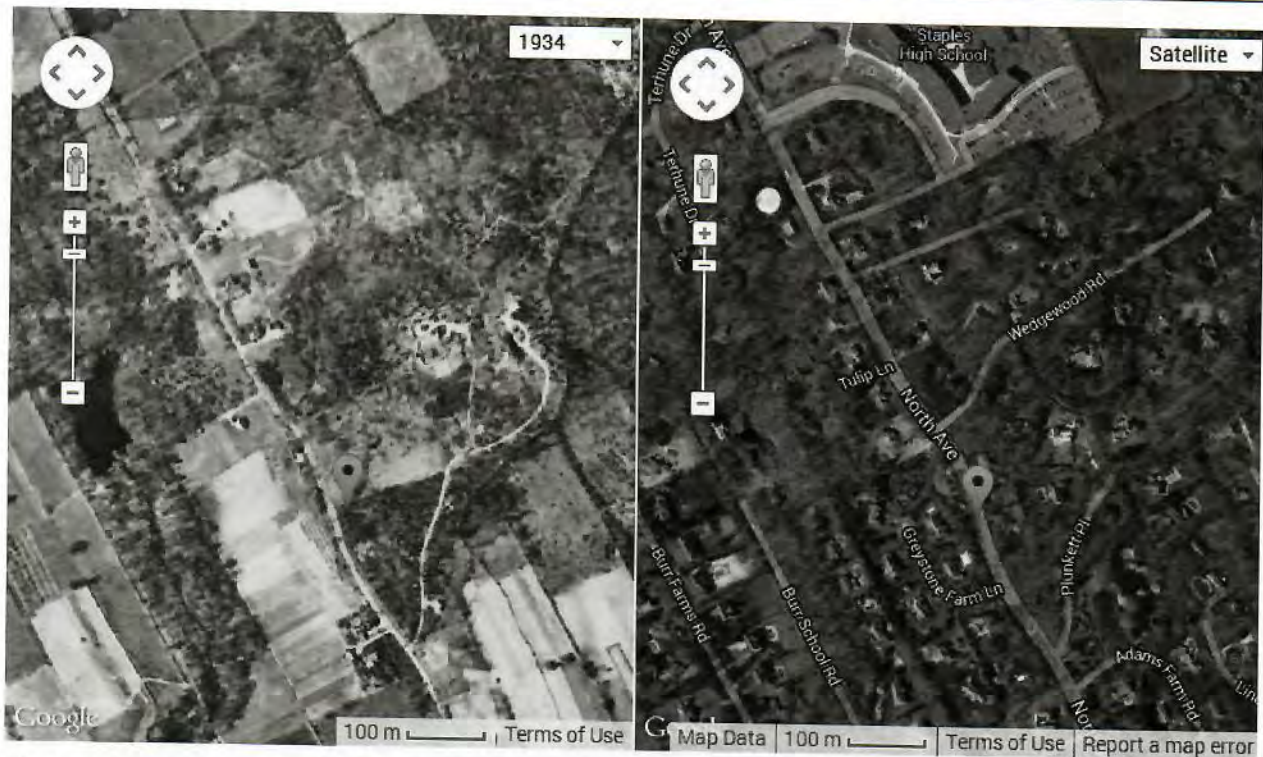
17. Fairchild 1934 aerial photograph of the site compared with modern Google Map view, showing the extent of farmland remaining in 1934 and the fully developed residential neighborhood of the present.

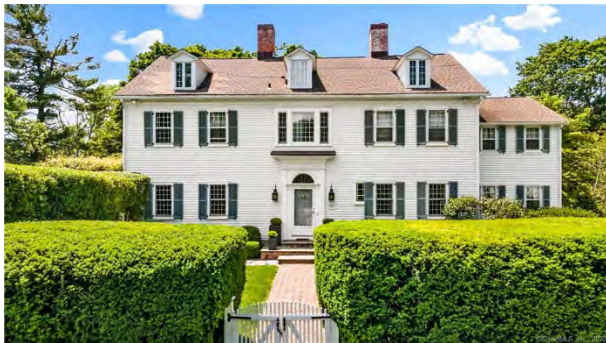
House prior to August 2021 sales date.

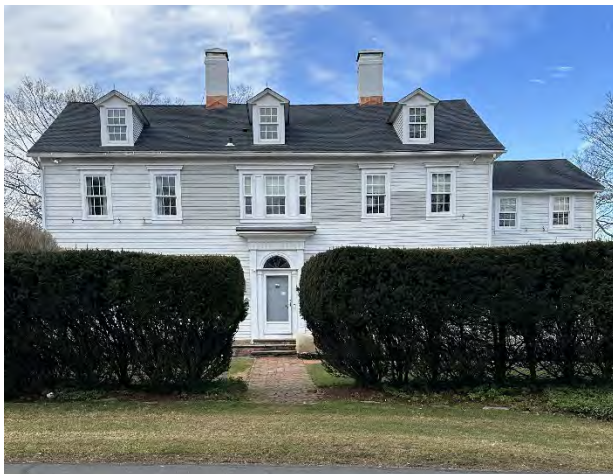
This 1873 house was purchased in August 2021 by Juliana and Jordan Bulgar and since then, until about December 2022, has been undergoing restoration of the exterior and enhancements to the interior. The exterior restoration and preservation included repairing clapboard siding, repair to windows including installing new second story middle window with a more age appropriate window and extending the rear second story patio to the left side of the building. The restoration removed a bay window on the second floor and installed 6 over 6 double pane windows with side slats.

Current image of house as of 1-2023.
