**HISTORIC RESOURCES INVENTORY
BUILDING AND STRUCTURES**

1 BUILDING NAME (Common)	(Historic)		
McCune House	McCune House		
2 TOWN CITY	VILLAGE	COUNTY	
Westport		Fairfield	
3 STREET AND NUMBER (and/or location)			
61 Clapboard Hill Road		5452-1/20-1	
4 OWNER(S)			
Pasternak, Bart M. <input type="checkbox"/> Public <input checked="" type="checkbox"/> Private			
5 USE (Present)		(Historic)	
Residence		Residence	
6 ACCESSIBILITY TO PUBLIC:	EXTERIOR VISIBLE FROM PUBLIC ROAD	INTERIOR ACCESSIBLE	IF YES, EXPLAIN
<input checked="" type="checkbox"/> Yes <input type="checkbox"/> No	<input type="checkbox"/> Yes <input checked="" type="checkbox"/> No

1. BUILDING NAME (Common) **Daniel Burr House** (Historic) **Daniel Burr House**

3. STREET AND NUMBER (and/or location) **60 Long Lots Rd.** **5445/123-C-3**

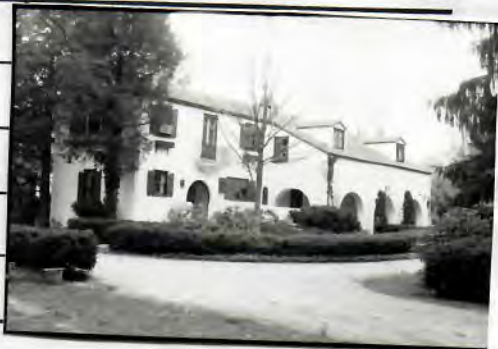
The well proportioned, textured stucco, Mediterranean Revival dwelling is oriented to the garden on the north side of the house rather than the road. Casually arranged to suggest the vernacular building tradition in Spain and Italy, the house has a tile roof and projecting arched porch. Six-over-six windows with shutters are aymmetrically placed. The shallow balconnette with an iron grill is set over the arched opening for the secondary entrance on the north elevation. The house is very well preserved.

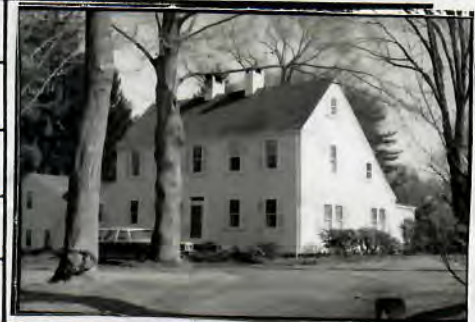
Originally a 5-bay, central chimney, Colonial, the house was moved to its present location between 1848 and 1851. It is not known if the central chimney was replaced then, or whether the two interior stacks are 20th century. It has been reworked in the Colonial Revival mode with 6-over-6 windows and a leaded transom over the central entrance. The house has been extended to the rear by a lean-to addition and a 20th century addition to the east. The cornice return on the gable end many date to the move as it is definitely not a 1770s detail.

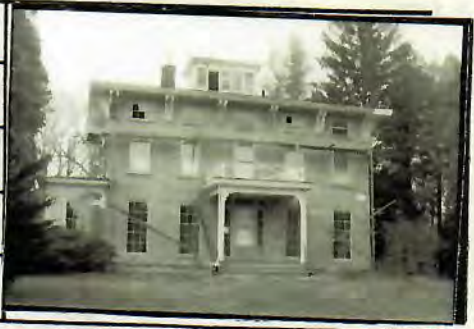
The impressive, 5-bay, 2 1/2-story, shallow, hip-roofed, Italianate house appears more severe today than it did originally because the the full-facade verandah has been reduced in length. It was serviced by the full-length, 6-over-6 windows on the first level. Arranged on the side-hall plan with interior chimneys, the interior is well preserved with Italianate marble mantels and heavily moulded, 4-panel doors. Exterior detailing includes the hallmarks of the Italianate taste with bold, coupled brackets under the overhanging eaves and 6-light frieze windows. A large, 5-sash wide belvedere crowns the roof, and the central, single-leaf entrance door is surrounded by a transom and nearly full-length sidelights. Unfortunately the exterior was sandblasted in 1988. The present entrance porch is a 20th century replacement and is simply detailed.

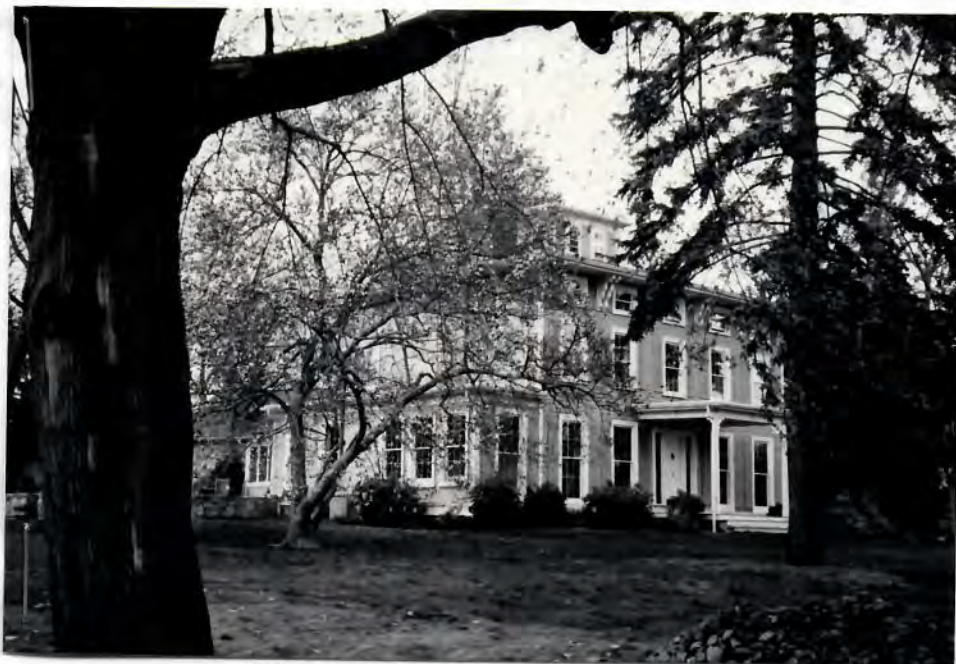
Neg No.: 4:7

13. INTEGRITY (Location)		WHEN ?	(Alterations)
<input checked="" type="checkbox"/> On original site	<input type="checkbox"/> Moved		<input checked="" type="checkbox"/> Yes <input type="checkbox"/> No
			verandah replaced, sandblasted

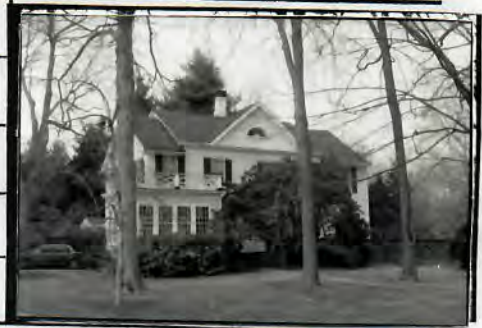
Although built in 1830, the house has been enlarged and extensively reworked in the Colonial Revival style since 1935. Originally it was a typical three-bay, sidehall-plan, Federal dwelling with a handsome Grecian frontispiece with geometric sidelights and transom and rosettes in the corner blocks. It ranks as one of the most handsome in town. In the 1930s the house was extended on both sides and the cross gable with a lunette window and Doric cornice were added. A flat-roofed solarium with a Chinese trellis balustrade was also added at the southeast corner. While not period, the additions are quite handsome and are representative of the fine revival craftsmanship that transformed many of Westport's early houses into gracious country estates.

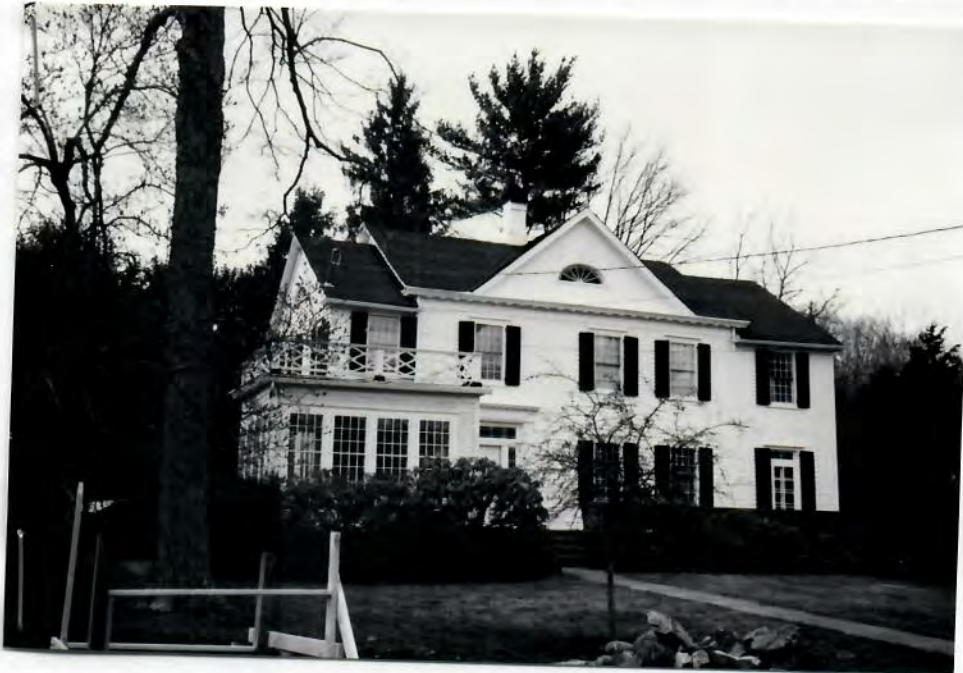
Neg No.: 4:5

The Rev. Thomas F. Davis, minister of the Greens Farms church from 1829-1839, built the house in 1830 on land he purchased from John Hyde. Davis was one of the founders and owners of the academy that was purchased by Ebenezer Adams in 1838(?) and became known as Adams Academy. Davis sold the "homestead with buildings" in 1839 to James B. Peffers (FLR 42:321,45:672). It remained in the Peffers family until 1935, passing to James H. and Charles Peffers in 1876, and they quit claimed it to Henry and Alice Peffers (13:117,14:367). Alice and Henry sold to Marvin E. Everly in 1935, and it then passed to his daughter, Holly E. Bisset, in 1948 (64:317). She sold to William and Diane Olney in 1957. It is assumed that the Everlys enlarged and reworked the house in the Colonial Revival mode after acquiring the property in 1935.

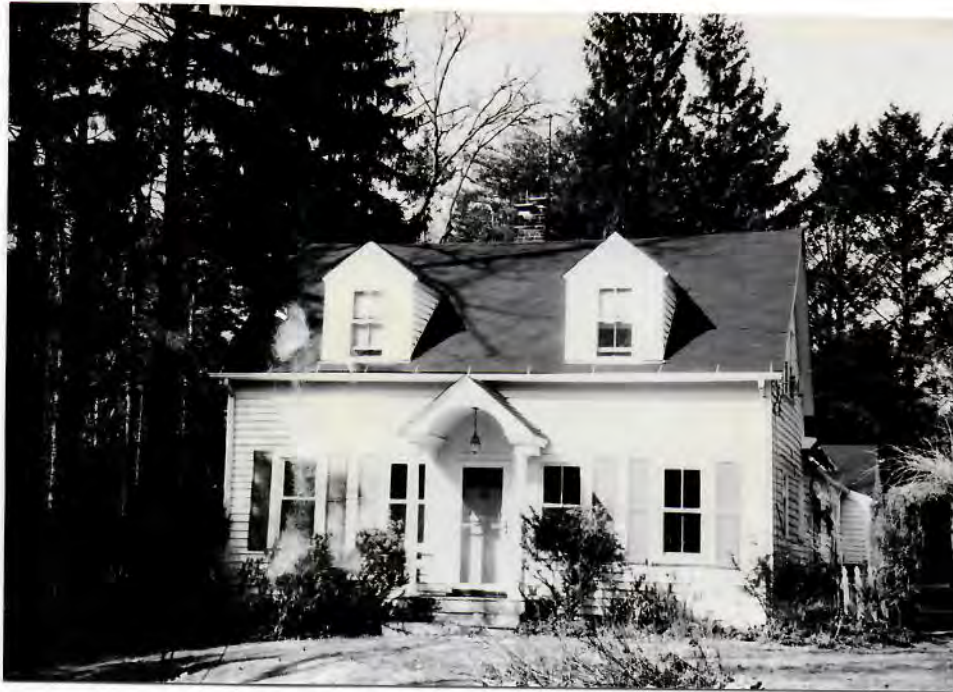
100 Hillspoint Road, Westport, CT

The property at 100 Hillspoint Road is a one-and-one-half-story, Colonial Revival style building. The rectangular plan building has a gable roof main block. The symmetrical, five-bay façade has a center entrance set beneath a projecting, pedimented portico supported by classical columns. The building is clad in replacement vinyl siding. Fenestration consists two-over-two double-hung sash windows. One central brick chimney and gable dormers interrupt the asphalt-sheathed roof. Alterations consist of replacement siding.

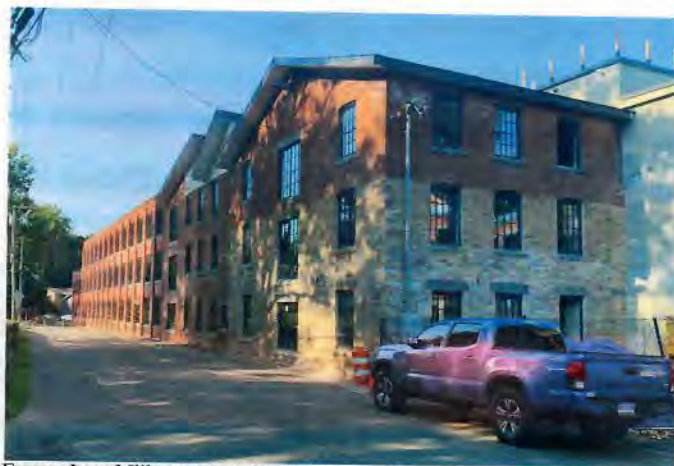
Former Lees Mill, east elevation looking south

The main mill building consists of multiple blocks of different dates and materials, with an interchanging roofline, stretching primarily south to north. The complex is a roughly U-shaped building open at the center, and enclosed west and east by wings paralleling Richmondville Avenue and by perpendicular blocks at its north and south; a new block (concrete block) is currently under construction at the north, Mill Bank Road end. The plant was founded in 1814 to manufacture twine and related products, and the complex has been rebuilt periodically throughout the course of its life. The Richmond Avenue (east) elevation is primarily three stories high and consists of three blocks. The northernmost block is a peak-roofed building (overhanging eaves), set with its gables to the east and west, with a random ashlar base (first two stories) and a brick third story. Among its distinctive features are its segmental-arched windows trimmed with double rows of brick headers and finished with faceted stone sills; first-floor windows have massive stone lintels. (Continued on page 3.)

Large, squared openings on the east side, former loading bays, are now fitted with multi-pane window sash (all window sash are replacements). To the south of this block is a squarely proportioned three-story block fabrication of brick with a distinctive saw-tooth roof; this section is distinguished by segmentally arched windows and trimmed with double rows of headers. Running south is the third block, an elongated flat-roofed building section also fabricated of brick, of thirteen bays, framed by 14 corbeled brick piers, each framing individual window bays (multi-pane casements throughout are new replacements). The south end of the building consists of a three-story flat roof block of similar design, set perpendicular. Five window bays are delineated by six brick piers, and a cantilevered entry canopy is located at the southwest corner. A 1½-story brick-and-concrete wing with a flat roof and shed dormer is currently under construction at the northwest corner. Located to the west, near the banks of the river, a one-story peak-roofed garage, wood framed (five vehicle bays) with a monitor roof is under construction; a second building of similar design is being built to the south, where it is set perpendicular.

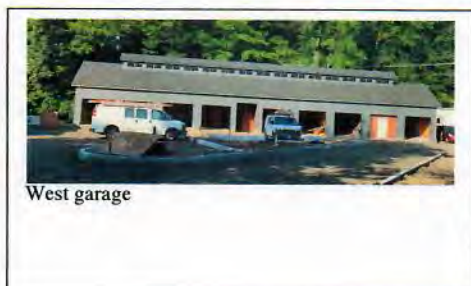
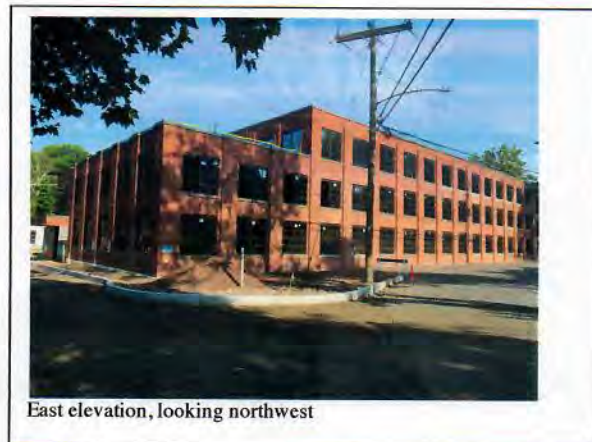
Sanborn Maps reveal that a three-story storage block, used for spinning yards, was in place in this part of the complex by 1891; at that time, lower wings extended south. As of 1923, the west wing was gone and the east wing had been enlarged to three stories, and the square section with its saw-tooth roof was in place.

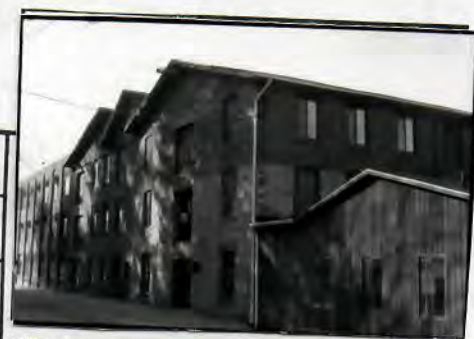
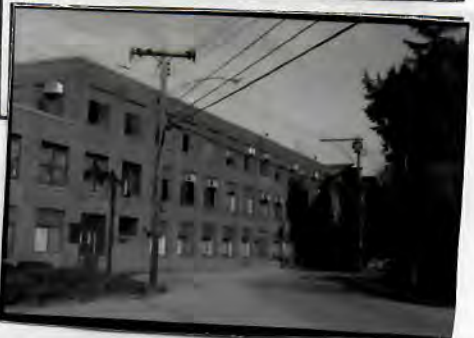
The mill complex was developed gradually since ca. 1880 with the major building occurring between 1910 and 1922. The oldest building is located at the northern end. Originally a 2-story, rubble-coursed, fieldstone structure with a gable roof, it was raised to 3 stories with a brick addition. The buildings to the south replace earlier frame structures and a water tower with the one immediately south of the original being laid up in fieldstone and topped by a sawtooth roof to maximize natural illumination. A 3-story, flat-roofed, pilastered brick wing to the south appears to be the last addition to the mill. All original/early windows were replaced with inappropriate sliding sash when the complex was converted to space in the 1970s. The interior has been subdivided into smaller spaces. No machinery survives.

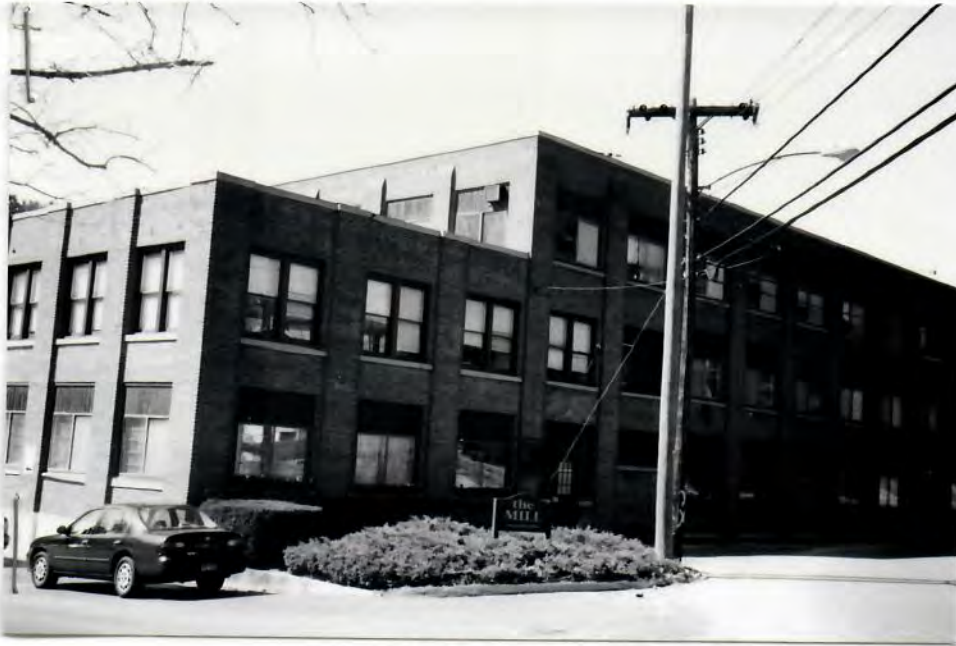
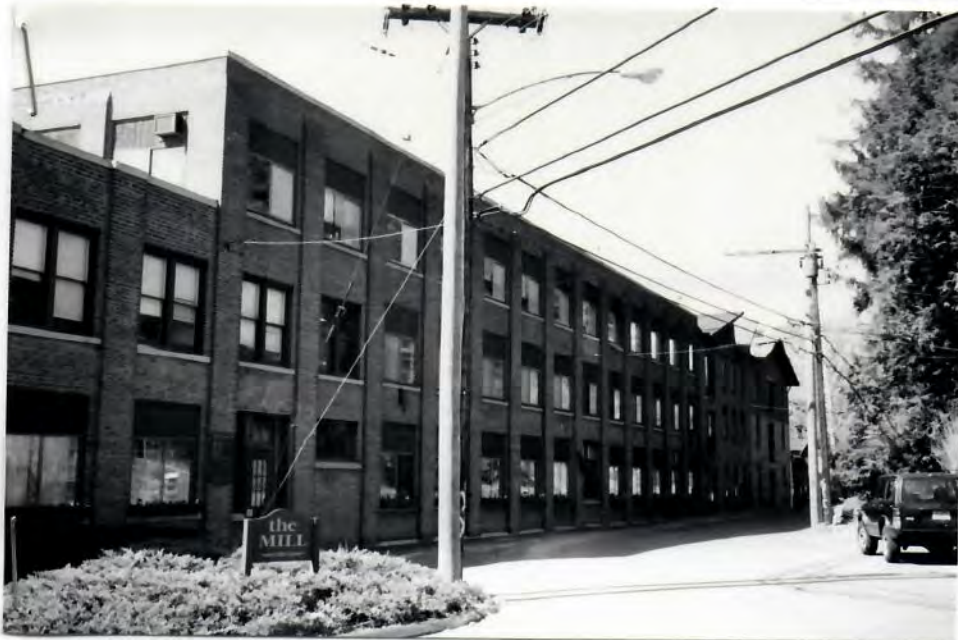
Neg No.: 7:36, 37

13. INTEGRITY (Location) On original site Moved WHEN? _____ (Alterations) Yes No IF YES, EXPLAIN windows replaced, interior divided
