# COMPO BEACH BUILDINGS WESTPORT, CT

A REPORT PREPARED BY:  
First Selectman's Maintenance Study Committee  
Town of Westport, Westport CT 06880

FIRST SELECTMAN'S MAINTENANCE STUDY COMMITTEE  
REPORT FOR COMPO BEACH BUILDINGS  
REPORT PREPARED ON April 10, 2023

INSPECTION OF THE COMPO BEACH BUILDINGS ON MARCH 21, 2024

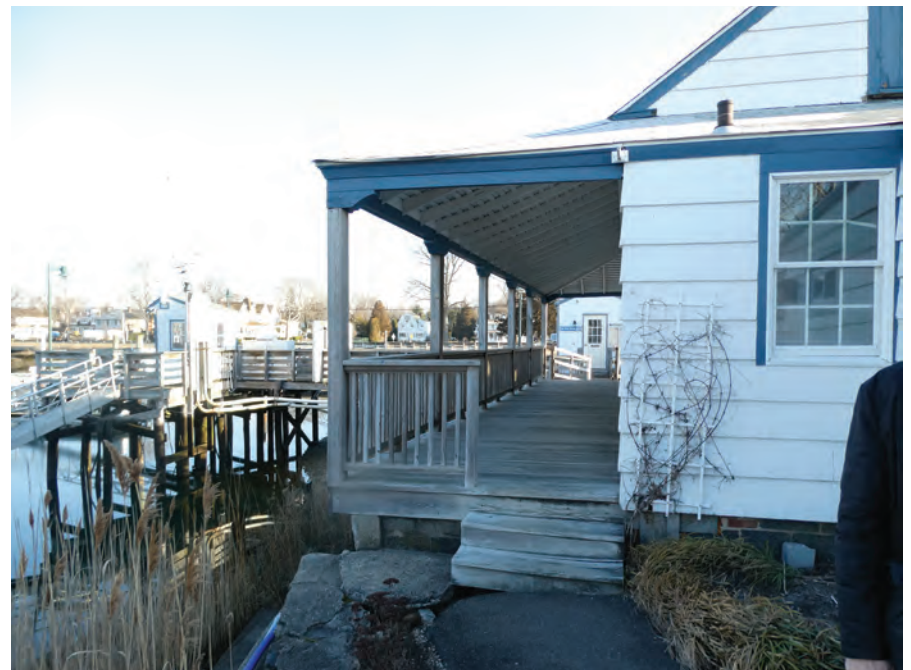
STEPS PORCH TO GRADE REBUILD WITH HANDRAIL.

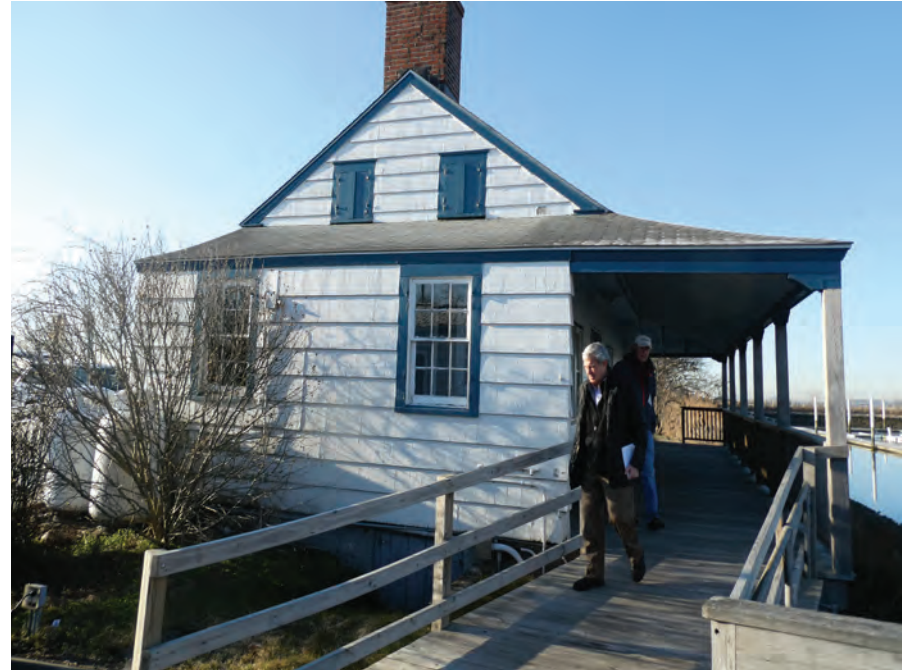
OVERALL NORTH ELEVATION SATISFACTORY.

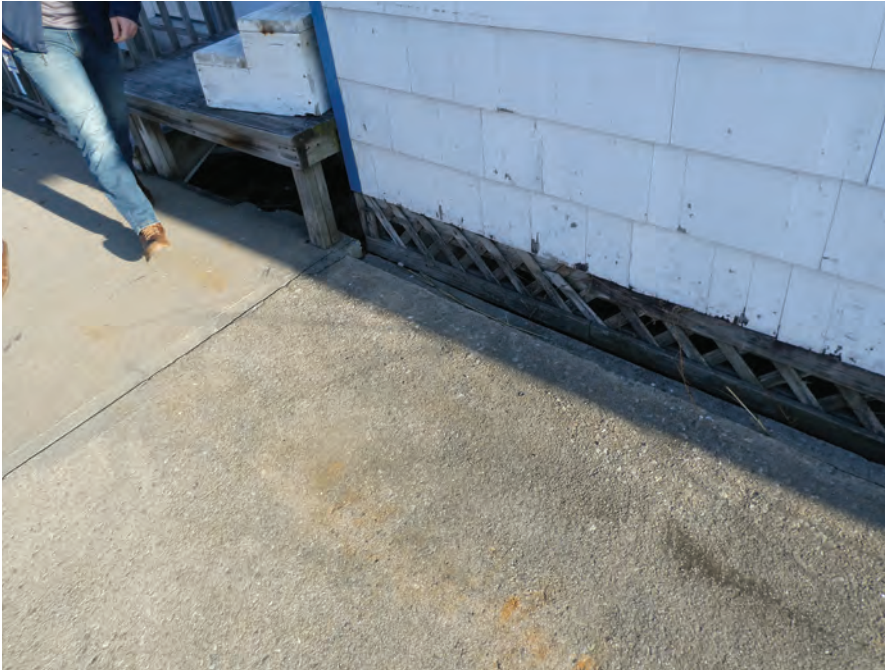
REPAIR SIDING AND PAINT.

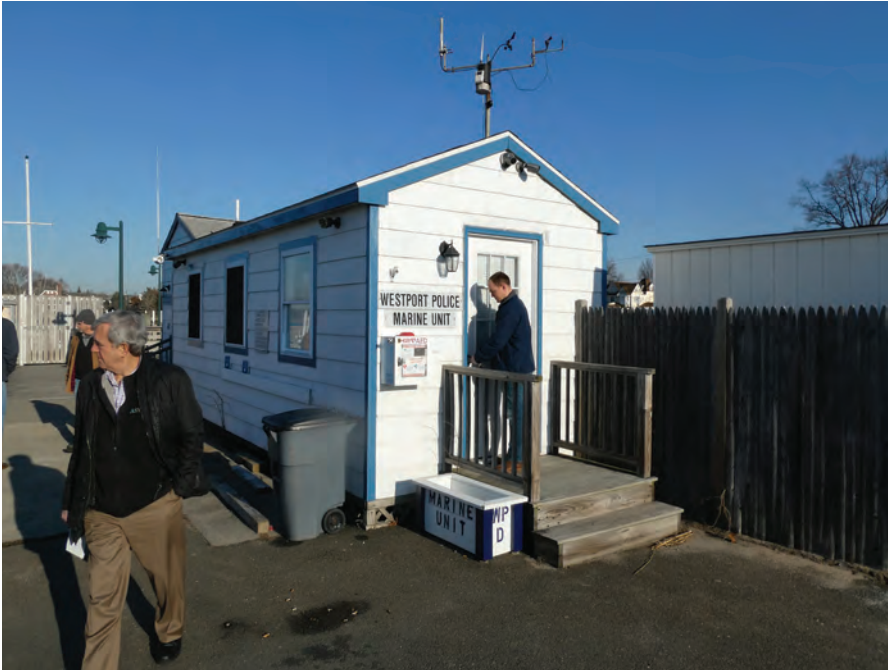
OVERALL BUILDING - EXTERIOR PAINT REQUIRED.

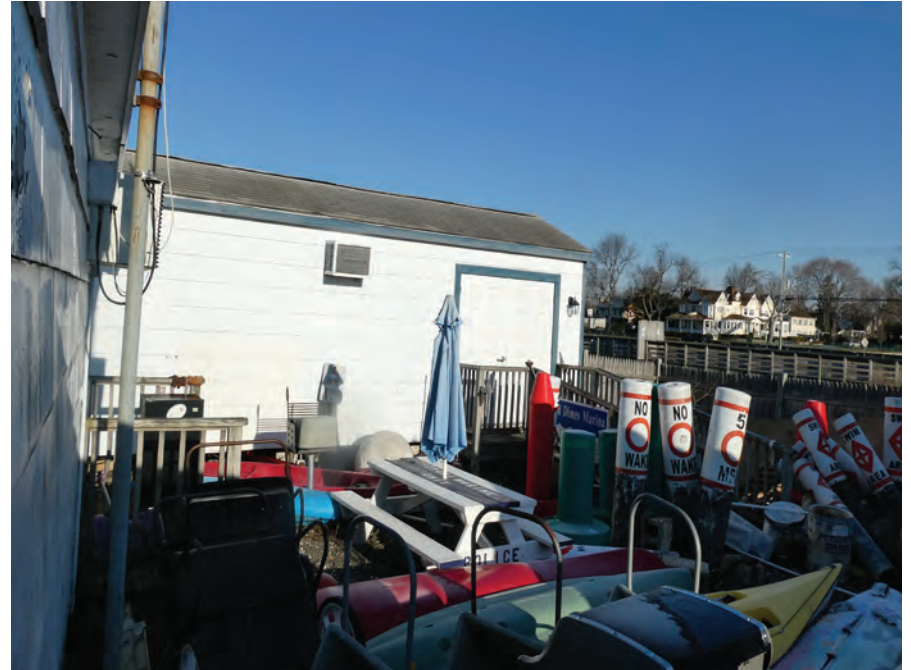
COURTYARD STORAGE AREA - ROOF REQUIRED.

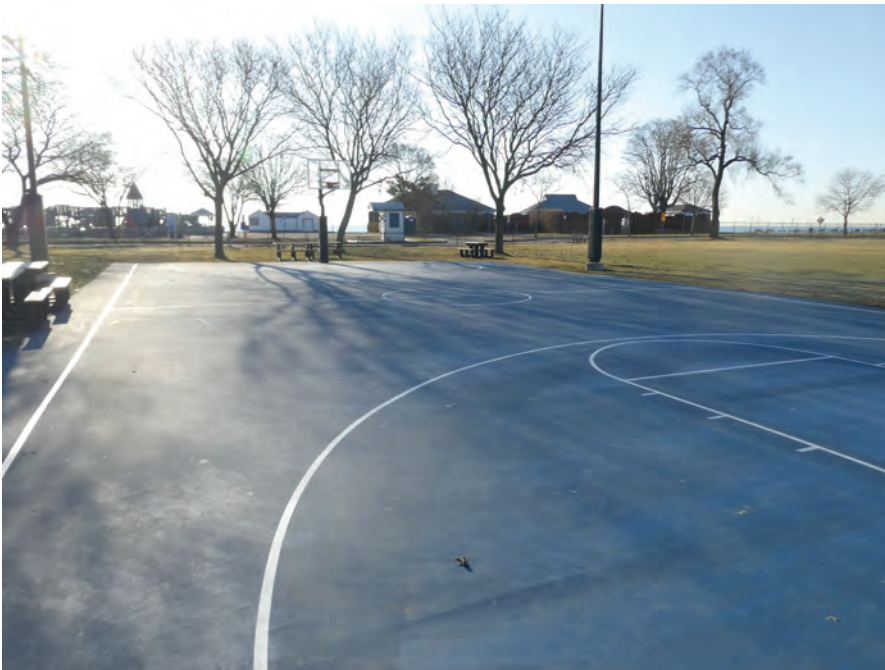
SELECT AREA DETERIORATION

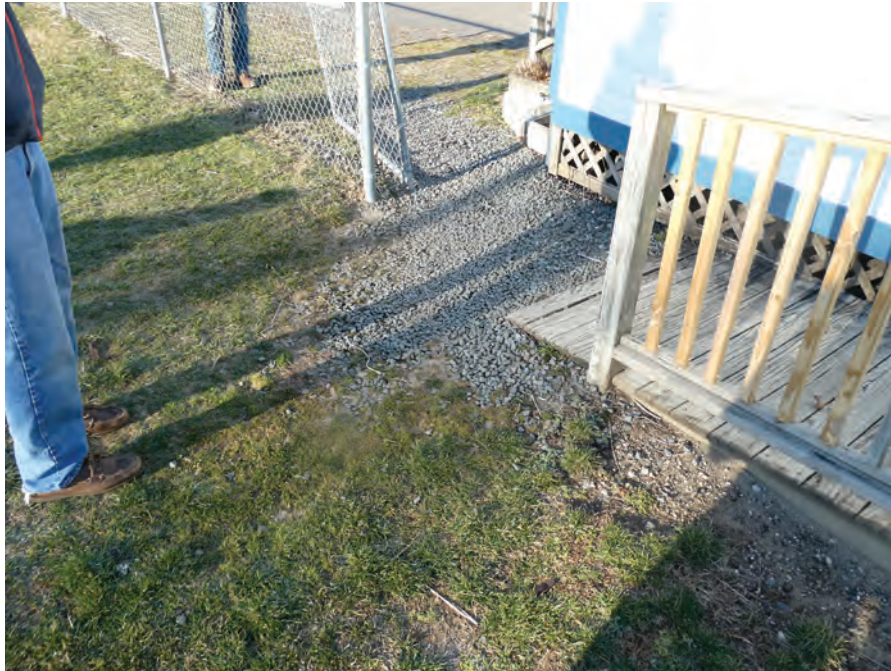
GRAVEL AREA SHOULD BE PAVED.

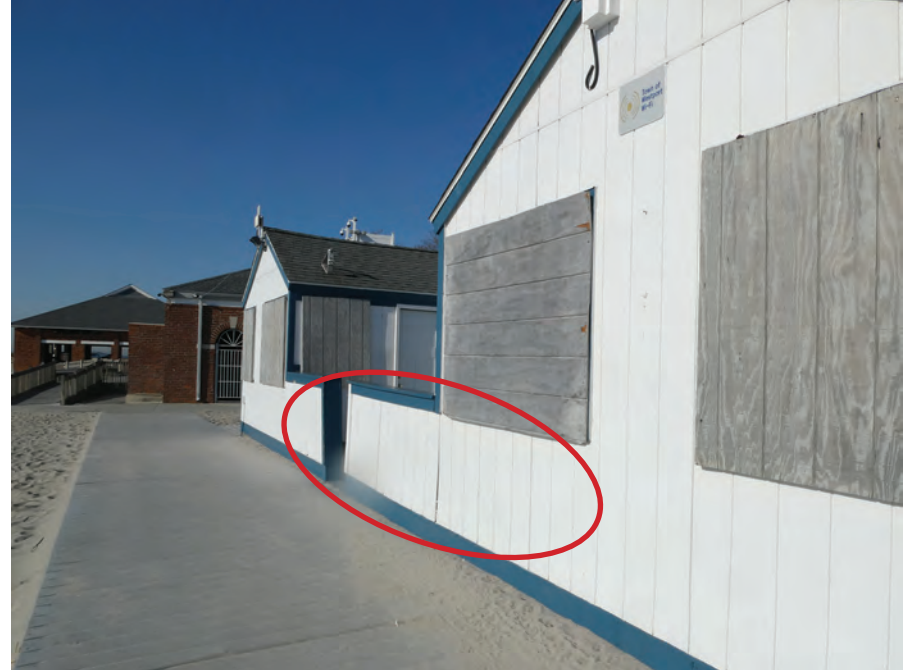
The lifeguard building was mostly repaired and had all exterior siding replaced approximately twenty-four (24) years ago. This structure is exposed to a lot of weathering and salt, and the elements are harsh to the paint surfaces. Asphalt shingles do not require replacement, they appear to have been replaced recently. Currently the siding is in fair shape, the shuttered doors are closed for the winter, and all appears satisfactory. The front parapet wall looks to need some trim replacement and painting before the summer of 2023, to be well presentable.

AREA REQUIRED SOME SIDING REPLACEMENT

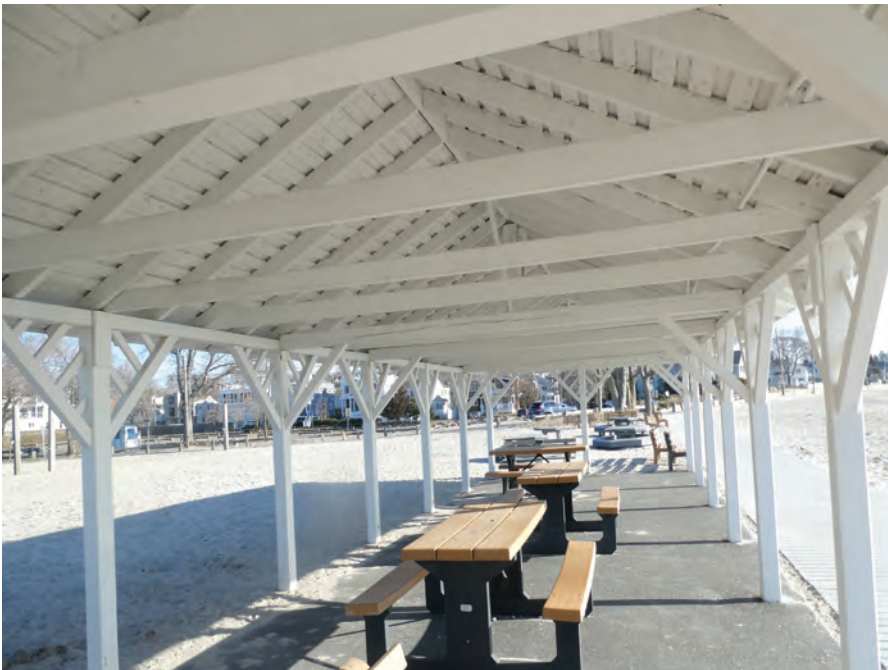
FIX SOME BEAMS

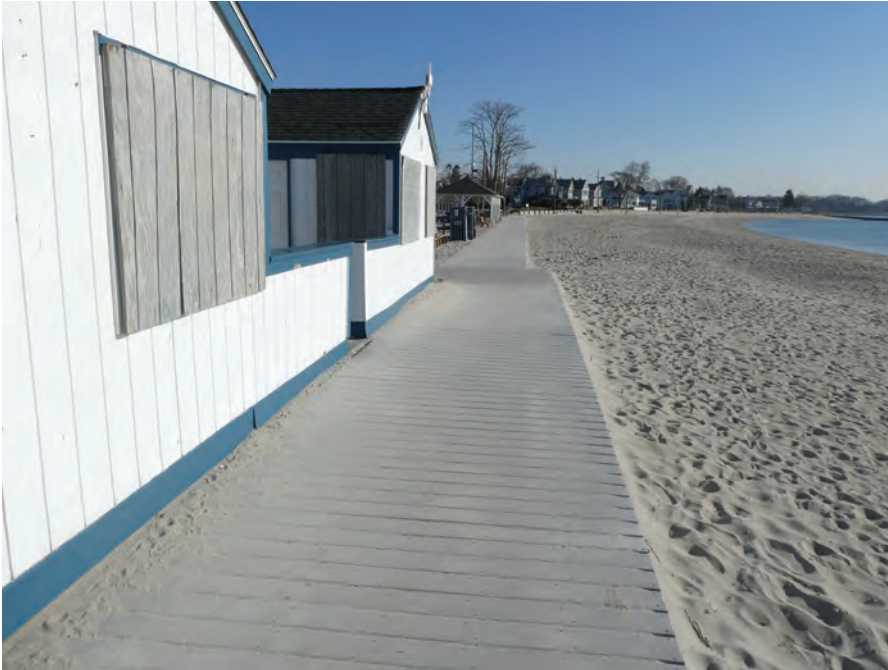
It was noted and observed that the main northern boardwalk surface is getting very old, (different from in front of the concession area). It has lost much of its surface grip and can be slippery when wet. Further the board have derogated with sun and wind and the SS screws are sticking up, this is a potential hazard too bare foot walkers, and others. Some screws also appear sharp. Screws are set into sleepers of the same vintage as the boards. The boardwalk has been reset and repaired many times over the years, after various bad storms. It is time to consider a full replacement of this boardwalk area, with a material and color to be selected, that also perhaps does not get so hot in the summer sun. The area in front of the concession (see pictures) also has some board ends with cupping and can be tripping hazards, as observed, and noted in photos.

OLD BOARDWALK - REPLACE

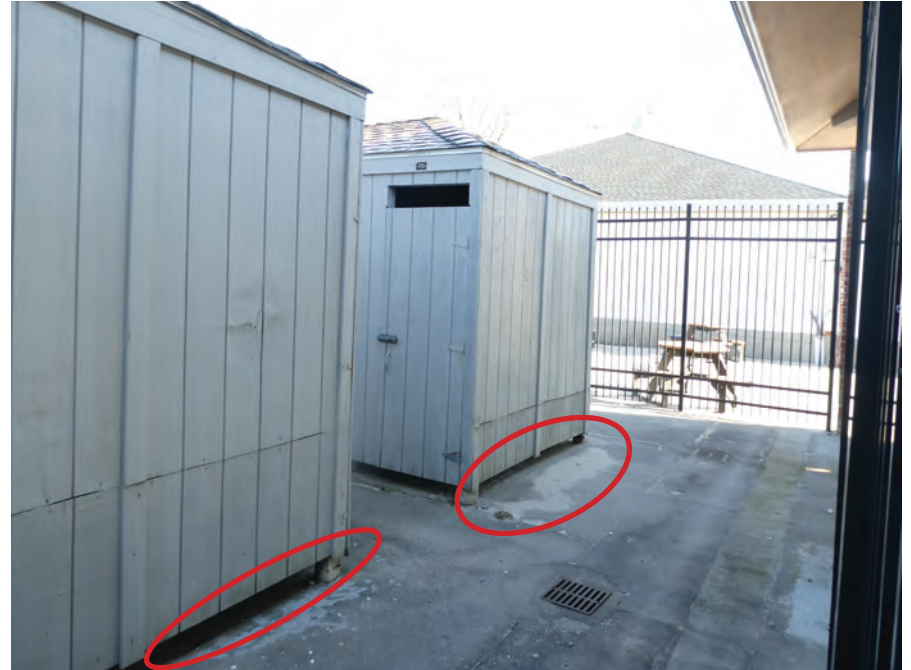
OLD CABANAS FROM WOOD REQUIRED REPLACEMENT - ROTTING IN AREAS

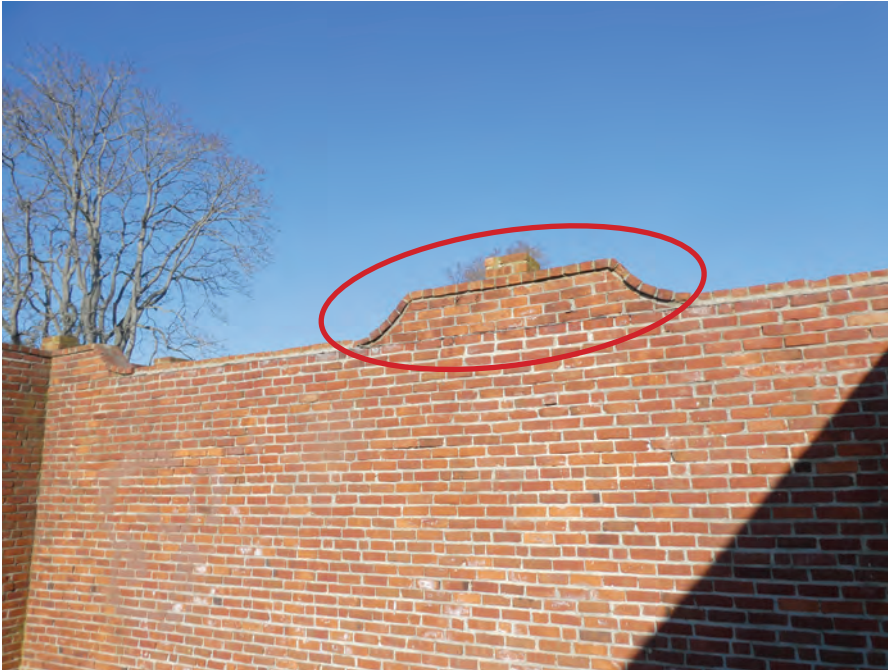
WALLS REQUIRED SOME REPOINTING.

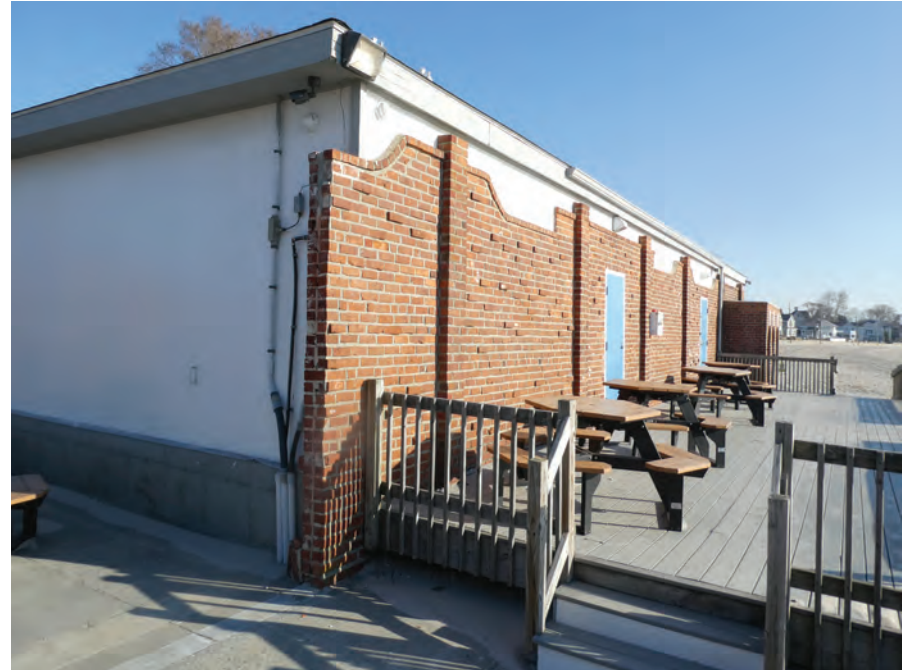
NEWER DECK AREA - SOME TRIPPING HAZARDS.

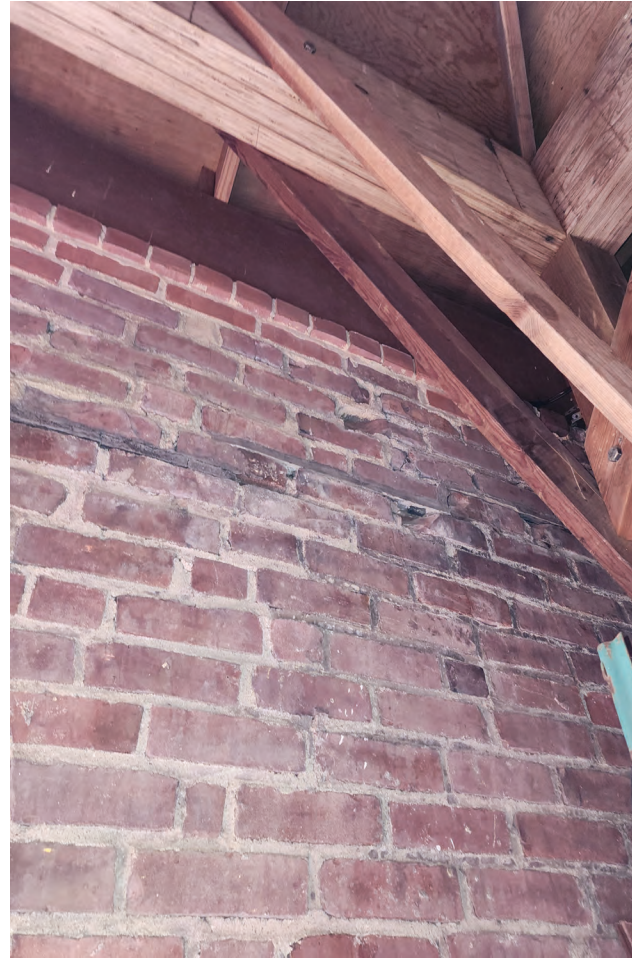
HORIZONTAL CRACK IN WALL.

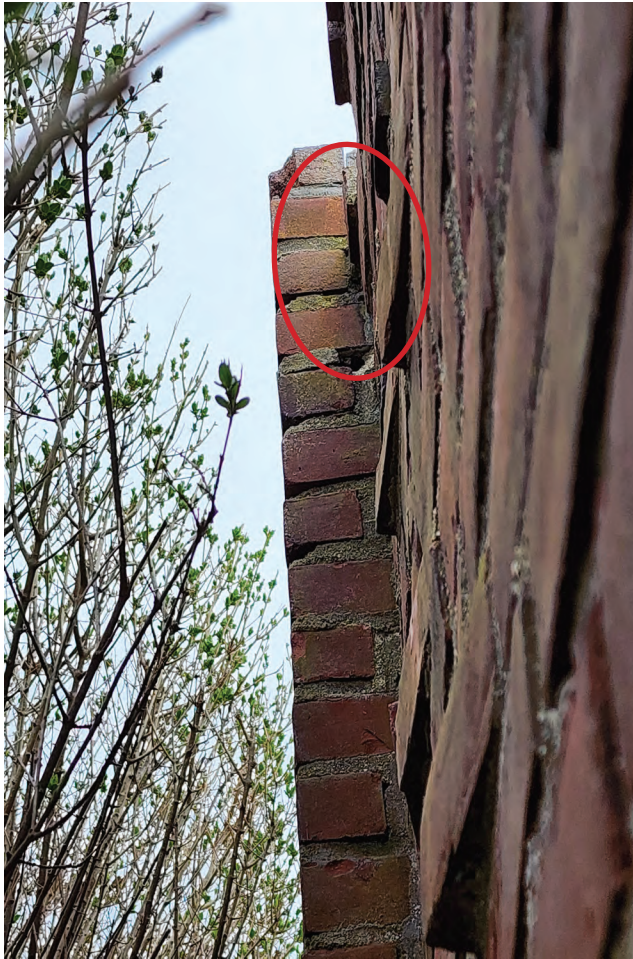
REPOINTING REQUIRED ON WALL.
