# COMPO BEACH BUILDINGS WESTPORT, CT

A REPORT PREPARED BY:  
First Selectman's Maintenance Study Committee  
Town of Westport, Westport CT 06880

FIRST SELECTMAN'S MAINTENANCE STUDY COMMITTEE  
REPORT FOR COMPO BEACH BUILDINGS  
REPORT PREPARED ON April 10, 2023

INSPECTION OF THE COMPO BEACH BUILDINGS ON MARCH 21, 2024

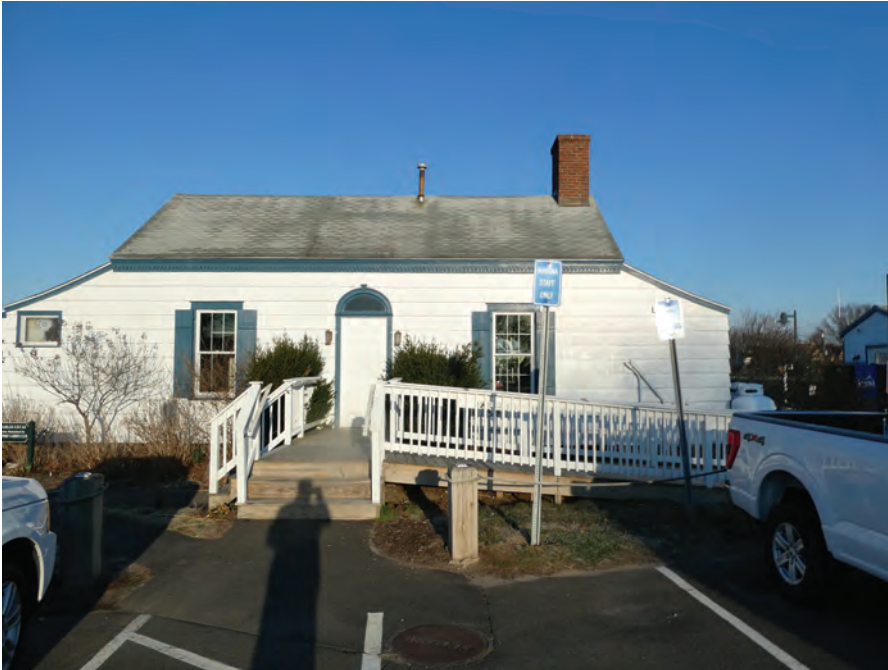
MAIN ELEVATION - REROOF SHORTLY.

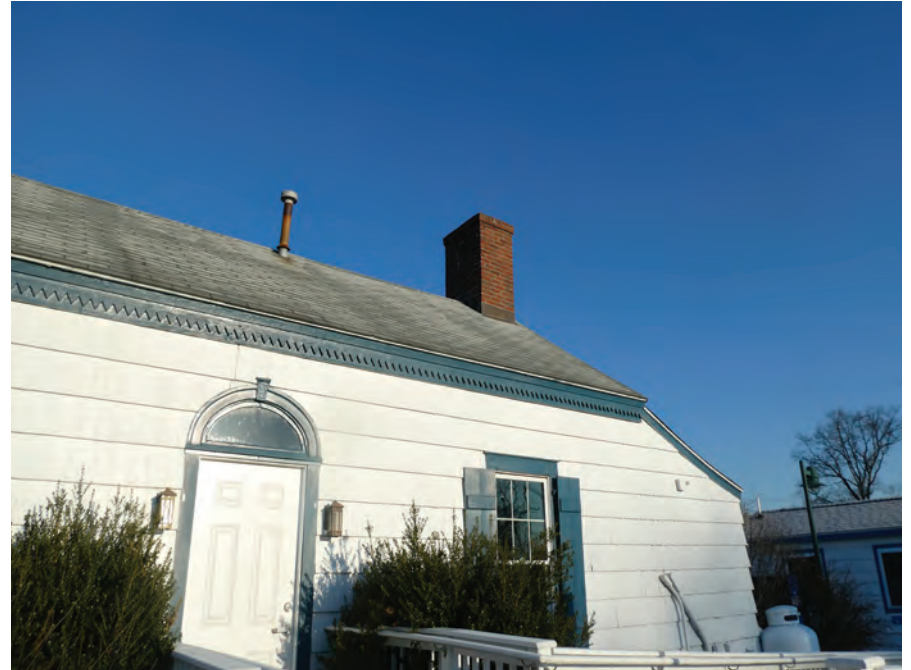
PAINT SHORTLY.

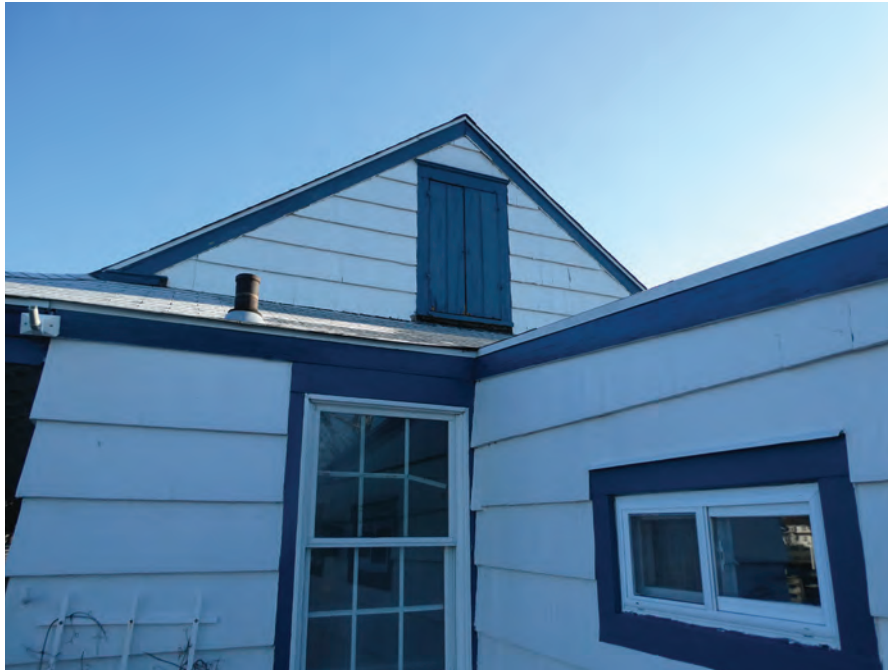
PAINT SIDING SOON

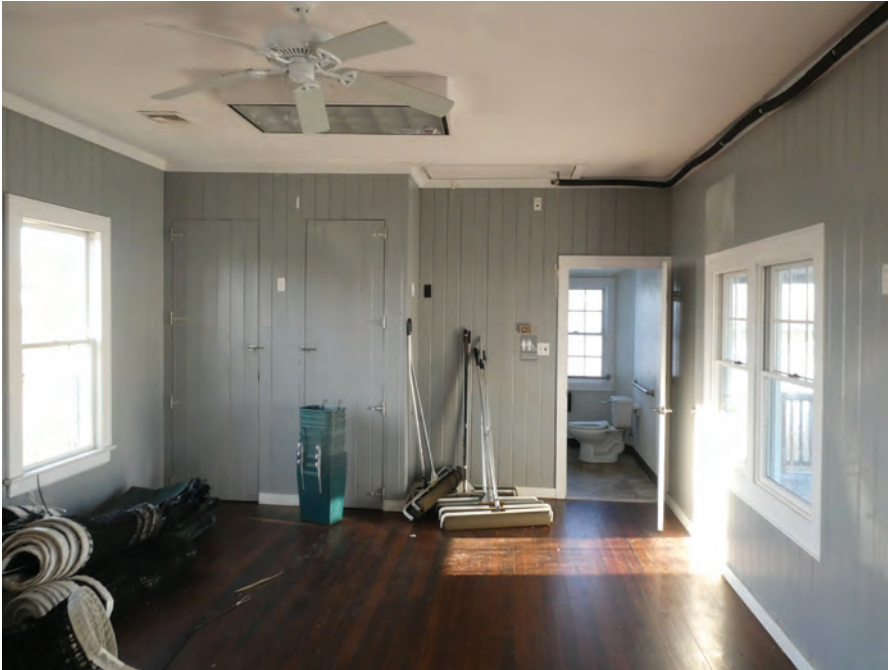
OLDER LIGHTING

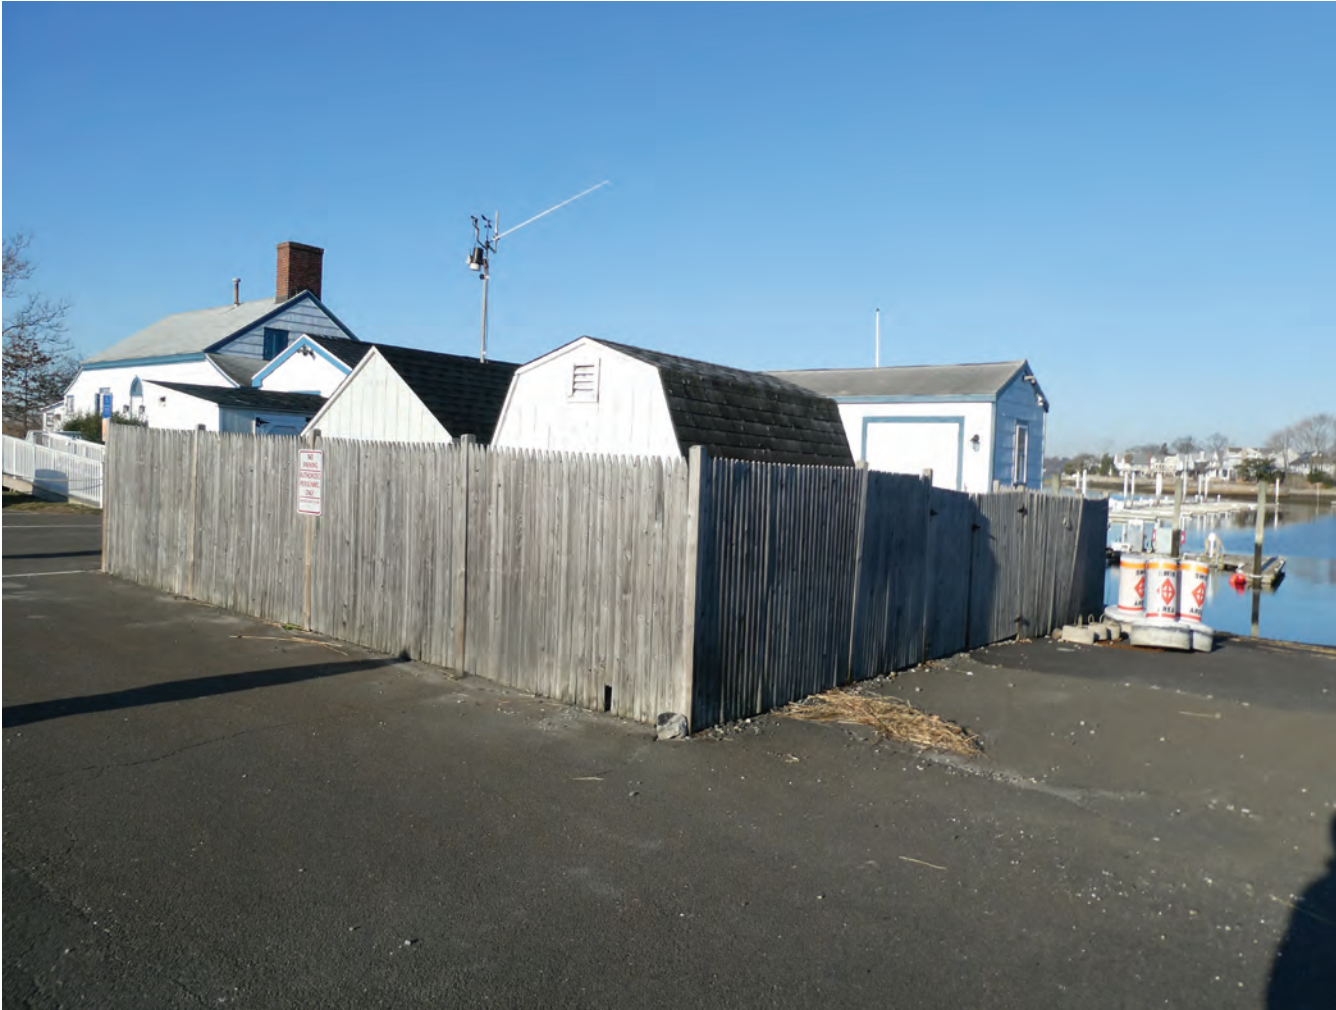
The Marina Offices and the Westport Marine Police structure appear to be in good working order. The exterior fence is rapidly becoming deteriorated around the storage courtyard where various storage items, buoy's, older canoes, and other such craft exist. The floor of the courtyard is gravel. The fence requires replacement, along with some gates on the north side of the courtyard.

REPLACE FENCING AND GATES.

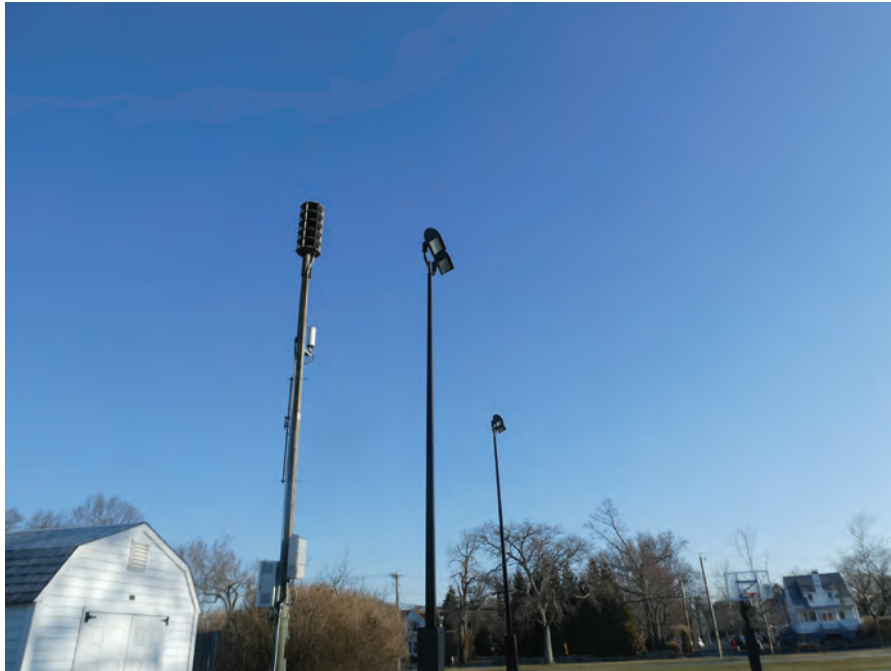
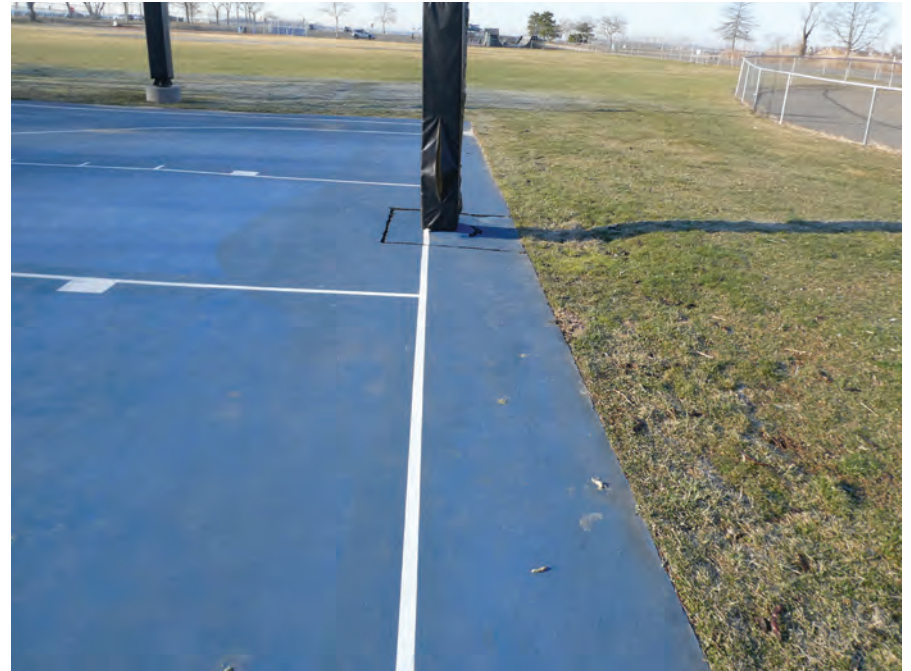
TRIPPING HAZARD

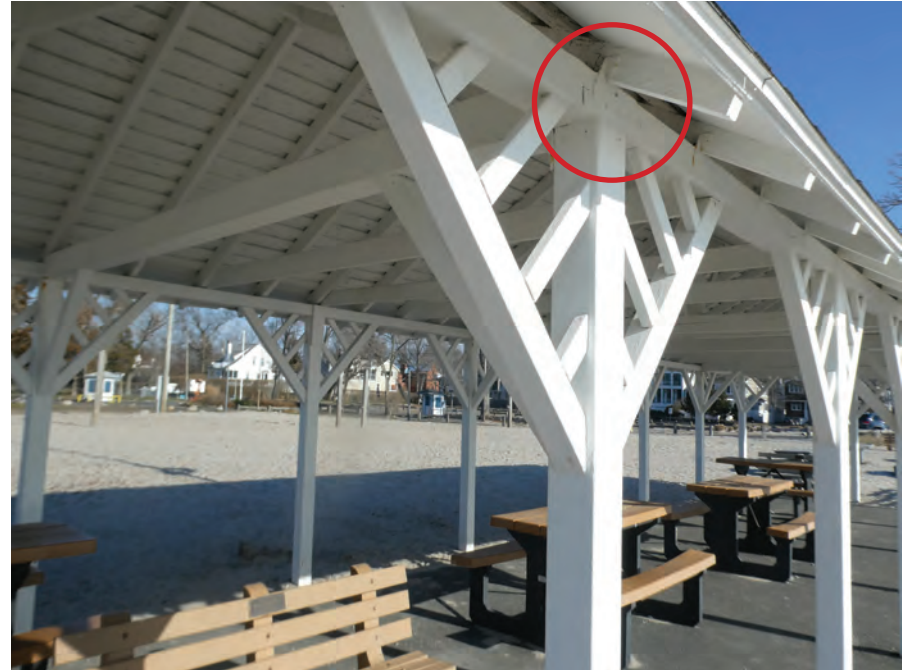
COLUMN REINFORCEMENT

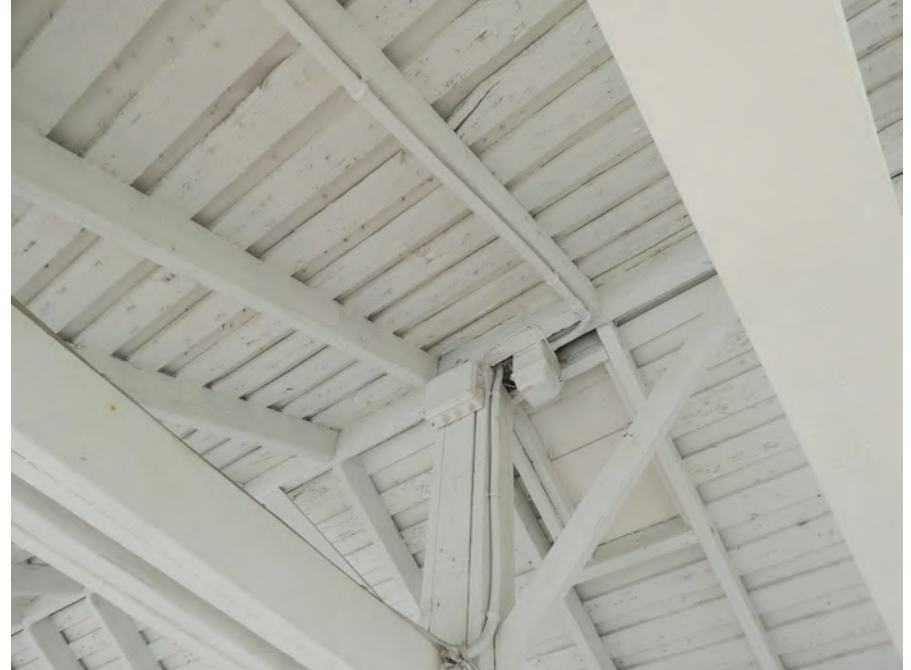
PAINT UNDERSIDE OF ROOF

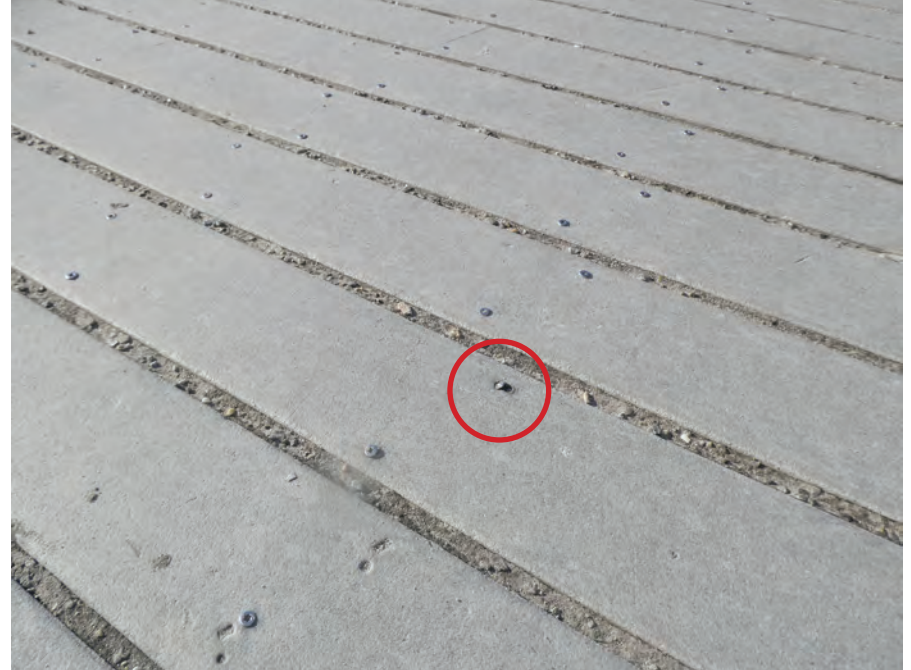
SHARP EDGES SCREWS

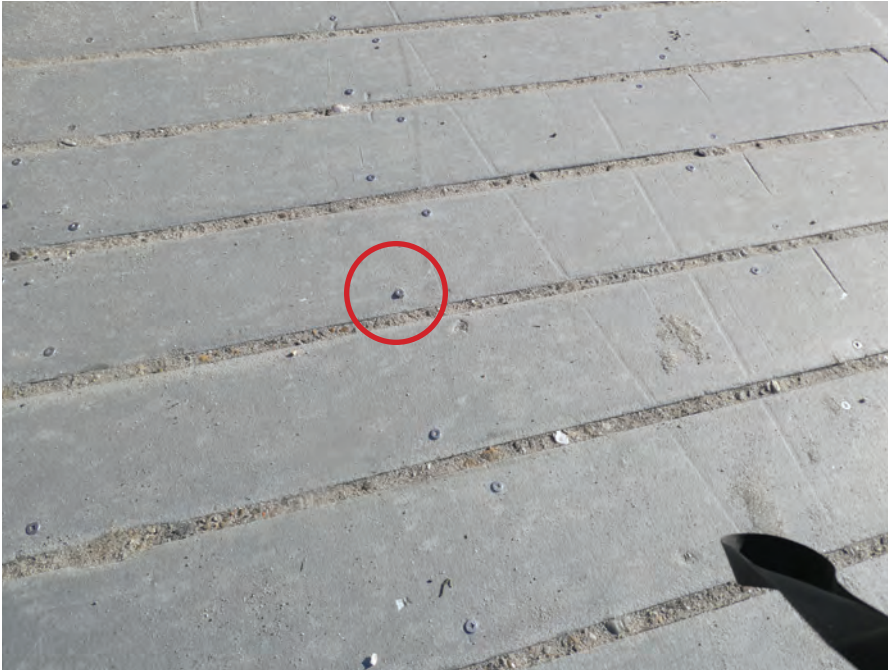
SHARP EDGES SCREWS

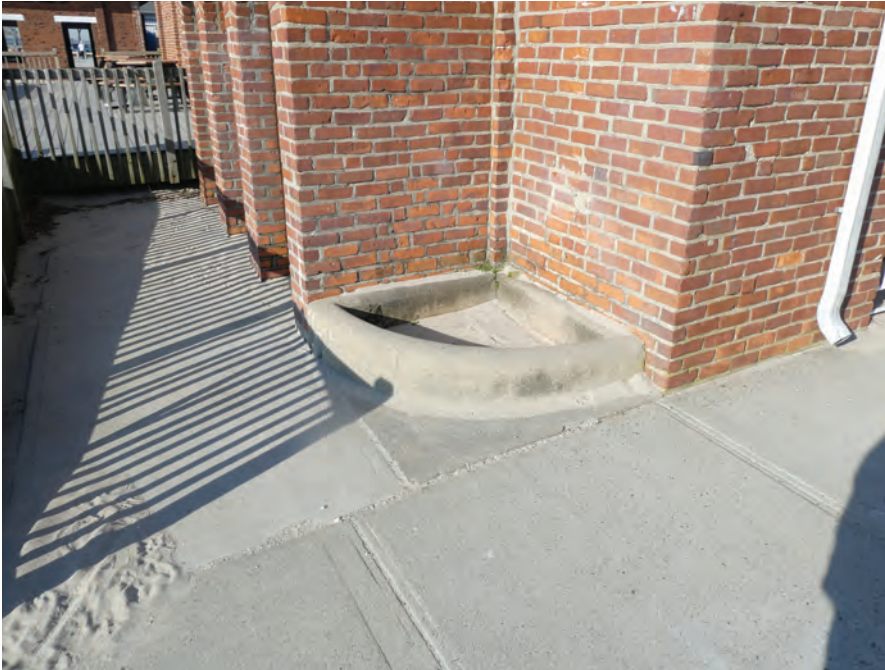
TOILET AREA - REQUIRED REMODELED.

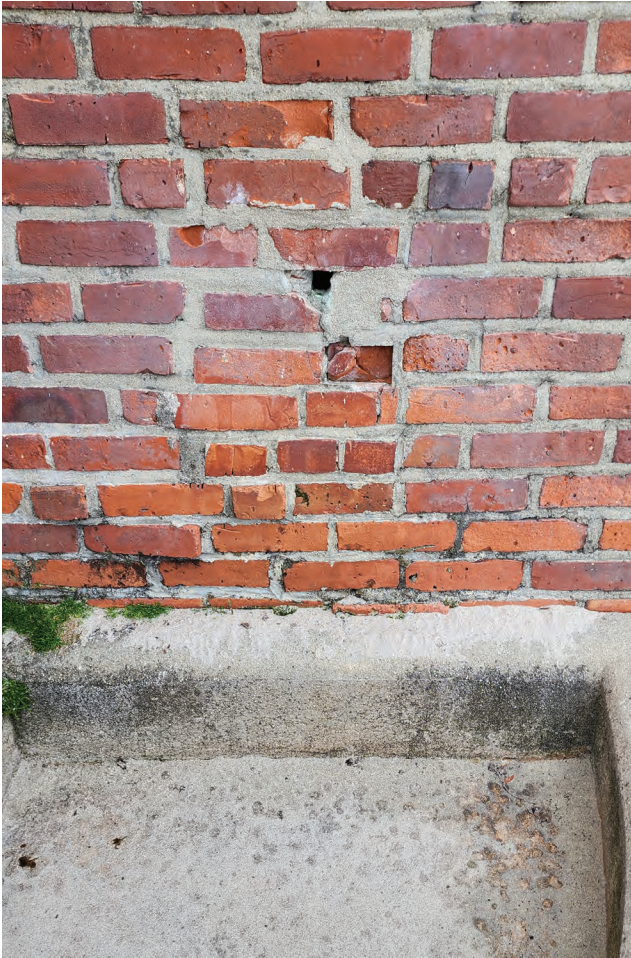
HORIZONTAL CRACK IN WALL.
